Ethical Issues from the Kansas City  
Hyatt Hotel Collapse

J. Paul Guyer, P.E., R.A.

Figure 2  
The Hyatt Regency Hotel in Kansas City

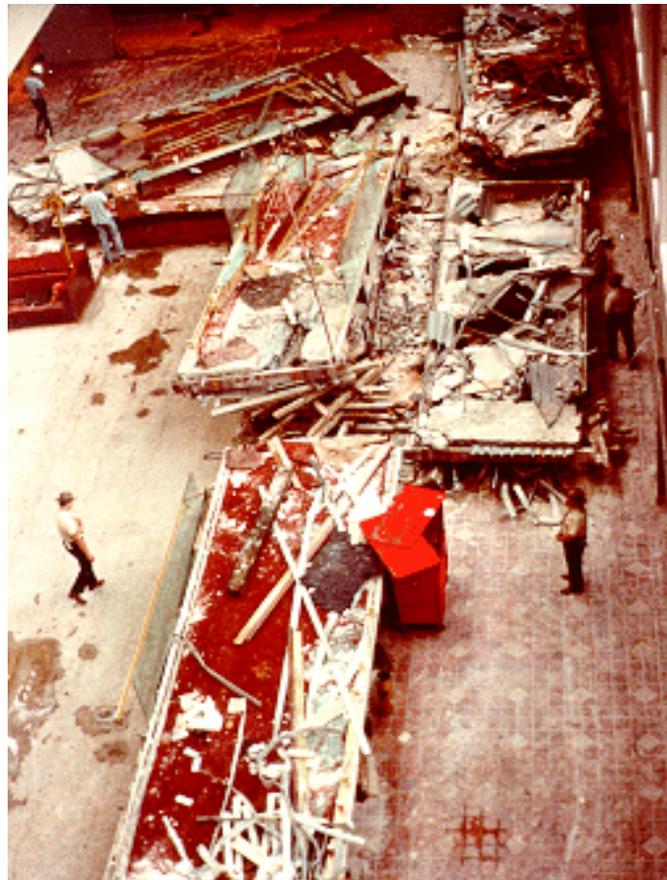
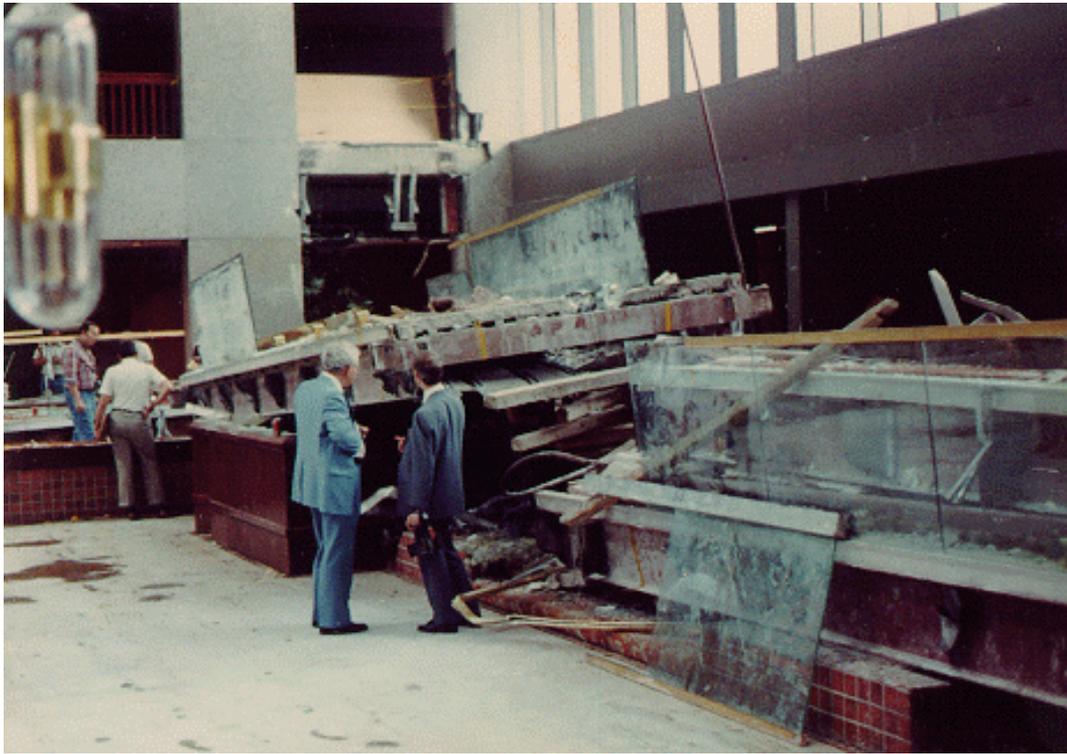
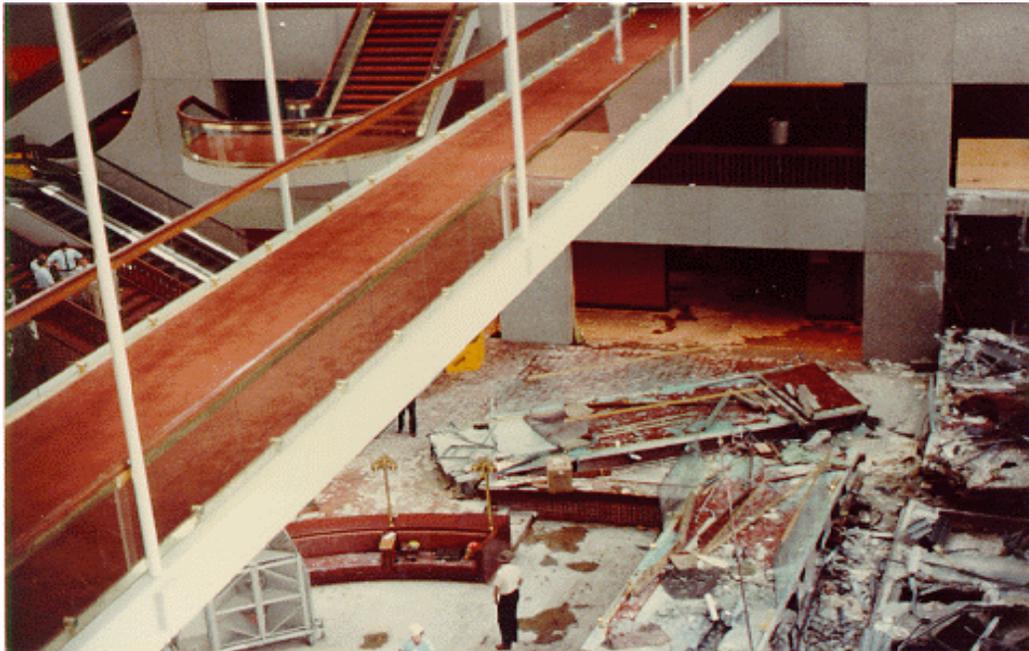
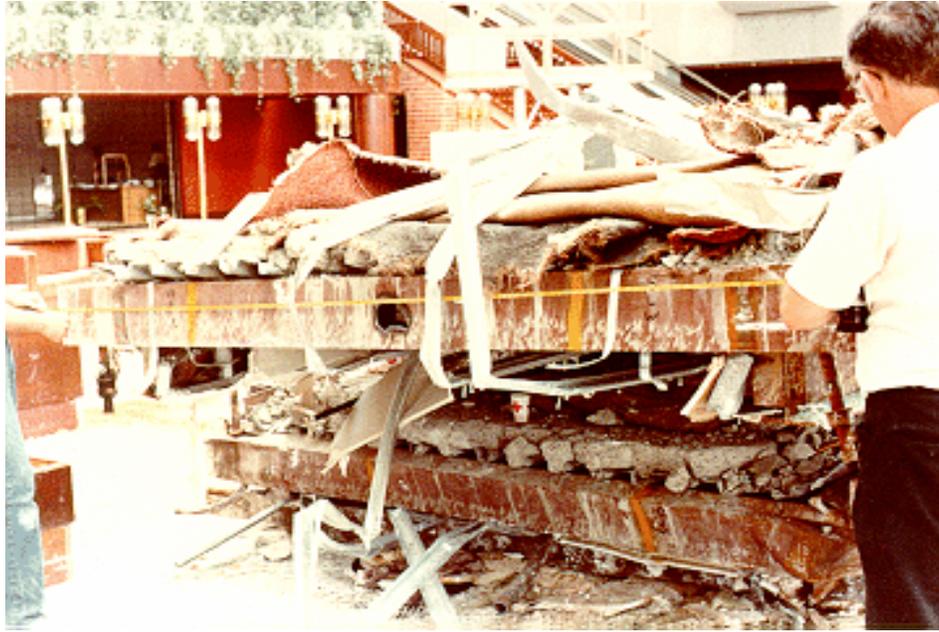
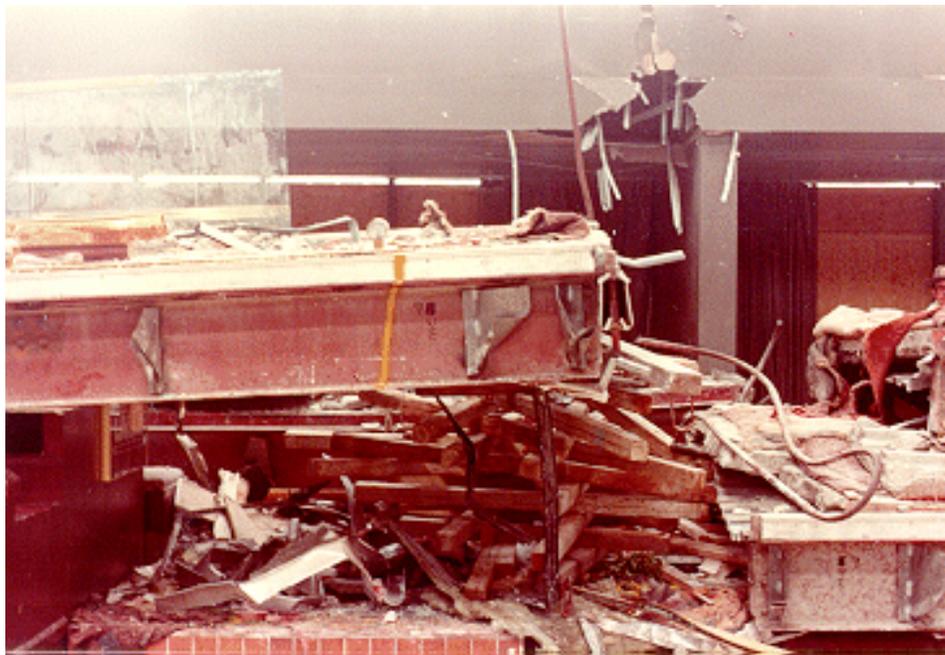
Here is what the incident scene looked like....

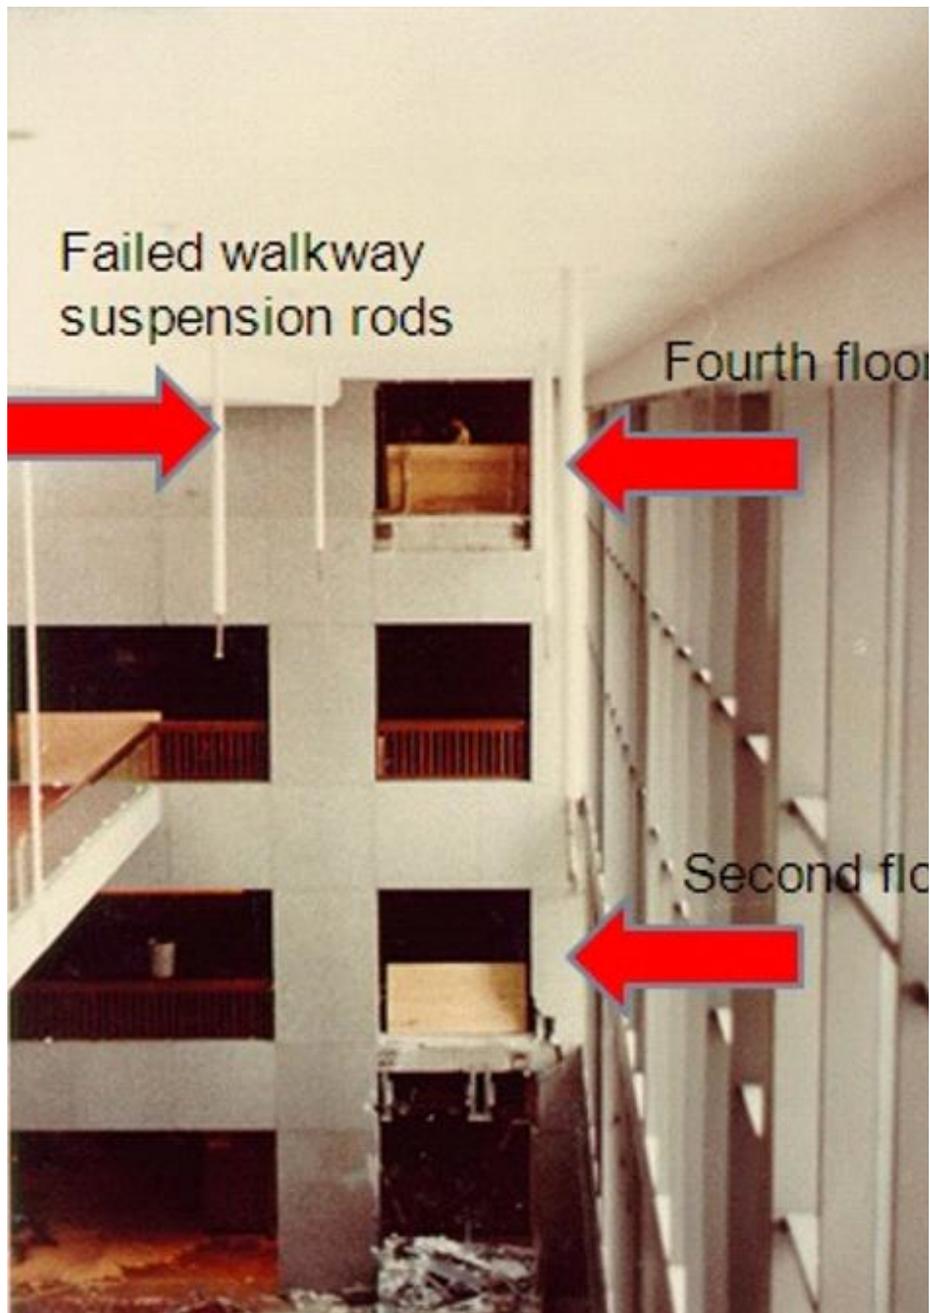
The fourth floor walkway failed, collapsed onto the second floor walkway, both crashed to the lobby floor, and 114 people were killed and 200 injured.

Figure 9  
Collapsed Walkways at 2<sup>nd</sup> and 4<sup>th</sup> Floors

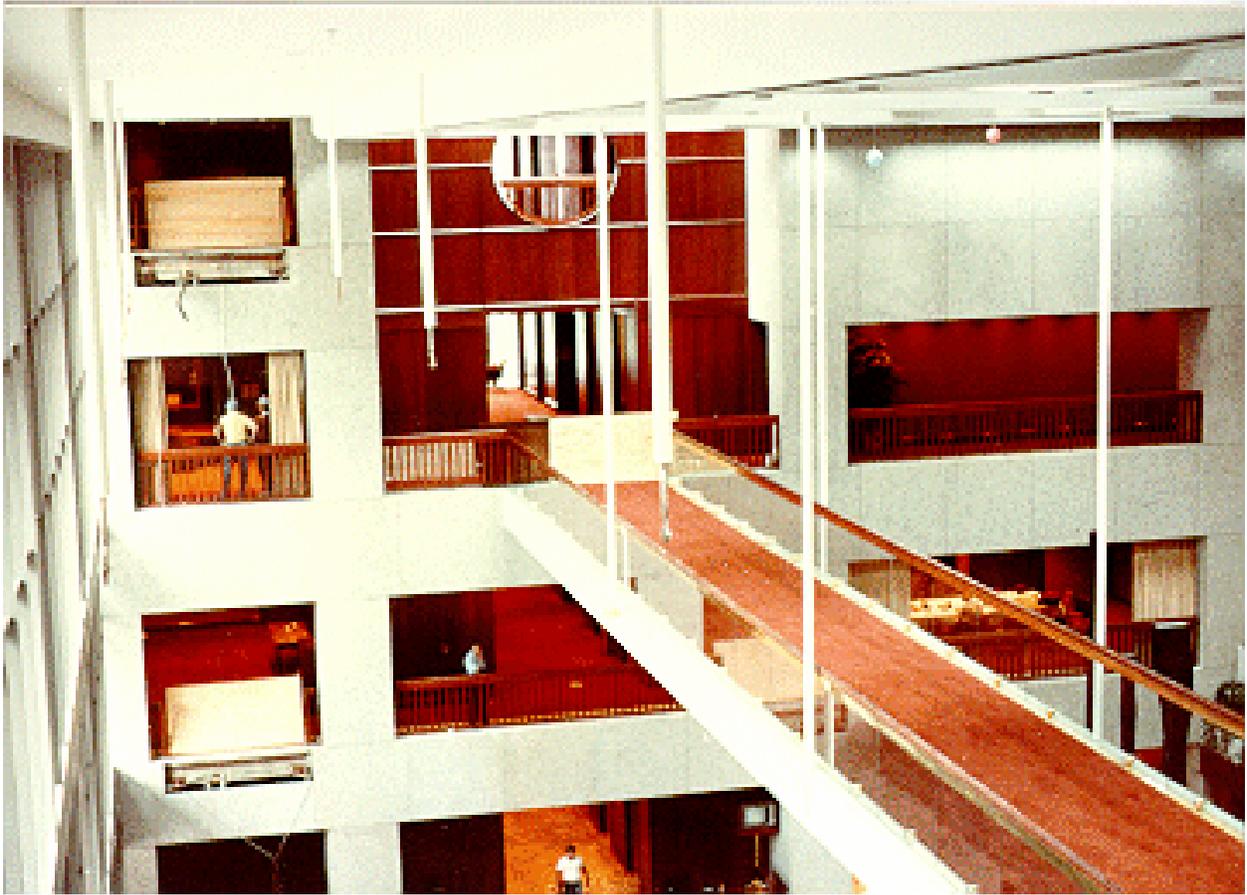
The third walkway, at the third floor, was offset from the other two and was not involved in the failure.

Figure 10  
Surviving 3<sup>rd</sup> Floor Walkway

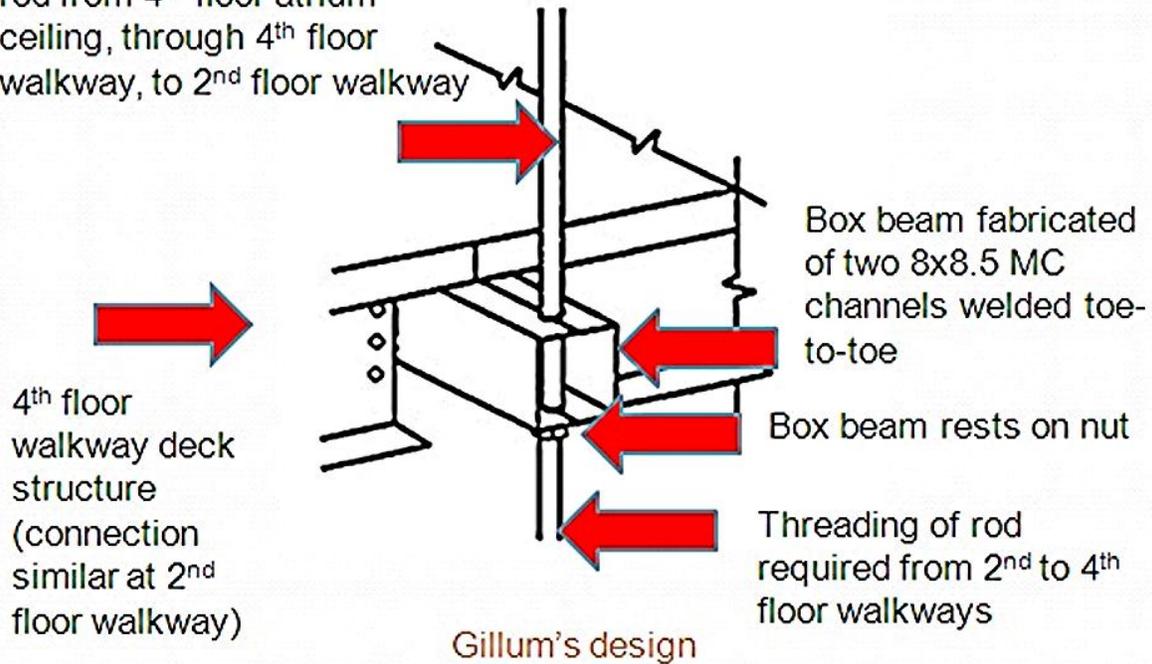
1-1/4" continuous suspension rod from 4<sup>th</sup> floor atrium ceiling, through 4<sup>th</sup> floor walkway, to 2<sup>nd</sup> floor walkway

Figure 13  
The Structural Engineer's Original Design

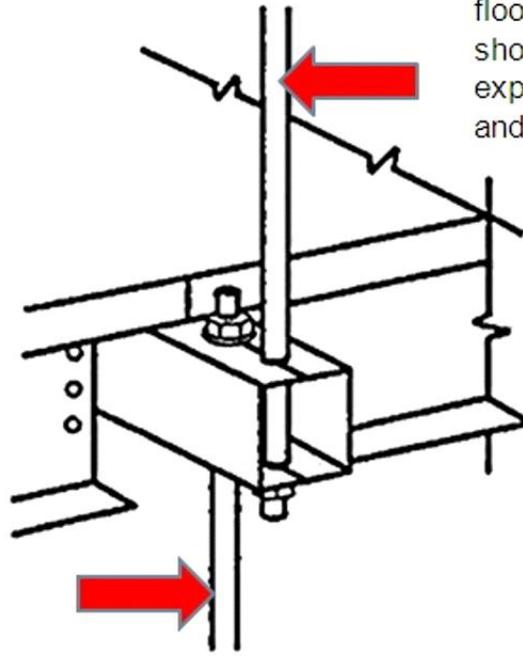
The cause of the failure was a change made by the steel detailer (WRW, a sub-contractor to Havens, which in turn was a sub-contractor to Eldridge) to the suspension rods design shown on the structural engineer Gillum's drawings.

One rod from 4<sup>th</sup> floor atrium ceiling to 4<sup>th</sup> floor walkway; shorter rods, less expensive to procure and install.

Second rod from 4<sup>th</sup> floor walkway ceiling to 2<sup>nd</sup> floor walkway; shorter rods, less expensive to procure and install, and lengthy threading of rod eliminated.

Figure 14  
The change made by the Steel Fabricator-Erector/Detailer

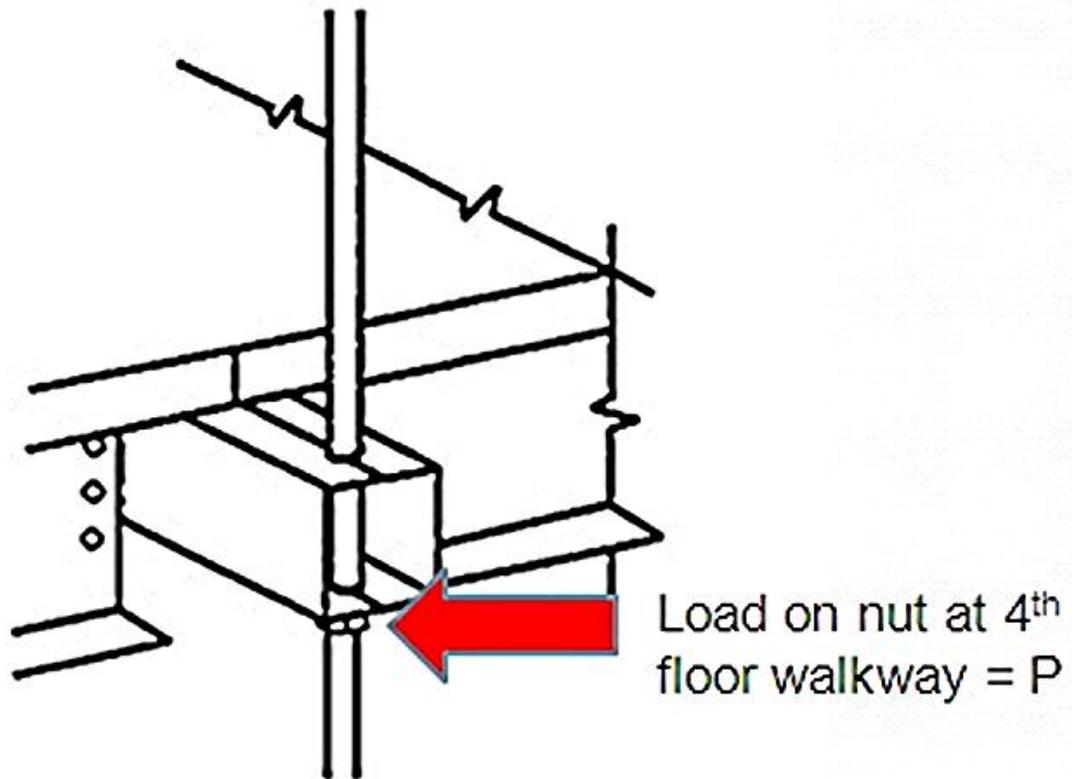
Gillum's design

Figure 15  
The Structural Engineer's Original Design

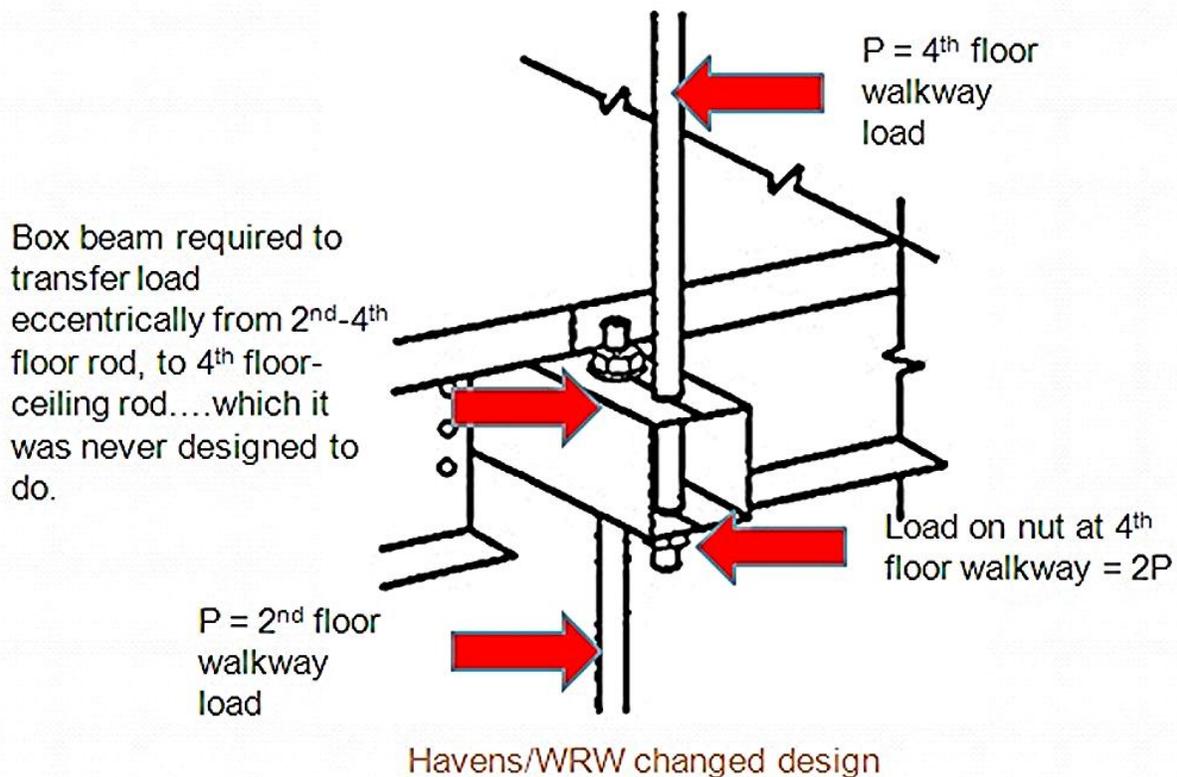
Figure 16  
The change made by the Steel Fabricator-Erector/Detailer

- **the design change which led to the failure at the box beam-nut-suspension rod connection**

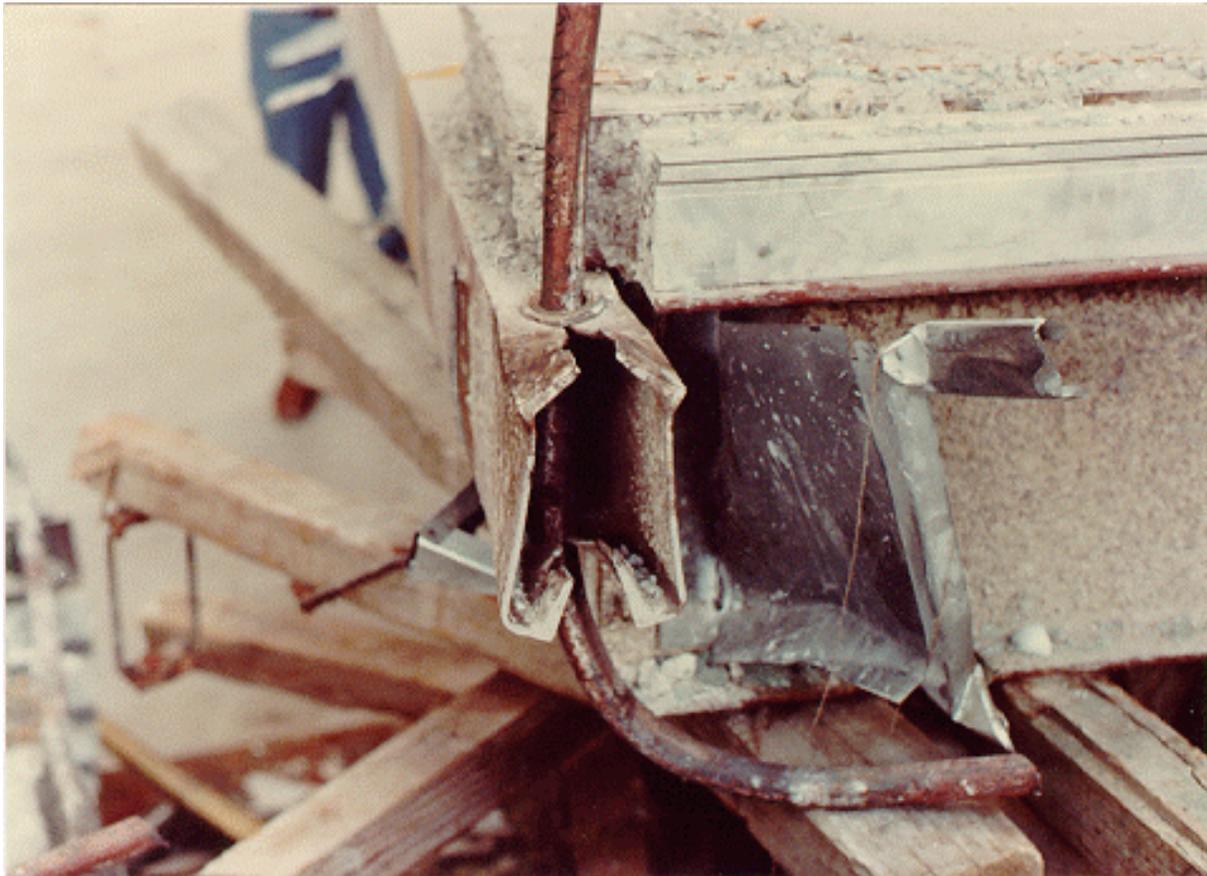
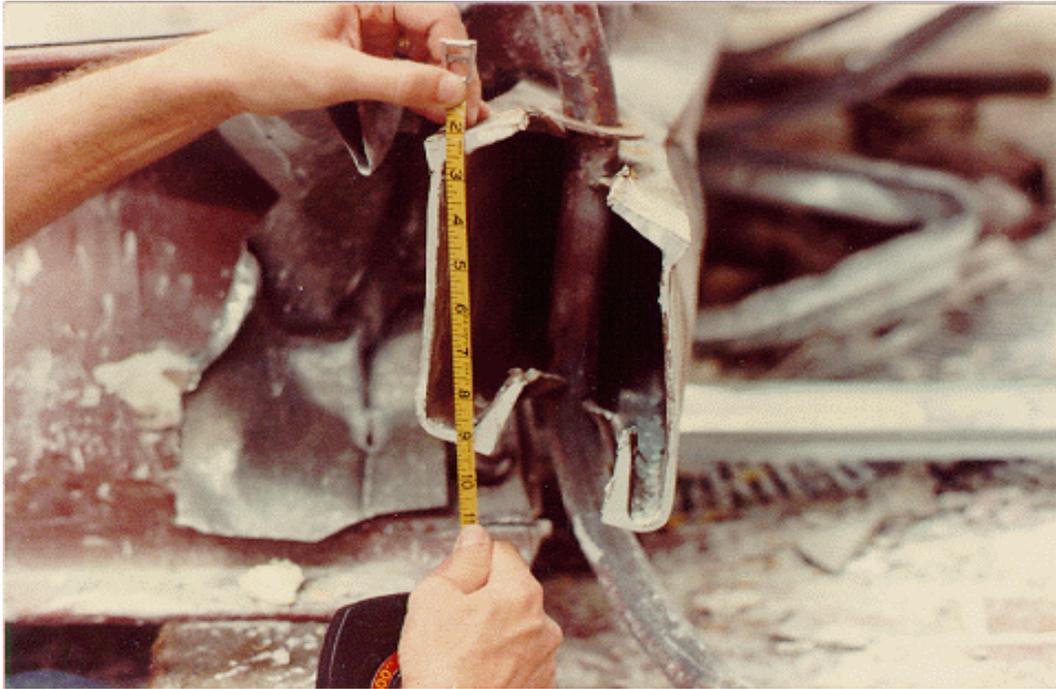
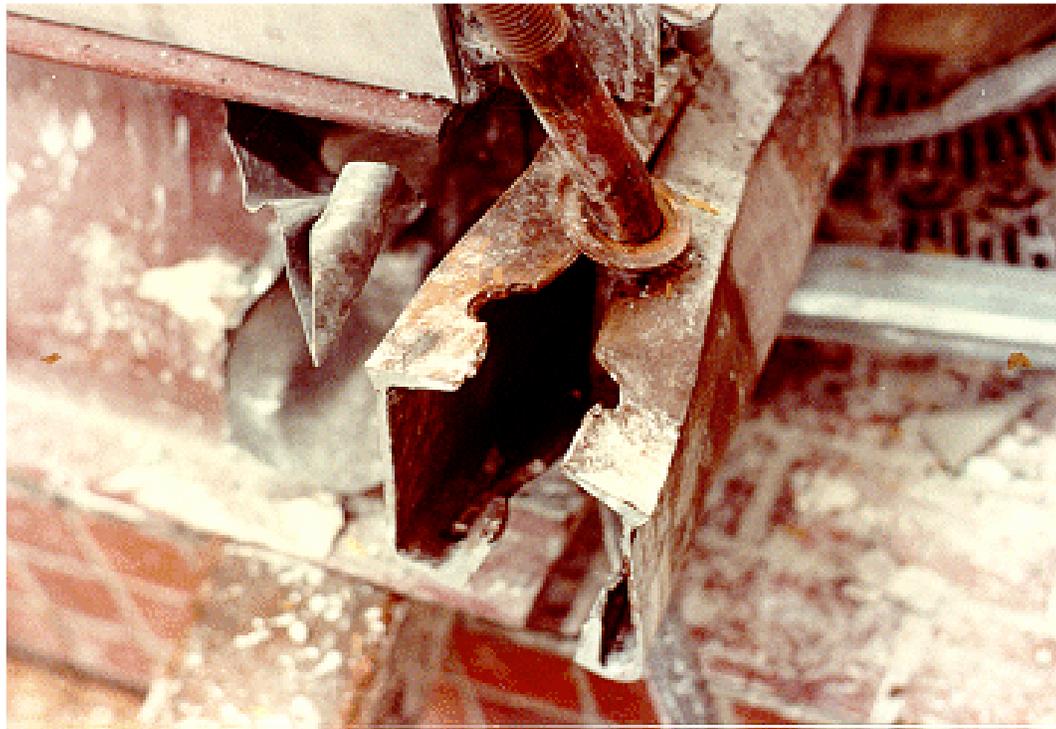
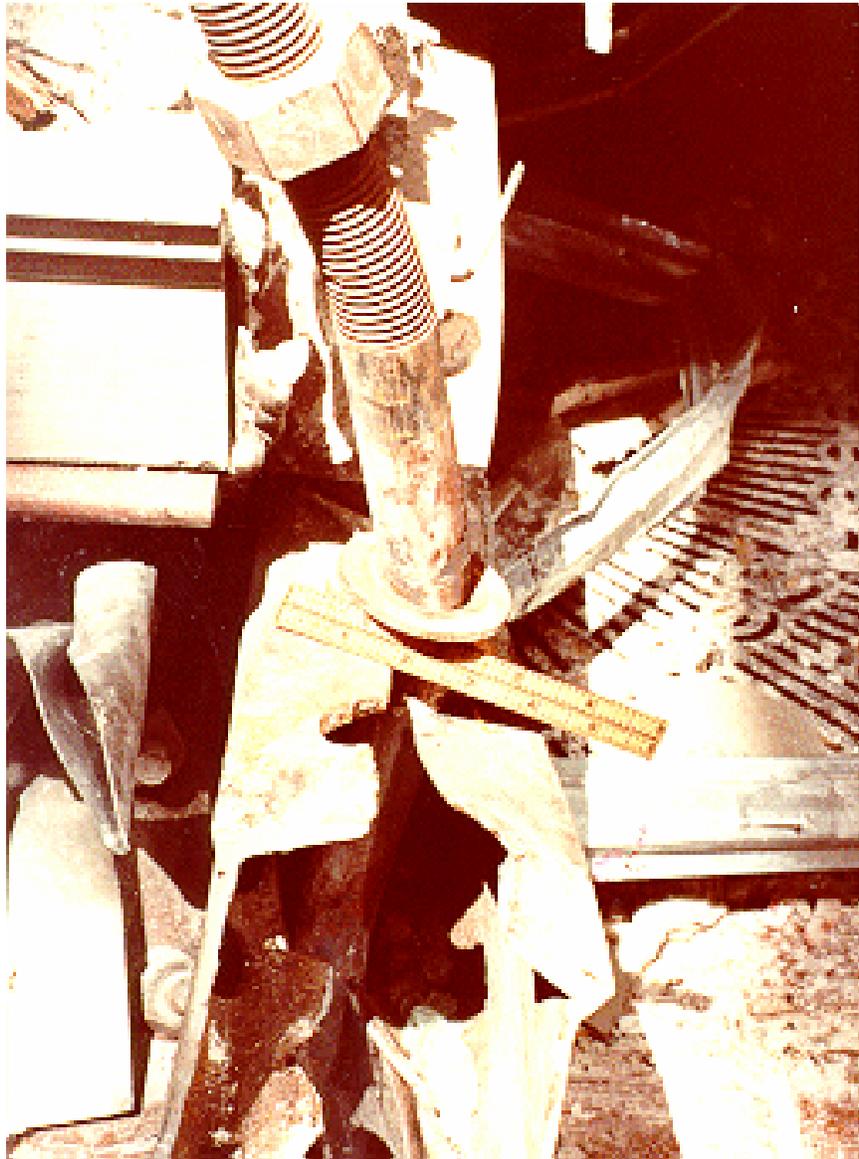
#### **4.5 AND HERE IS WHAT HAPPENED....**
