**NORTH AMERICAN ELECTRIC RELIABILITY COUNCIL**

**Technical Analysis of the  
August 14, 2003, Blackout:  
*What Happened, Why, and What Did We Learn?***

**Report to the NERC Board of Trustees  
by the NERC Steering Group**

**July 13, 2004**

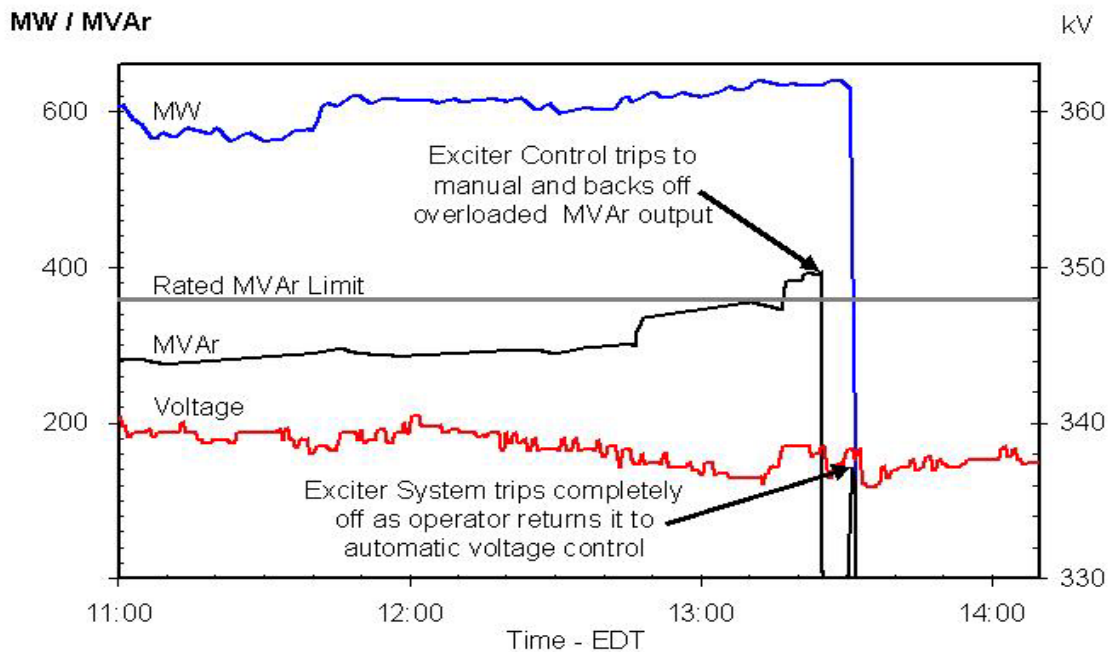
Figure III.1 — Eastlake 5 Output Prior to Trip at 13:31 EDT

The effects of the plant operator trying to go to “max max” at 13:16 are apparent in Figure III.1. The reactive output rose above the assumed maximum for about four minutes. There is a slight step increase in the reactive output of the unit again. This increase is believed to correlate with the trip of a 138-kV capacitor bank in the FE system that field personnel were attempting to restore to service. The reactive output remains at this level for another three to four minutes and then the Automatic Voltage Regulator (AVR) tripped to manual operation and a set point that effectively brought the (gross) Mvar output of the unit to zero. When a unit at full MW load trips from AVR to manual control, the Mvar output should not be designed or set to decrease the Mvar output to zero. Normal practice is to decrease the exciter to the rated full load DC field current or a reasonable preset value. Subsequent investigation found that this unit was set incorrectly.

About four or five minutes after the Mvar output decreased to zero, the operator was increasing the terminal voltage and attempting to place the exciter back on AVR control when the excitation system tripped altogether (see Figure III.1). The unit then tripped off at 13:31:34 when the loss of excitation relay operated. Later phone transcripts indicate subsequent trouble with a pump valve at the plant that would not re-seat after the trip. As a result, the unit could not be quickly returned to service.

The excitation system failure not only tripped the Eastlake unit 5 — a critical unit in the Cleveland area — the effort to increase Eastlake 5 voltage did not produce the desired result. Rather, the result of trying to increase the reactive output of the Eastlake 5 generating unit, once the unit tripped, was a decrease in reactive support to the Cleveland-Akron area.

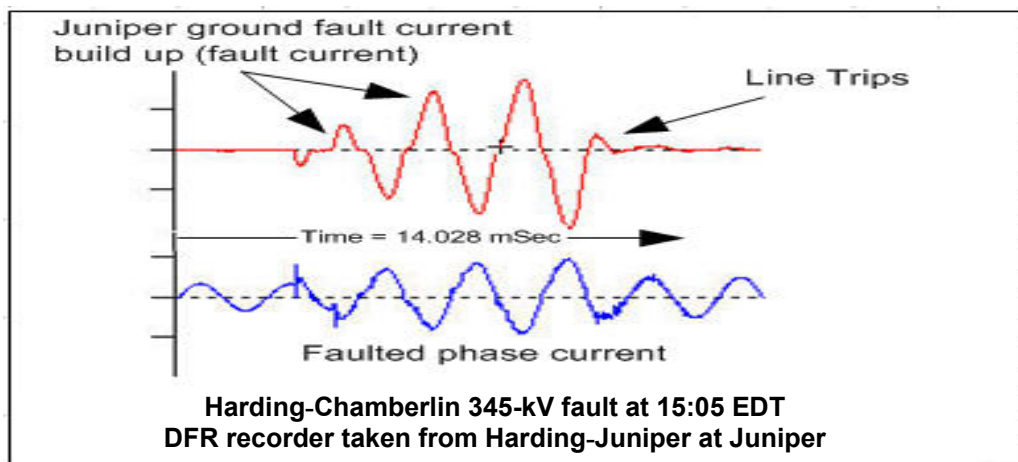
**Figure III.4 — Juniper DFR Indication of Tree Contact for Loss of the Chamberlin-Harding Line**

At 15:05:41, The FE Chamberlin-Harding 345-kV line tripped and locked out while loaded at 500 MVA or 43.5 percent of its normal and emergency ratings of 1,195 MVA (which are the same values). At 43.5 percent loading, the conductor temperature did not exceed its design temperature and the line could not have sagged sufficiently to allow investigators to conclude that the line sagged into the tree due to overload. Instead, investigators determined that FE had allowed trees in the Chamberlin-Harding right-of-way to grow too tall and encroach into the minimum safe clearance from a 345-kV energized conductor. The investigation team examined the relay data for this trip, which indicated high impedance Phase C fault-to-ground, and identified the geographic location of the fault. They determined that the relay data match the classic signature pattern for a tree-to-line fault (Figure III.4). Chamberlin-Harding tripped on directional ground relay — part of a directional comparison relay scheme protecting the line.

Going to the fault location as determined from the relay data, the field team found the remains of trees and brush. At this location, conductor height measured 46 feet 7 inches, while the height of the felled tree measured 42 feet; however, portions of the tree had been removed from the site. This means that while it is difficult to determine the exact height of the line contact, the measured height is a minimum and the actual contact was likely three to four feet higher than estimated here. Burn marks were observed 35 feet 8 inches up the tree, and the crown of this tree was at least six feet taller than the observed burn marks. The tree showed evidence of fault current damage.

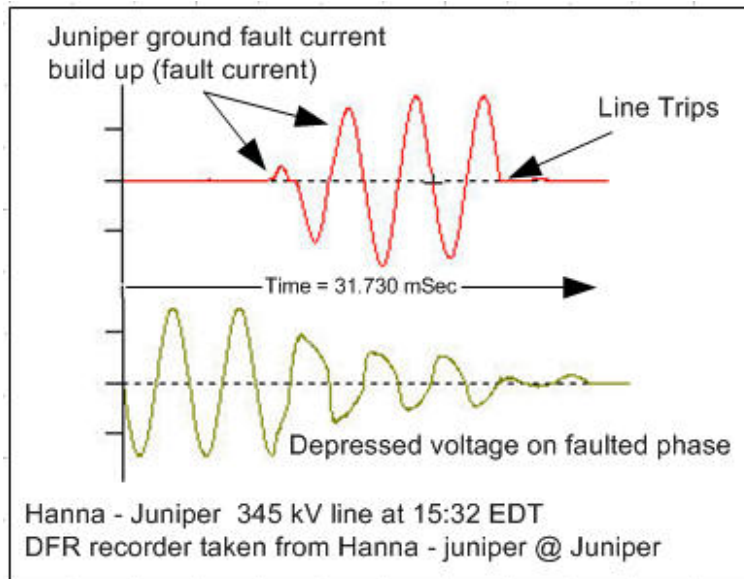
**Figure III.5 — Juniper DFR Indication of Tree Contact for Loss of Hanna-Juniper**

Incremental line current and temperature increases, escalated by the loss of Chamberlin-Harding, caused enough sag on the Hanna-Juniper line that it experienced a fault current due to tree contact, tripped and locked out at 15:32:03, with current flow at 2,050 amperes or 87.5 percent of its normal and emergency line rating of 2,344 amperes. Figure III.5 shows the Juniper digital fault recorder indicating the tree signature of a high-impedance ground fault. Analysis showed high arc resistance limiting the actual fault current well below the calculated fault current assuming a "bolted" (no arc resistance) fault.

The tree contact occurred on the south phase of the Hanna-Juniper line, which is lower than the center phase due to construction design. Although little evidence remained of the tree during the field visit in October, the team observed a tree stump 14 inches in diameter at its ground line and talked to a member of the FE tree-trimming crew who witnessed the contact on August 14 and reported it to the FE operators. FE was conducting right-of-way vegetation maintenance and the tree crew at Hanna-Juniper was three spans away clearing vegetation near the line, when the contact occurred on August 14. FE provided photographs that clearly indicate that the tree was of excessive height. Similar trees nearby but not in the right-of-way were 18 inches in diameter at ground line and 60 feet in height. Further inspection showed at least 20 trees growing in this right-of-way.

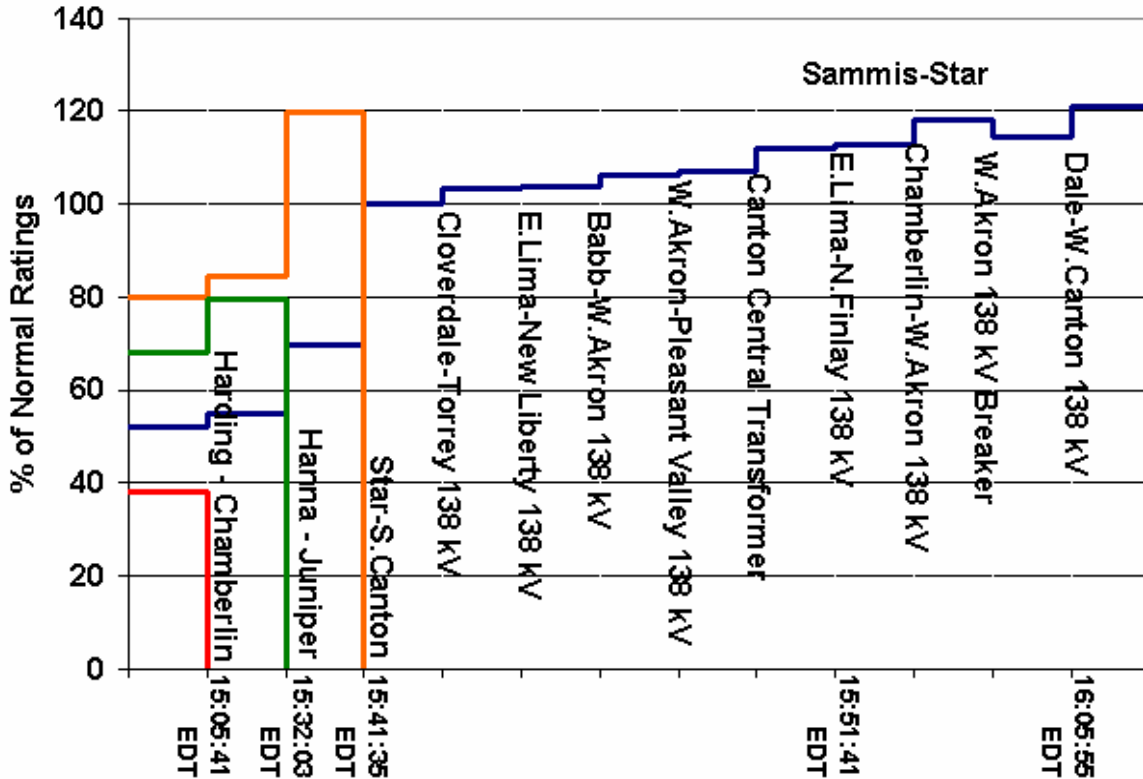
**Figure III.6 — Line Loadings as the Northeast Ohio 345-kV Lines Trip**

Figure III.6 shows the line loadings calculated by the investigation team as the 345-kV lines in northeast Ohio began to trip. Showing line loadings on the 345-kV lines as a percent of normal rating, the graph tracks how the loading on each line increased as each subsequent 345-kV and 138-kV line tripped out of service between 15:05 (Chamberlin-Harding) and 16:06 (Dale-West Canton). As the graph shows, none of the 345- or 138-kV lines exceeded their normal ratings on an actual basis (although contingency overloads existed) until after the combined trips of Chamberlin-Harding and Hanna-Juniper. But immediately after Hanna-Juniper was lost, Star-South Canton's loading jumped from an estimated 82 percent of normal to 120 percent of normal (still below its emergency rating) and remained at that level for ten minutes before tripping out. To the right, the graph shows the effects of the 138-kV line failures (discussed next) on the remaining 345-kV line, i.e., Sammis-Star's loading increased steadily above 100 percent with each succeeding 138-kV line lost.

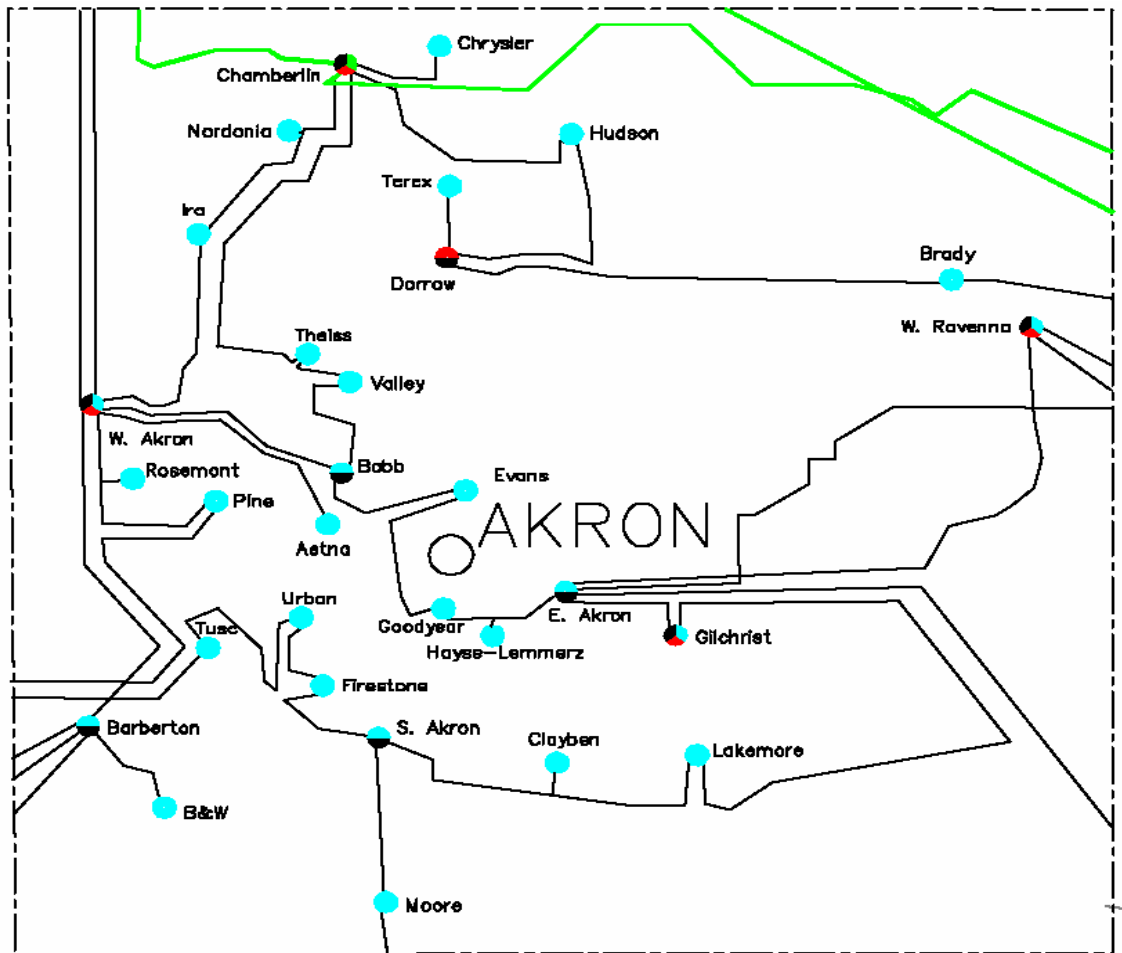
Figure III.7 — Akron Area Substations Participating in Localized 138-kV Cascade

During this same period at 15:45:41, the Canton Central-Tidd 345-kV line tripped and then reclosed at 15:46:29. The Canton Central 345/138-kV Circuit Breaker A1 operated multiple times, causing a low air pressure problem that inhibited circuit breaker tripping. This event forced the Canton Central 345/138-kV transformer to disconnect and remain out of service, further weakening the Canton-Akron area 138-kV transmission system.

Approximately 600 MW of customer loads were shut down in Akron and areas to the west and south of the city during the cascade because they were being served by transformers connected to those lines. As the lines failed, severe voltage drops caused a number of large industrial customers with voltage-sensitive equipment to go off-line automatically to protect their operations.

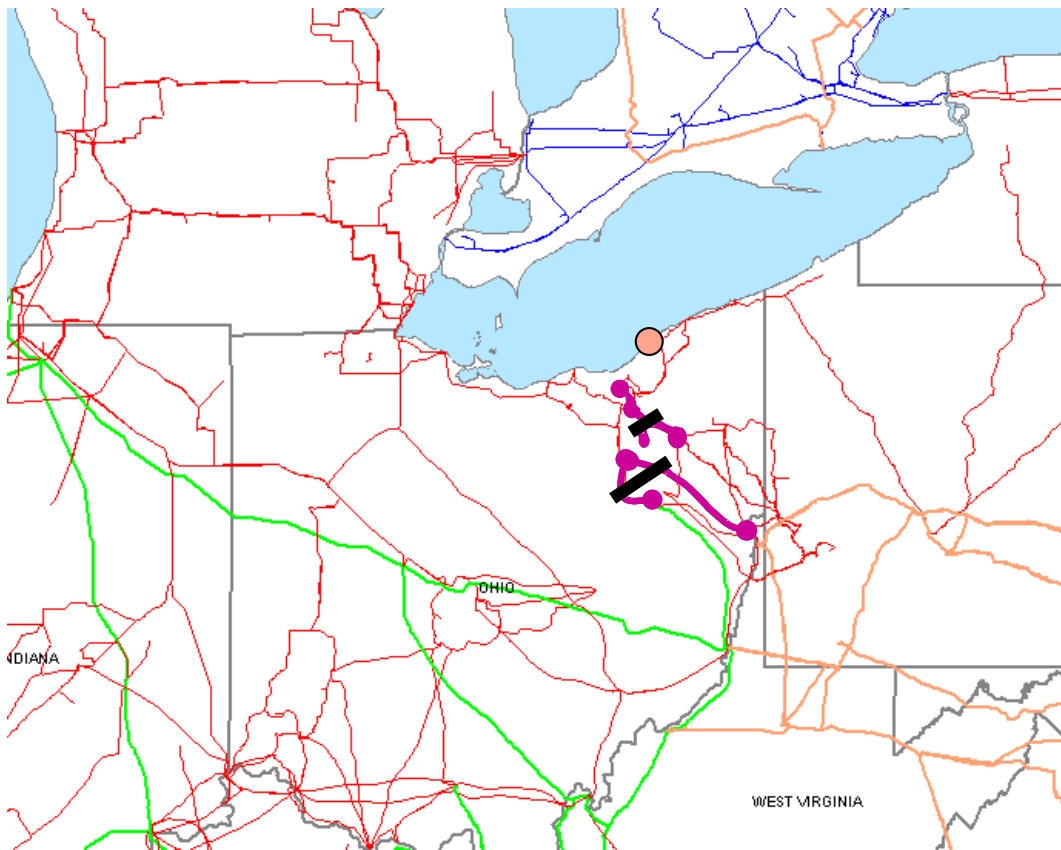
**Figure III.8 — Cleveland-Akron Cut Off**

As shown in Figure III.8, the Sammis-Star line trip completely severed the 345-kV path into northern Ohio from southeast Ohio, triggering a new, fast-paced sequence of 345-kV transmission line trips in which each line trip placed a greater flow burden on those lines remaining in service. After Sammis-Star tripped, there were only three paths left for power to flow into northern Ohio: (1) from northwestern Pennsylvania to northern Ohio around the south shore of Lake Erie, (2) from southern Ohio, and (3) from eastern Michigan and Ontario. Northeastern Ohio had been substantially weakened as a source of power to eastern Michigan, making the Detroit area more reliant on 345-kV lines west and northwest of Detroit, and from northwestern Ohio to eastern Michigan.

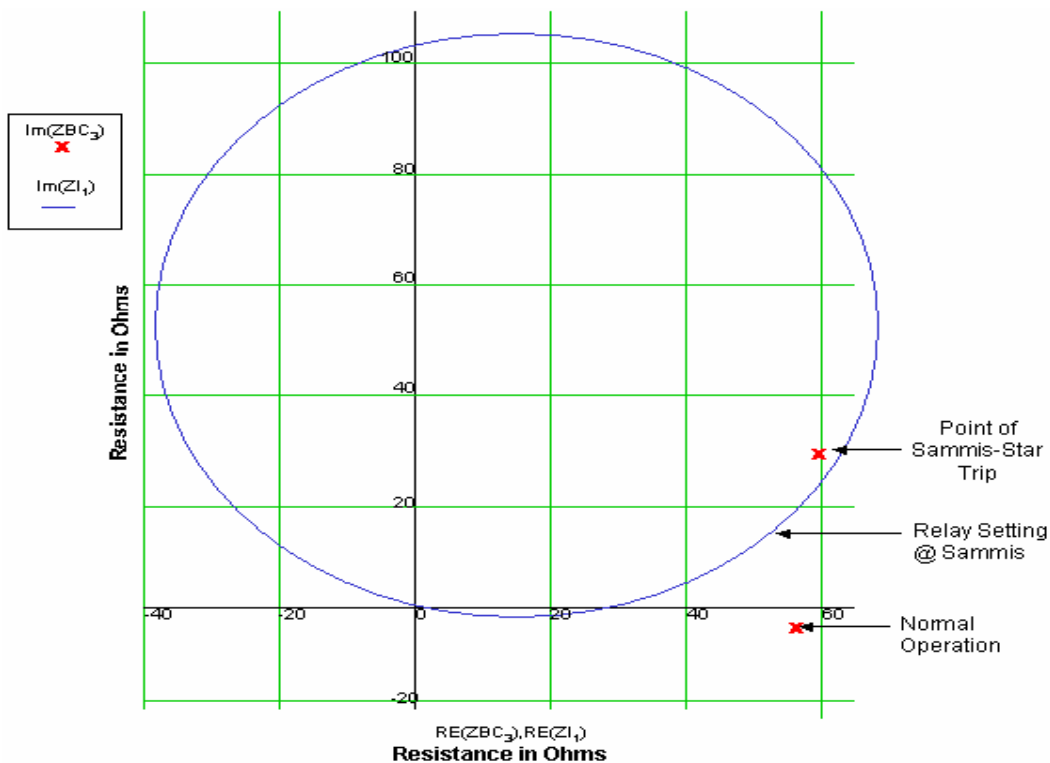
**Figure III.9 — Load Encroachment of Sammis-Star Zone 3 Impedance Relay**

A zone 3 relay can be defined as an impedance relay that is set to detect system faults on the protected transmission line and beyond.<sup>5</sup> It sometimes serves a dual purpose. It can act through a timer to see faults beyond the next bus up to and including the furthest remote element attached to the bus. It is used for equipment protection beyond the line and it is an alternative to equipment failure communication systems sometimes referred to as breaker failure transfer trip. Zone 3 relays can also be used in the high-speed relaying system for the line. In this application, the relay needs directional intelligence from the other end of the line that it receives via a highly reliable communication system. In the Sammis-Star trip, the zone 3 relay operated because it was set to detect a remote fault on the 138-kV side of a Star substation transformer in the event of a breaker failure.
