NORTH AMERICAN ELECTRIC RELIABILITY COUNCIL

Technical Analysis of the August 14, 2003, Blackout: *What Happened, Why, and What Did We Learn?*

**Report to the NERC Board of Trustees
by the NERC Steering Group**

July 13, 2004

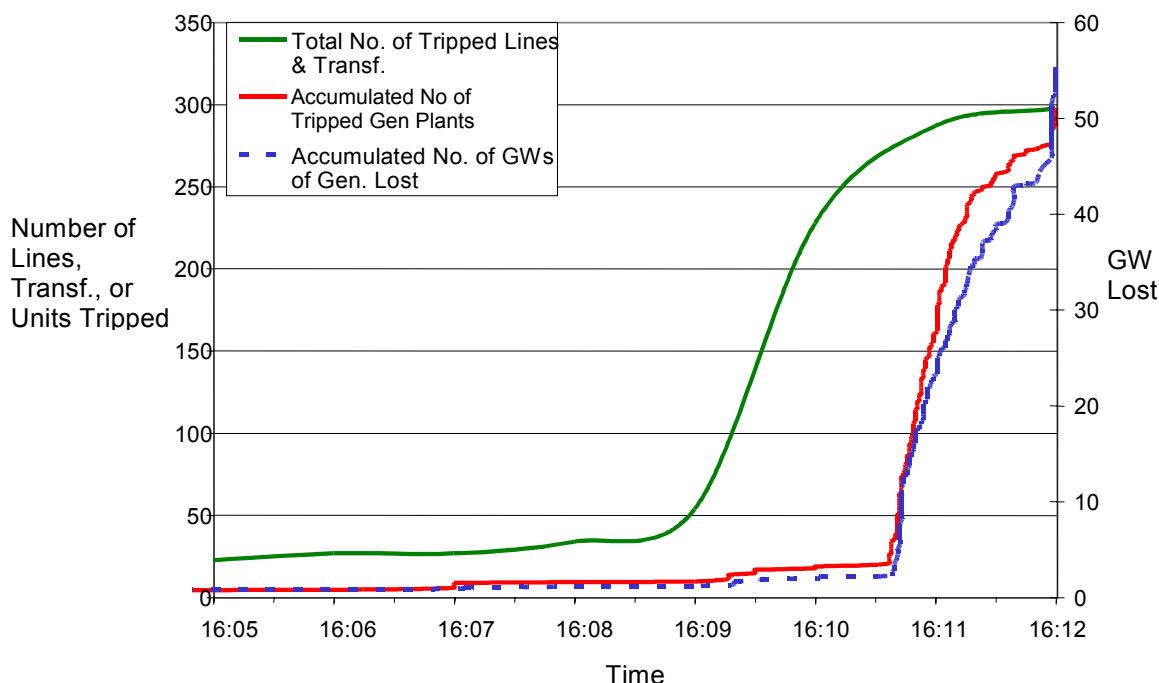
Figure IV.1 — Accumulated Line and Generator Trips During the Cascade

The events in the cascade started slowly, but spread quickly. Figure IV.1 illustrates how the number of lines and generators lost stayed relatively low during the Ohio phase of the blackout, but then picked up speed after 16:08:59. The cascade was complete only two-and-one-half minutes later.

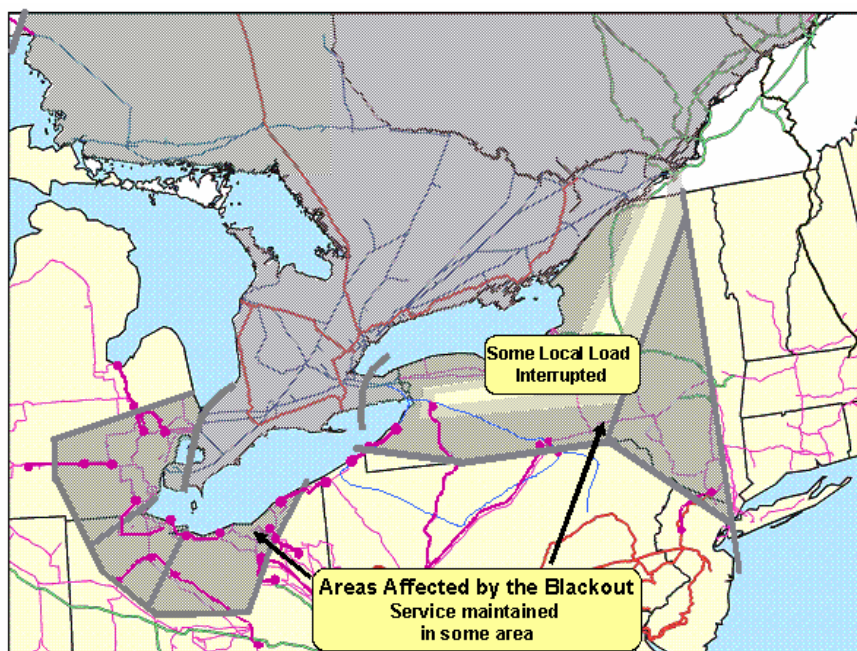
Figure IV.2 — Area Affected by the Blackout

In the final phase, after 16:10:46, the large electrical island in the northeast had less generation than load, and was unstable with large power surges and swings in frequency and voltage. As a result, many lines and generators across the disturbance area tripped, breaking the area into several electrical islands. Generation and load within most of the smaller islands were unbalanced, leading to further tripping of lines and generating units until equilibrium was established in each island. Although much of the disturbance area was fully blacked out in this process, some islands were able to reach equilibrium between generation and load without a total loss of service. For example, the island consisting of most of New England and the Maritime provinces stabilized, and generation and load returned to balance. Another island consisted of load in western New York and a small portion of Ontario, supported by some New York generation, the large Beck and Saunders plants in Ontario, and the 765-kV interconnection to Québec. These two large islands survived but other areas with large load centers collapsed into a blackout condition (Figure IV.2).

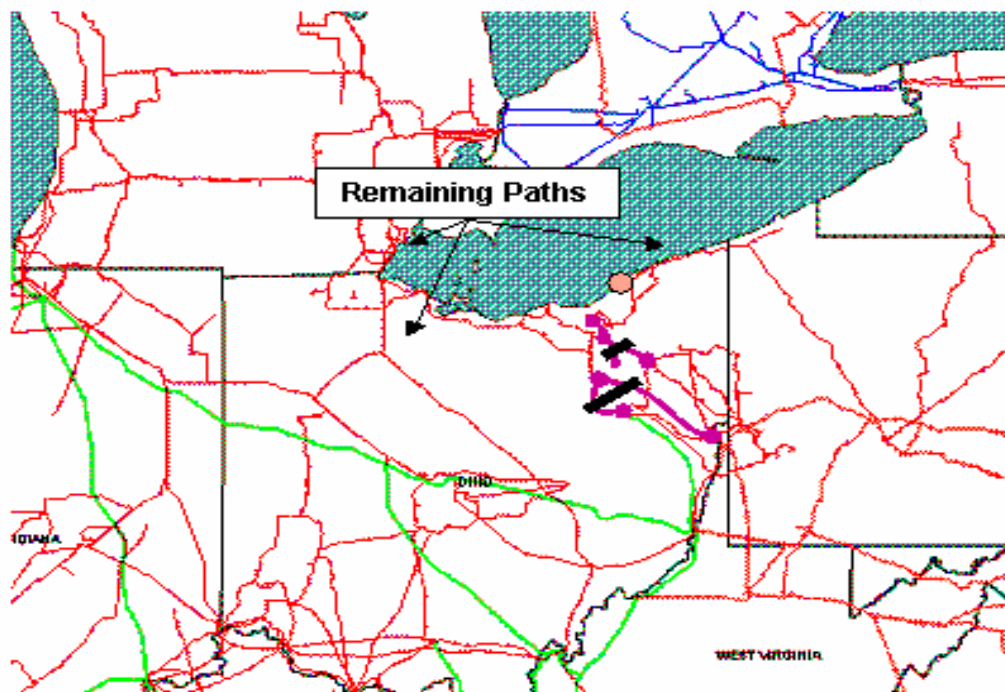
Figure IV.3 — Sammis-Star 345-kV Line Trip 16:05:57

After the loss of Sammis-Star and the underlying 138-kV system, there were no large capacity transmission lines left from the south to support the significant amount of load in northern Ohio (Figure IV.3). This overloaded the transmission paths west and northwest into Michigan, causing a sequential loss of lines and power plants.

Sammis-Star did not trip due to a short circuit to ground (as did the prior 345-kV lines that tripped). Sammis-Star tripped due to protective zone 3 relay action that measured low apparent impedance (Figure III.9). There was no fault and no major power swing at the time of the trip; rather, high flows at 130 percent of the line's emergency rating, together with depressed voltages, caused the overload to appear to the protective relays as a remote fault on the system. In effect, the relay could no longer differentiate between a remote three-phase fault and conditions of high loading and low voltage. Moreover, the reactive flows (Vars) on the line were almost ten times higher than they had been earlier in the day because of the degrading conditions in the Cleveland-Akron area. The relay operated as designed.

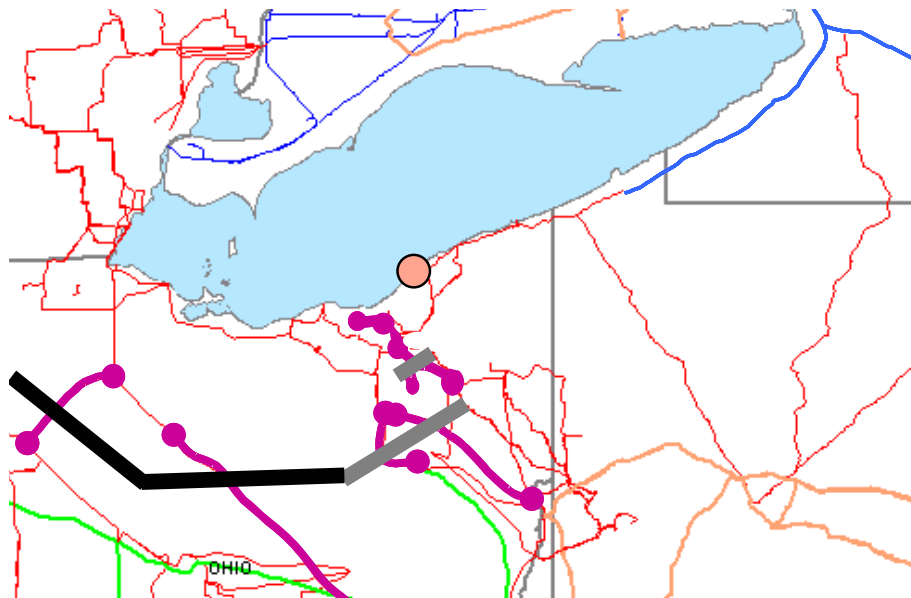
Figure IV.7 — Ohio 345-kV Lines Trip, 16:08:59 to 16:09:07

numerous 138-kV line trips in central Ohio, the East Lima-Fostoria Central line tripped at 16:09:06 on zone 3 relay operation due to high current and low voltage (80 percent). Modeling indicates that if automatic under-voltage load-shedding had been in place in northeastern and central Ohio, it might have been triggered at or before this point and dropped enough load to reduce or eliminate the subsequent line overloads that spread the cascade. The line trips across Ohio are shown in figure IV.7.

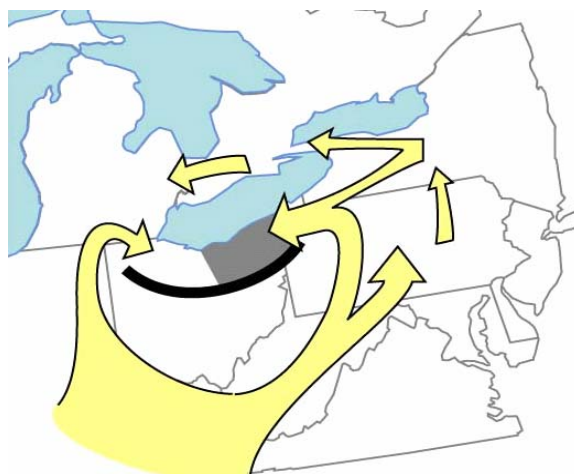
Figure IV.8 — Power Flows at 16:09:25

The tripping of the Galion-Ohio Central-Muskingum and East Lima-Fostoria Central transmission lines removed the transmission paths from southern and western Ohio into northern Ohio and eastern Michigan. Northern Ohio was connected to eastern Michigan by only three 345-kV transmission lines near the southwestern bend of Lake Erie. Thus, the combined northern Ohio and eastern Michigan load centers were left connected to the rest of the grid only by: (1) transmission lines eastward from northeastern Ohio to northwestern Pennsylvania along the southern shore of Lake Erie, and (2) westward by lines west and northwest of Detroit, Michigan, and from Michigan into Ontario (Figure IV.8).

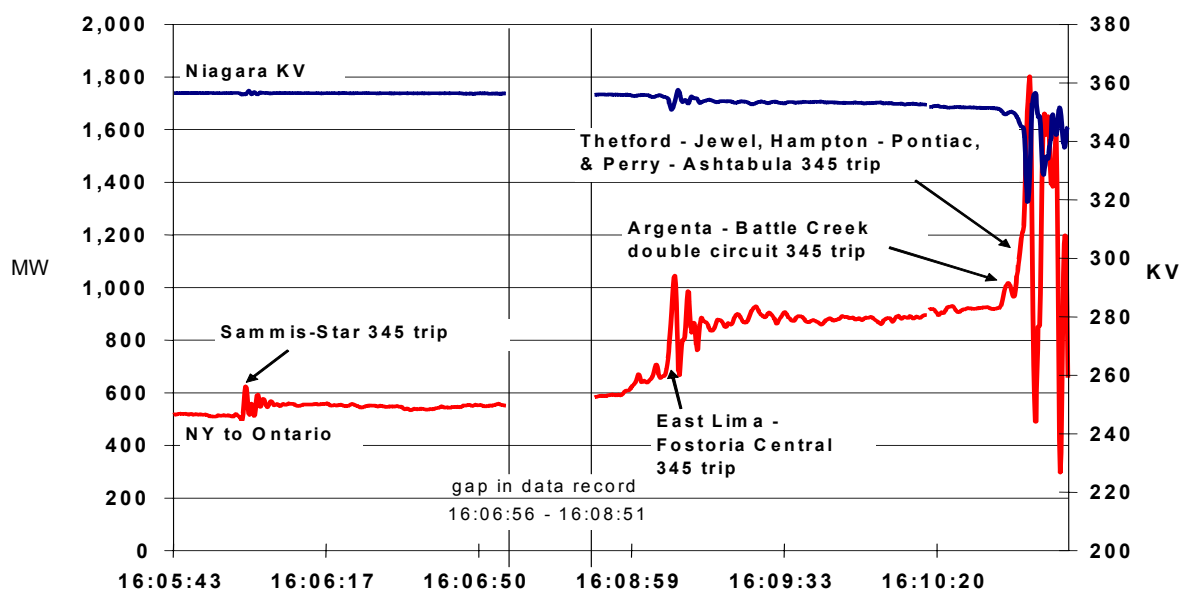
Figure IV.9 — New York-Ontario Line Flows at Niagara

Figure IV.9 shows voltage levels recorded in the Niagara area. It shows that voltage levels remained stable until about 16:10:30, despite significant power fluctuations. In the cascade that followed, the voltage instability was a companion to, not a driver of, the angular instability that tripped generators and lines. A high-speed recording of 345-kV flows at Niagara Falls taken by the Hydro One recorders (shown as the lower plot in Figure IV.9), shows the impact of the East Lima-Fostoria Central and the New York-to-Ontario power swing, which continued to oscillate for more than ten seconds. Looking at the MW flow plot, it is clear that when Sammis-Star tripped, the system experienced oscillations that quickly damped out and rebalanced. But East Lima-Fostoria triggered significantly greater oscillations that worsened in magnitude for several cycles, and then dampened more slowly but continued to oscillate until the Argenta-Battle Creek trip 90 seconds later. Voltages also began to decline at that time.

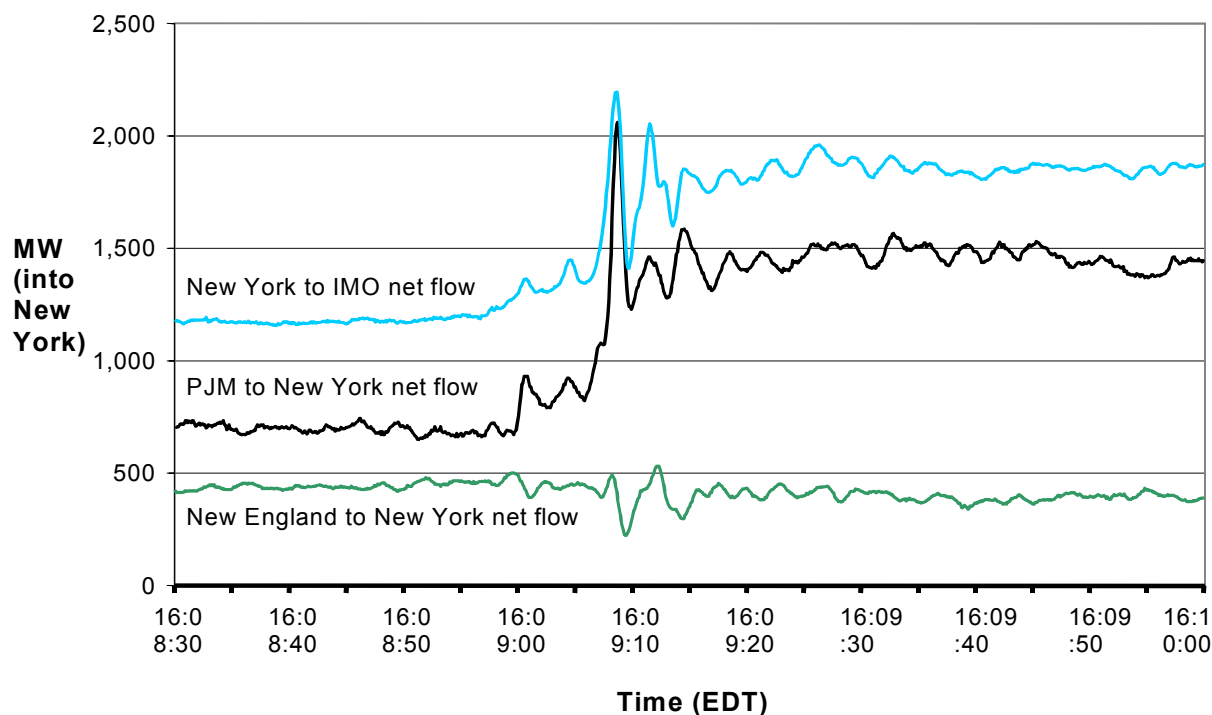
Figure IV.10 — First Power Swing has Varying Impacts on New York Interfaces

Figure IV.10, showing metered power flows along the New York interfaces, documents how the flows heading north and west toward Detroit and Cleveland varied at three different New York interfaces. Beginning at 16:09:05, power flows jumped simultaneously across all three interfaces; but when the first power surge peaked at 16:09:09, the change in flow was highest on the PJM interface and lowest on the New England interface. Power flows increased significantly on the PJM-New York and New York-Ontario interfaces because of the redistribution of flow around Lake Erie to serve the loads in northern Ohio and eastern Michigan. The New England and Maritimes systems maintained the same generation-to-load balance and did not carry the redistributed flows because they were not in the direct path of the flows. Therefore, the New England-New York interface flows showed little response.

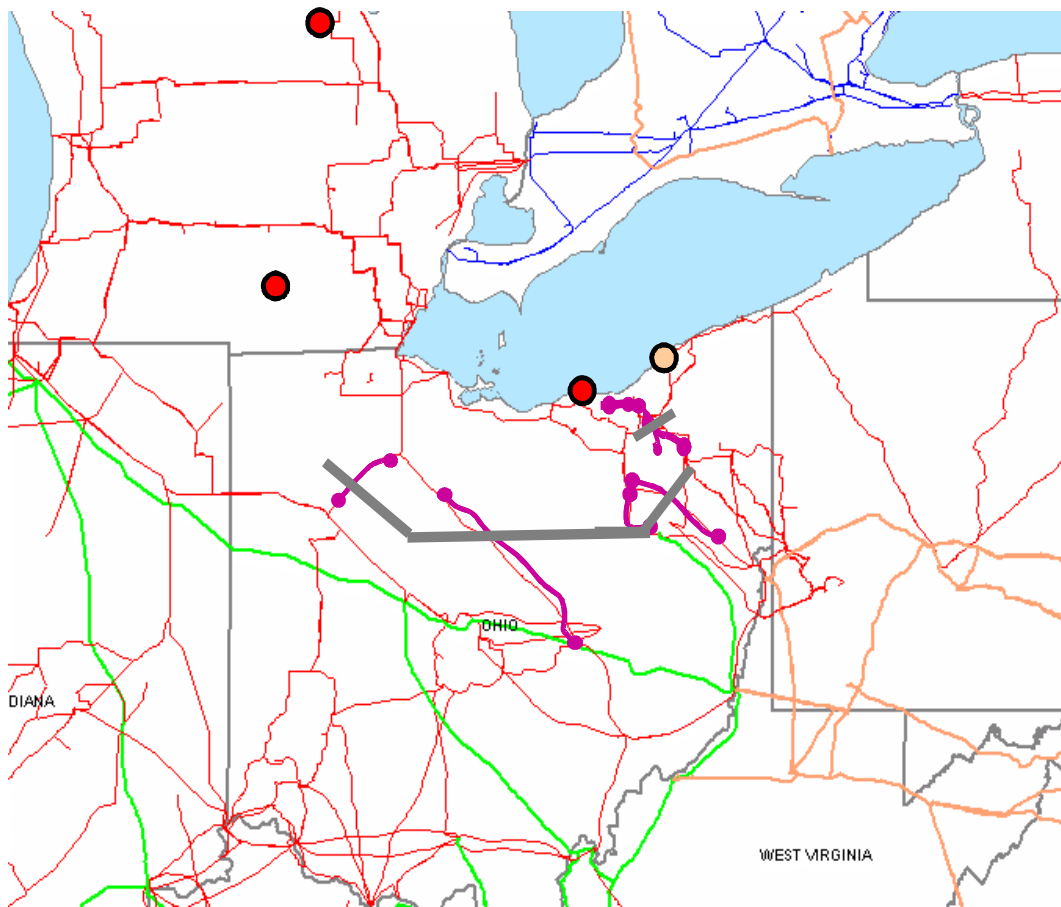
Figure IV.11 — Michigan and Ohio Power Plants Trip or Run Back

The MCV plant in central Michigan experienced a 300 MW run-back. The Avon Lake 7 unit tripped due to the loss of the voltage regulator. The Burger units tripped after the 138-kV lines from the Burger 138-kV generating substation bus to substations in Ohio tripped from high reactive power flow due to the low voltages in the Cleveland area. Three units at the Kinder Morgan generating station in south-central Michigan tripped due to a transformer fault and over-excitation.

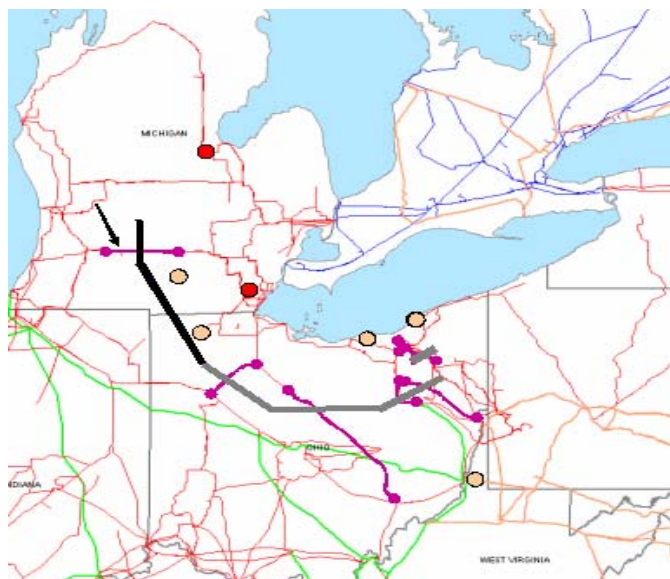
Figure IV.12 — Transmission and Generation Trips in Eastern Michigan, 16:10:36 to 16:10:37

Together, the above line outages interrupted the west-to-east transmission paths into the Detroit area from south-central Michigan. The Sumpter generating units tripped in response to under-voltage on the system. Michigan lines west of Detroit then began to trip, as shown in Figure IV.12.

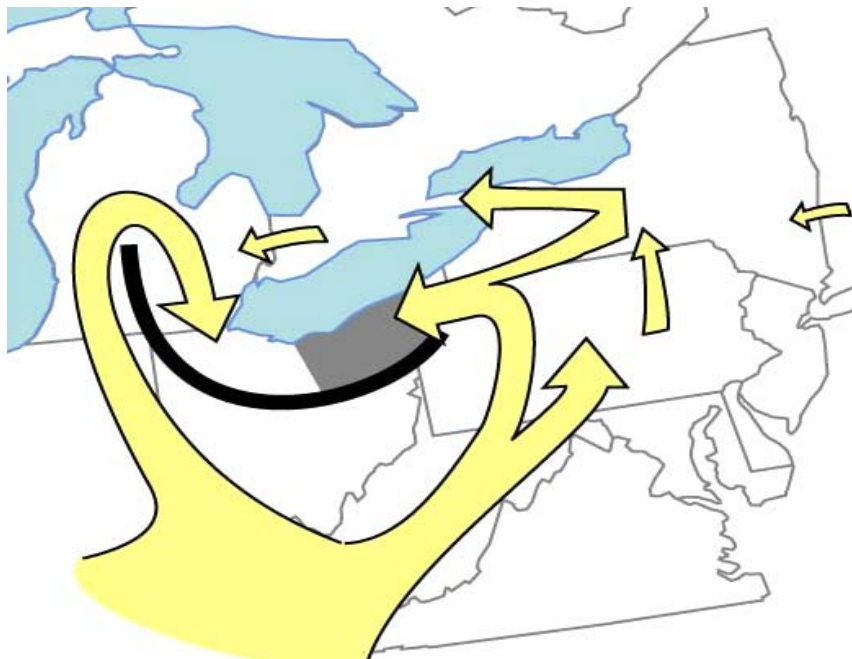
Figure IV.13 — Power Flows at 16:10:37

The Argenta-Battle Creek relay first opened the line at 16:10:36.230. The line reclosed automatically at 16:10:37, then tripped again. This line connects major generators — including the Cook and Palisades nuclear plants and the Campbell fossil plant — to the Eastern MECS system. This line is designed with auto-reclose breakers at each end of the line, which do an automatic high-speed reclose as soon as they open to restore the line to service with no interruptions. Since the majority of faults on the North

American grid are temporary, automatic reclosing can enhance stability and system reliability. However, situations can occur where the power systems behind the two ends of the line could go out of phase during the high-speed reclose period (typically less than 30 cycles, or one half second, to allow the air to de-ionize after the trip to prevent arc re-ignition). To address this and protect generators from the harm that an out-of-synchronism reconnect could cause, it is worth studying whether a synchro-check relay is needed to reclose only when the two ends of a line are within a certain voltage and phase angle tolerance. No such protection was installed at Argenta-Battle Creek. When the line reclosed, there was a 70 degree difference in phase across the circuit breaker reclosing the line. There is no evidence that the reclose harmed the local generators. Power flows following the trip of the central Michigan lines are shown in Figure IV.13.

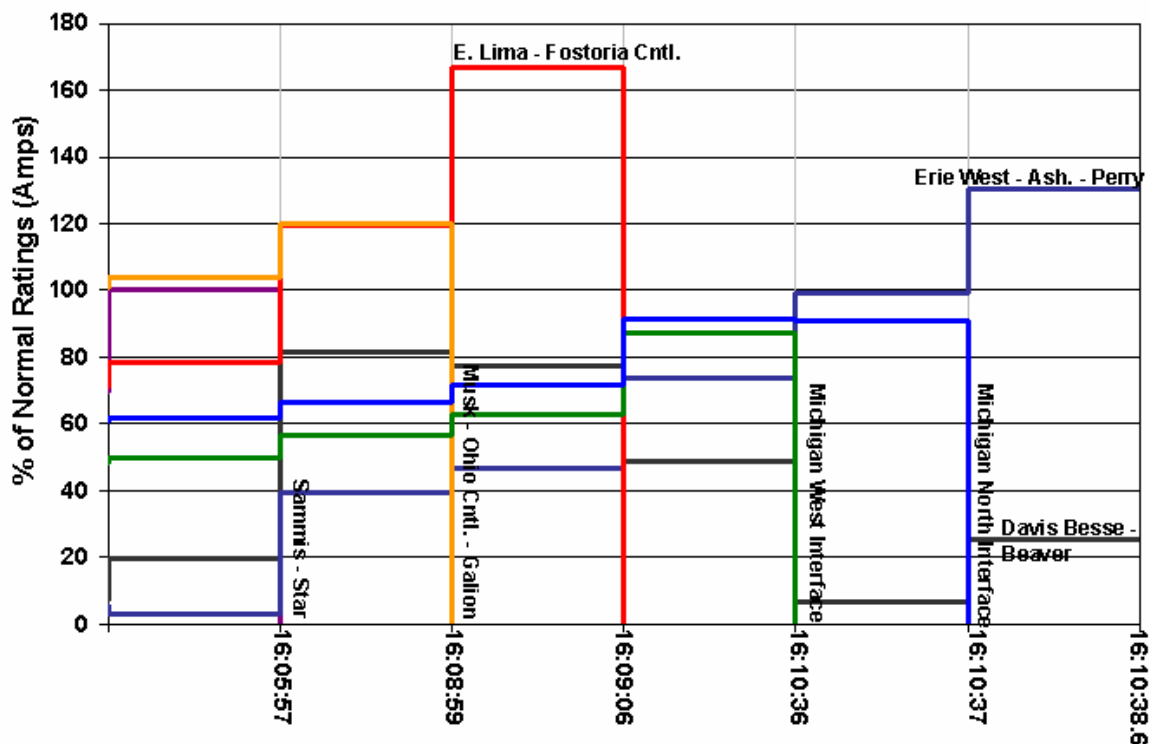
Figure IV.15a — Simulated 345-kV Line Loadings From 16:05:57 Through 16:10:38.6

Figure IV.15a shows the results of modeling of line loadings on the Ohio, Michigan, and other regional interfaces for the period between 16:05:57 until the Thetford-Jewell trip; this helps to illustrate how power flows shifted during this period. Evolving system conditions were modeled for August 14, based on the 16:05:50 power flow case developed by the MAAC-ECAR-NPCC Operations Studies Working Group. Each horizontal line in the graph indicates a single or set of 345-kV lines and their loading as a function of normal ratings over time as first one, then another, set of circuits tripped out of service. In general, each subsequent line trip causes the remaining line loadings to rise. Note that Muskingum and East Lima-Fostoria Central were overloaded before they tripped, but the Michigan west and north interfaces were not overloaded before they tripped. Erie West-Ashtabula-Perry was loaded to 130 percent after the Hampton-Pontiac and Thetford-Jewell trips.

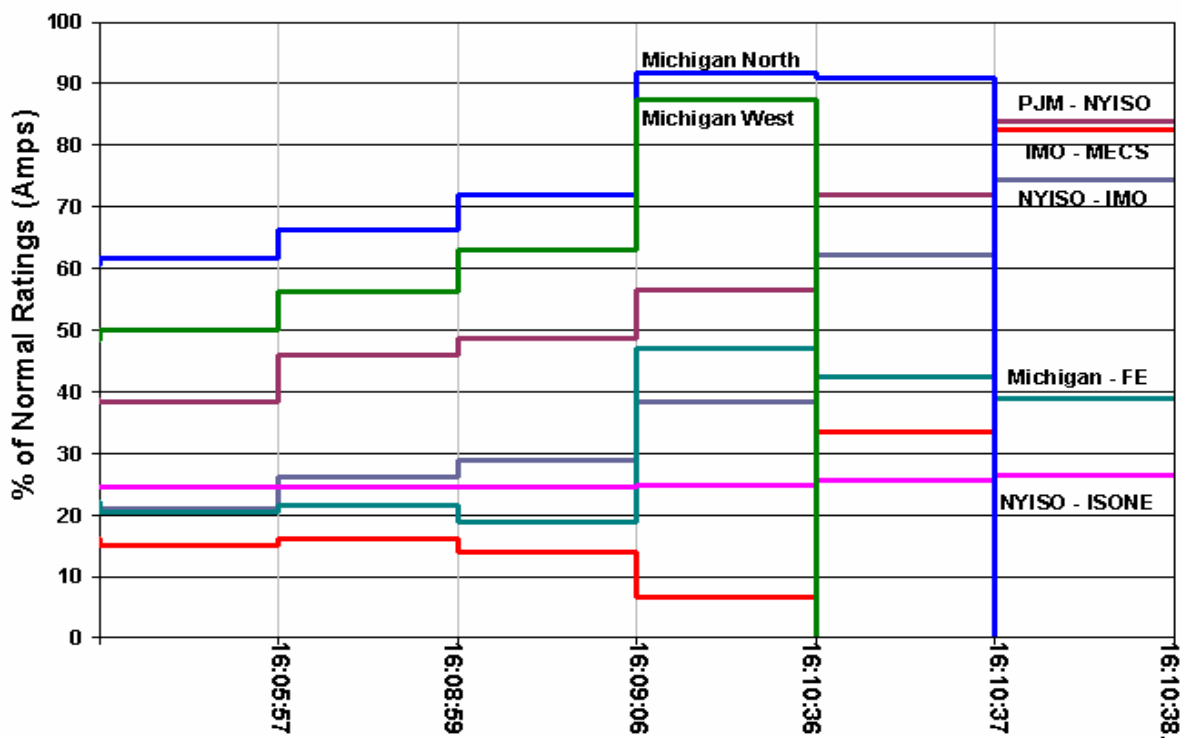
Figure IV.15b — Simulated Regional Interface Loadings From 16:05:57 Through 16:10:38.4

The regional interface loadings graph (Figure VI.15b) shows that loadings at the interfaces between PJM-New York, New York-Ontario, and New York-New England were well within normal ratings before the east-west Michigan separation.

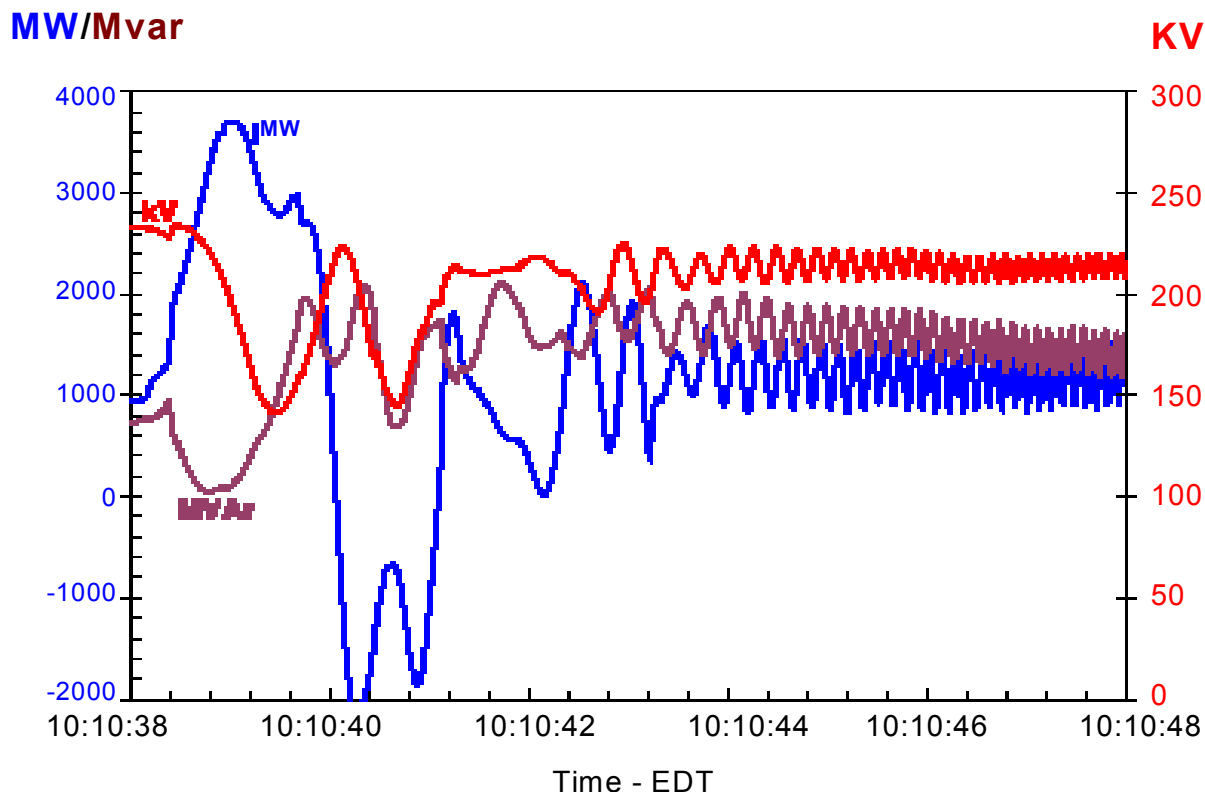
Figure IV.17 — Real and Reactive Power and Voltage From Ontario Into Michigan

At 16:10:38.6, after the 345-kV transmission paths in Michigan and Ohio tripped, the power that had been flowing at modest levels into Michigan from Ontario suddenly jumped in magnitude. While flows from Ontario into Michigan had been in the 250 to 350 MW range since 16:10:09.06, with this new surge the

flows peaked at 3,700 MW at 16:10:39 (Figure IV.17). Electricity moved along a giant loop from the rest of the Eastern Interconnection through Pennsylvania and into New York and Ontario, and then into Michigan via the remaining transmission path to serve the combined loads of Cleveland, Toledo, and Detroit (Figure IV.18). This sudden large change in power flows lowered voltages and increased current levels on the transmission lines along the Pennsylvania-New York transmission interface.

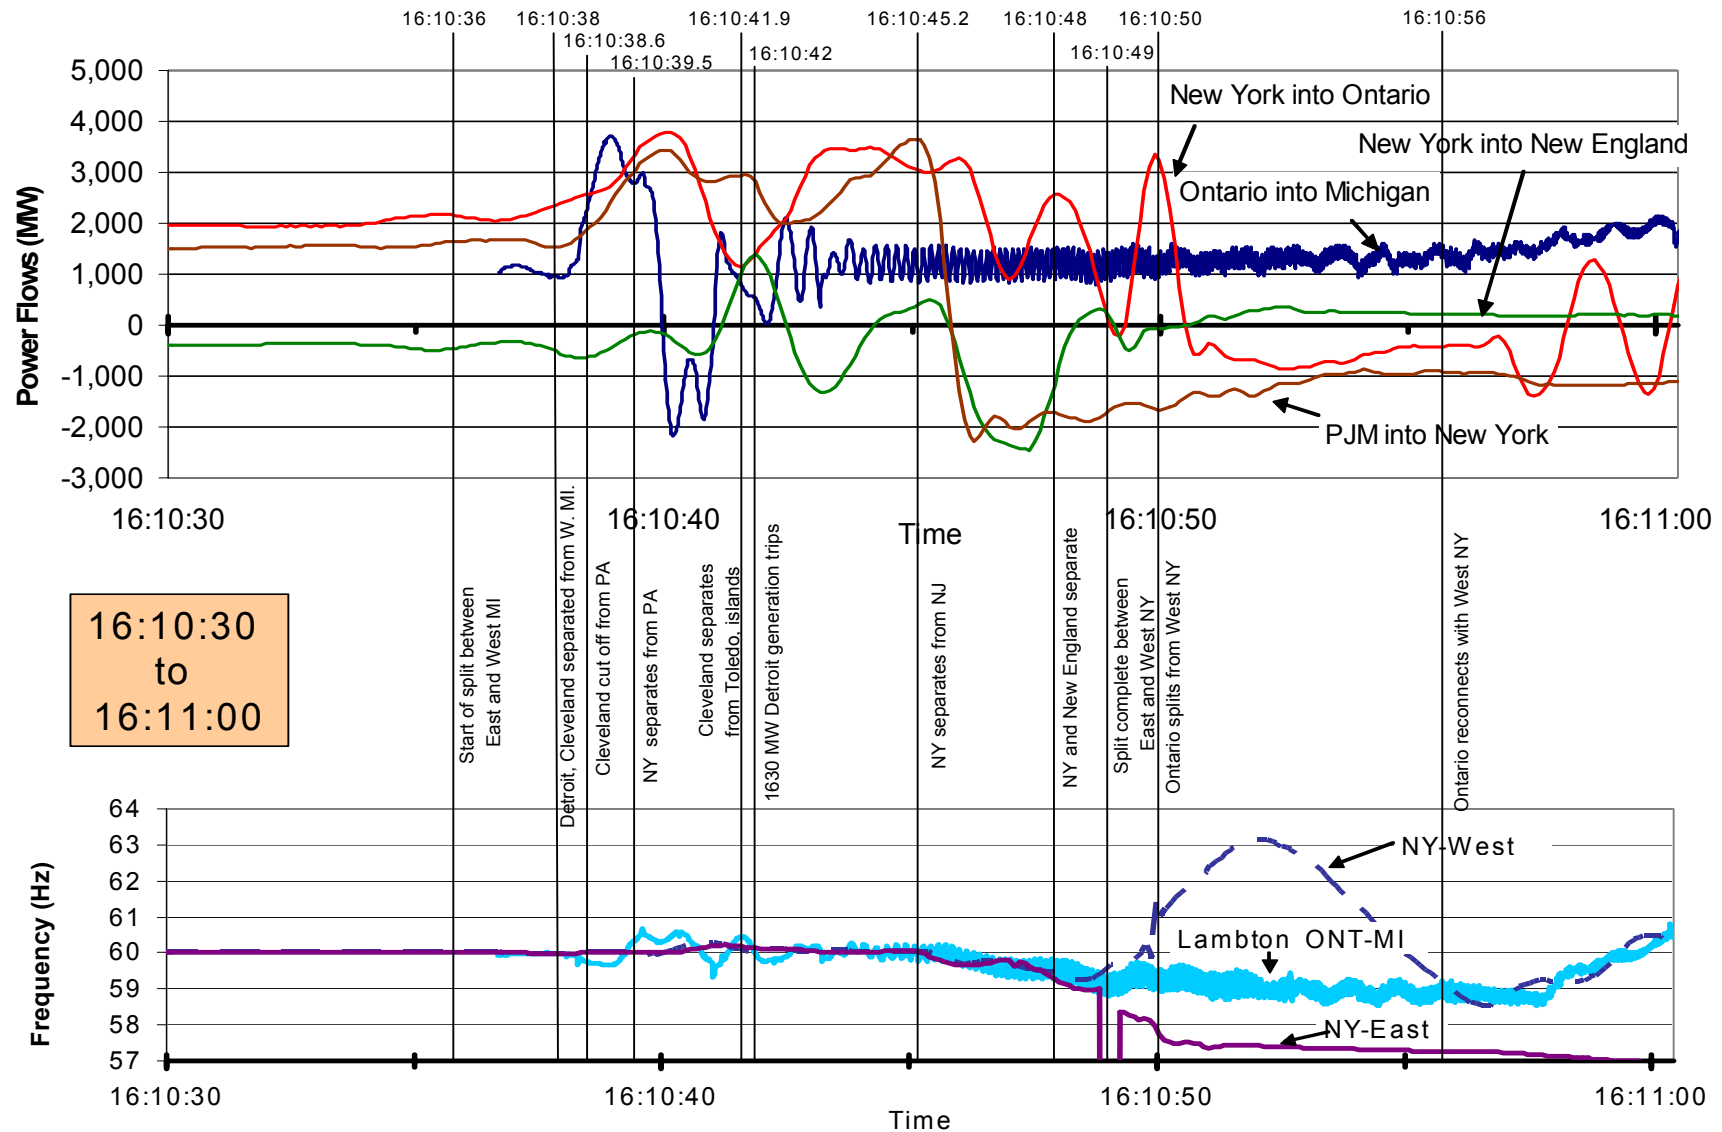
Figure IV.19 — Measured Power Flows and Frequency Across Regional Interfaces, 16:10:30 to 16:11:00, With Key Events in the Cascade

After Cleveland was cut off from Pennsylvania and eastern power sources, Figure IV.19 also shows the start of the dynamic power swing at 16:10:38.6. Because the loads of Cleveland, Toledo, and Detroit (less the load already blacked out) were now served through Michigan and Ontario, this forced a large shift in power flows to meet that demand. As noted above, flows from Ontario into Michigan increased from 1,000 MW to a peak of 3,700 MW shortly after the start of the swing, while flows from PJM into New York were close behind (Figure IV.20). But within one second after the peak of the swing, at 16:10:40, flows reversed and flowed back from Michigan into Ontario at the same time that frequency at the interface dropped (Figure IV.21). The large load and imports into northern Ohio were losing synchronism with southeastern Michigan. Flows that had been westbound across the Ontario-Michigan interface by more than 3,700 MW at 16:10:38.8 reversed to 2,100 MW eastbound by 16:10:40, and then returned westbound starting at 16:10:40.5.

Re-examination of Figure IV.19 shows the power swing from the northeast through Ontario into Michigan and northern Ohio that began at 16:10:37, and how it reverses and swings back around Lake Erie at 16:10:39. That return was caused by the combination of natural oscillation accelerated by major load losses, as the northern Ohio system disconnected from Michigan. It caused a power flow change of 5,800 MW, from 3,700 MW westbound to 2,100 eastbound across the Ontario-to-Michigan border between 16:10:39.5 and 16:10:40. Since the system was now fully dynamic, this large oscillation eastbound would lead naturally to a rebound, which began at 16:10:40 with an inflection point reflecting generation shifts between Michigan and Ontario and additional line losses in Michigan.

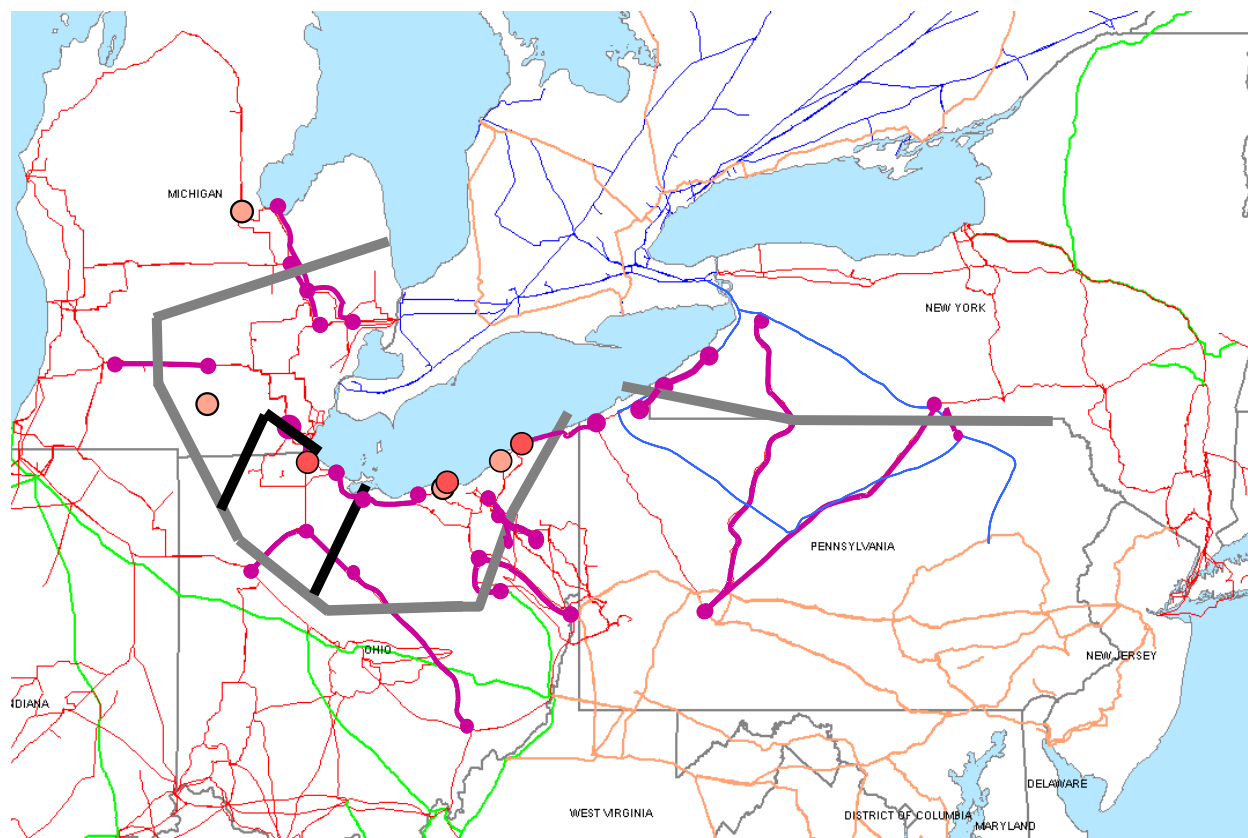
Figure IV.22 — Cleveland and Toledo Islanded, 16:10:39 to 16:10:46

In northern Ohio, the trips of the Bay Shore-Monroe, Majestic-Lemoyne, Allen Junction-Majestic-Monroe 345-kV lines, and the Ashtabula 345/138-kV transformer cut off Toledo and Cleveland from the north, turning that area into an electrical island (Figure IV.22). After these 345-kV line trips, the high power imports from southeastern Michigan into Ohio suddenly stopped at 16:10:40. Frequency in this island began to fall rapidly. This caused a series of power plants in the area to trip off-line due to the operation of underfrequency relays, including the Bay Shore units. Cleveland area load was disconnected by automatic underfrequency load shedding (approximately 1,300 MW), and another 434 MW of load

was interrupted after the generation remaining within this transmission island was tripped by underfrequency relays. This sudden load drop would contribute to the reverse power swing described previously. In its own island, portions of Toledo blacked out from automatic underfrequency load shedding but most of the Toledo load was restored by automatic reclosing of lines such as the East Lima-Fostoria Central 345-kV line and several lines at the Majestic 345-kV substation.

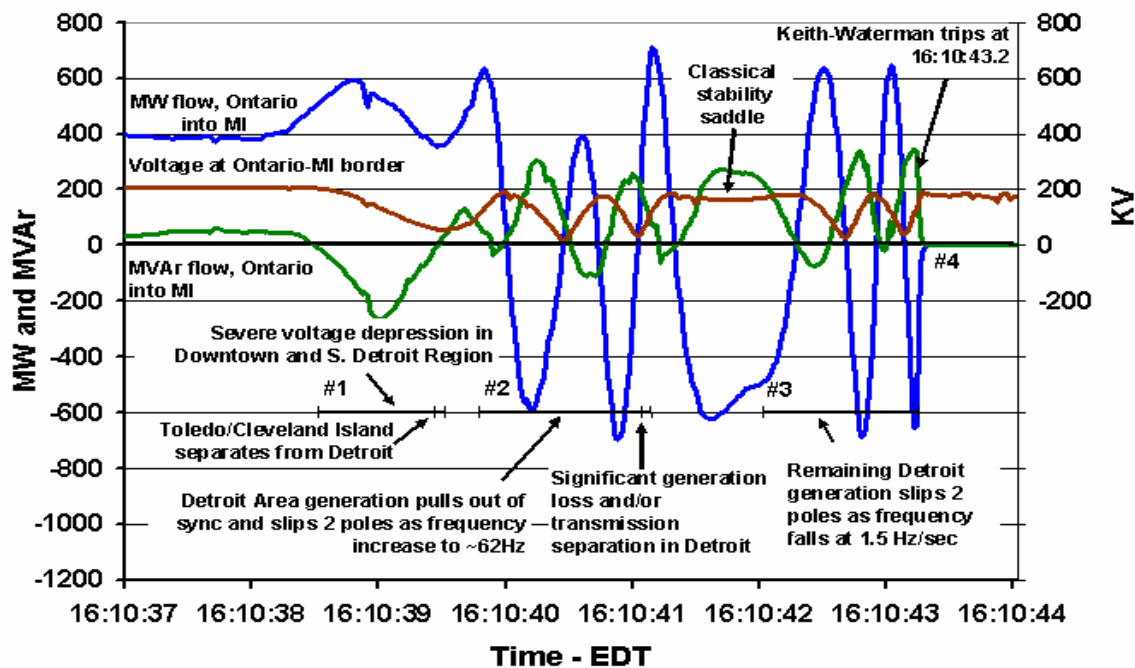
Figure IV.23 — Generators Under Stress in Detroit, as Seen From Keith PSDR

The large power surge into Michigan, beginning at 16:10:38, occurred when Toledo and Cleveland were still connected to the grid through Detroit. After the Bayshore-Monroe line tripped at 16:10:39, Toledo and Cleveland separated into their own island, dropping a large amount of load off of the Detroit system. This suddenly left Detroit with excess generation, much of which greatly accelerated in angle as the depressed voltage in Detroit (caused by the high demand in Cleveland) caused the Detroit units to begin to pull out of step with the rest of the grid. When voltage in Detroit returned to near-normal, the generators could not sufficiently decelerate to remain synchronous. This out-of-step condition is evident in Figure IV.23, which shows at least two sets of generator “pole slips” by plants in the Detroit area

between 16:10:40 and 16:10:42. Several large units around Detroit: Belle River, St. Clair, Greenwood, Monroe, and Fermi Nuclear all tripped in response. After the Cleveland-Toledo island formed at 16:10:40, Detroit frequency spiked to almost 61.7 Hz before dropping, momentarily equalized between the Detroit and Ontario systems. But Detroit frequency then began to decay at 2 Hz/sec and the generators experienced under-speed conditions.

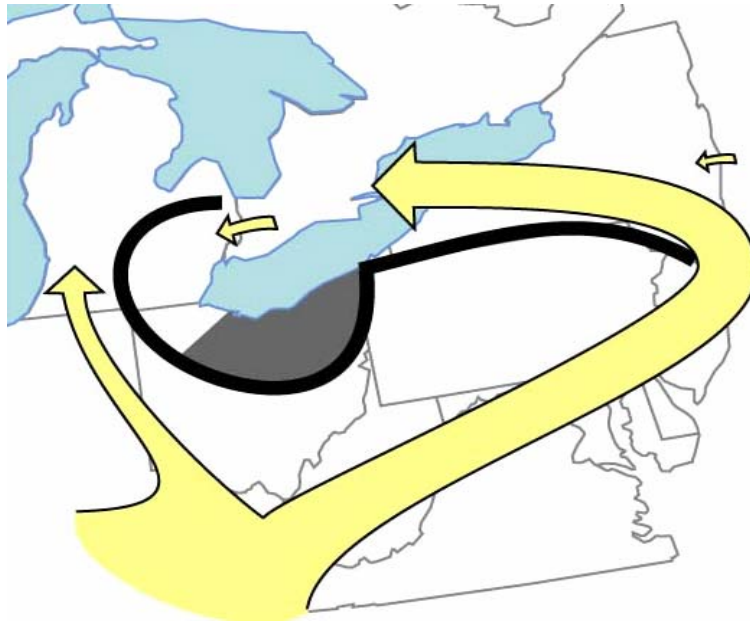
Figure IV.25 — Power Flows at 16:10:44

At 16:10:44, (see Figure IV.25) the northern part of the Eastern Interconnection (including eastern Michigan) was connected to the rest of the Interconnection at only two locations: (1) in the east through the 500-kV and 230-kV ties between New York and northeastern New Jersey, and (2) in the west through the long and electrically fragile 230-kV transmission path connecting Ontario to Manitoba and Minnesota. The separation of New York from Pennsylvania (leaving only the lines from New Jersey into New York connecting PJM to the northeast) helped to buffer PJM in part from these swings. Frequency was high in Ontario at that point, indicating that there was more generation than load, so much of this flow reversal never got past Ontario into New York.

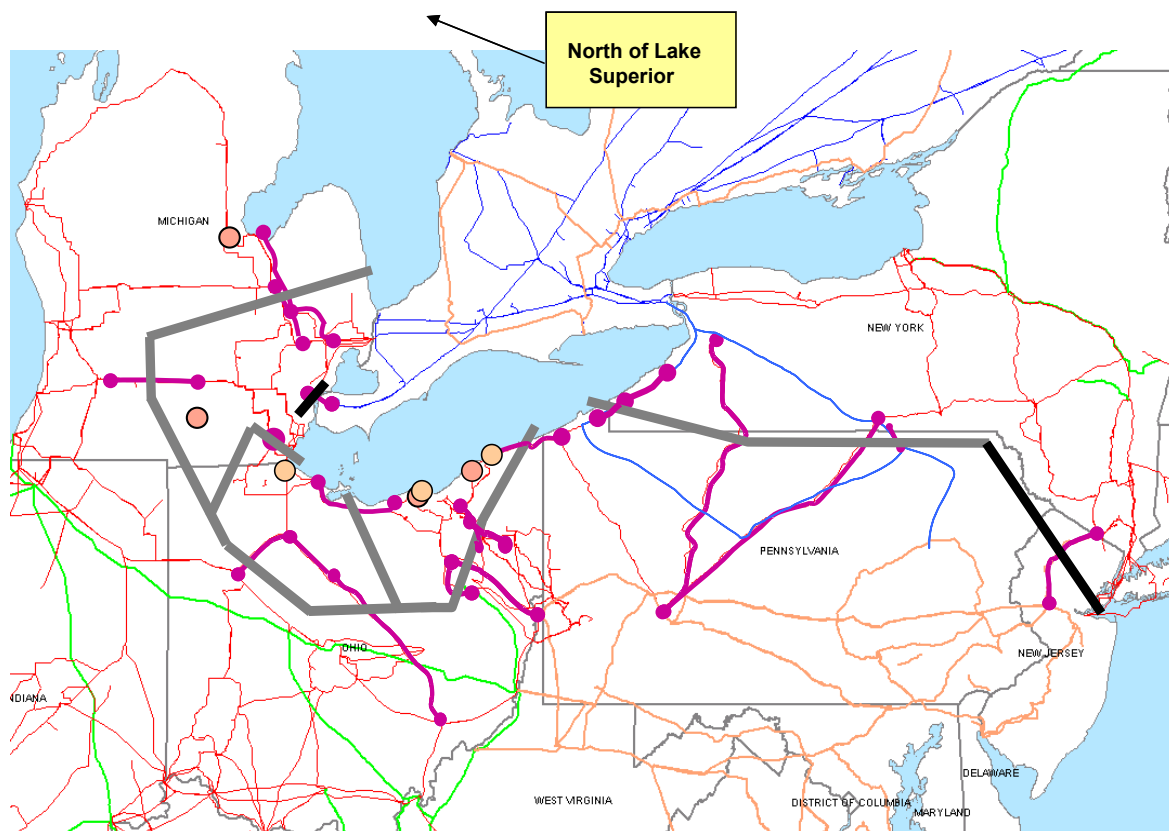
Figure IV.26 — Northeast Separates From Eastern Interconnection, 16:10:45

At 16:10:45, northwest Ontario separated from the rest of Ontario when the Wawa-Marathon 230-kV lines (168 km long) disconnected along the northern shore of Lake Superior, tripped by zone 1 distance relays at both ends. This separation left the loads in the far northwest portion of Ontario connected to the Manitoba and Minnesota systems, and protected them from the blackout (Figure IV.26).

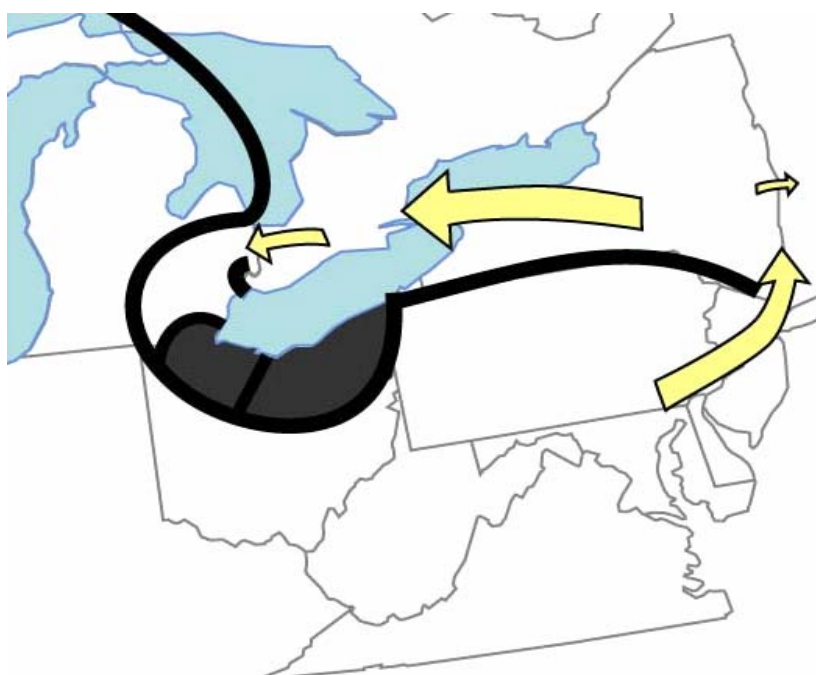
Figure IV.27 — Power Flows at 16:10:45

As shown in Figure IV.27, the 69-mile long Branchburg-Ramapo line and Ramapo transformer between New Jersey and New York was the last major transmission path remaining between the Eastern Interconnection and the area ultimately affected by the blackout. Figure IV.28 shows how that line disconnected at 16:10:45, along with other underlying 230 and 138-kV lines in northeastern New Jersey. Branchburg-Ramapo was carrying over 3,000 MVA and 4,500 amps with voltage at 79 percent before it tripped, either on a high-speed swing into zone 1 or on a direct transfer trip. The investigation team is still examining why the higher impedance 230-kV overhead lines tripped while the underground Hudson-Farragut 230-kV cables did not; the available data suggest that the lower impedance of underground cables made these less vulnerable to the electrical strain placed on the system.

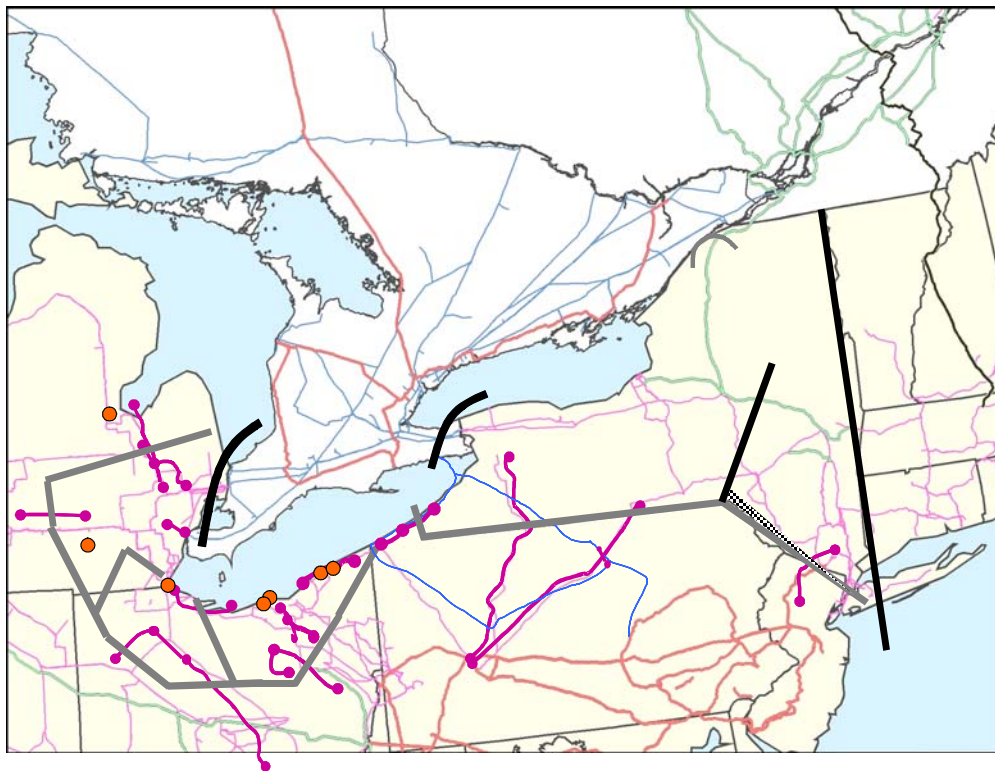
Figure IV.29 — New York and New England Separate, Multiple Islands Form

Figure VI.29 illustrates the events of this phase.

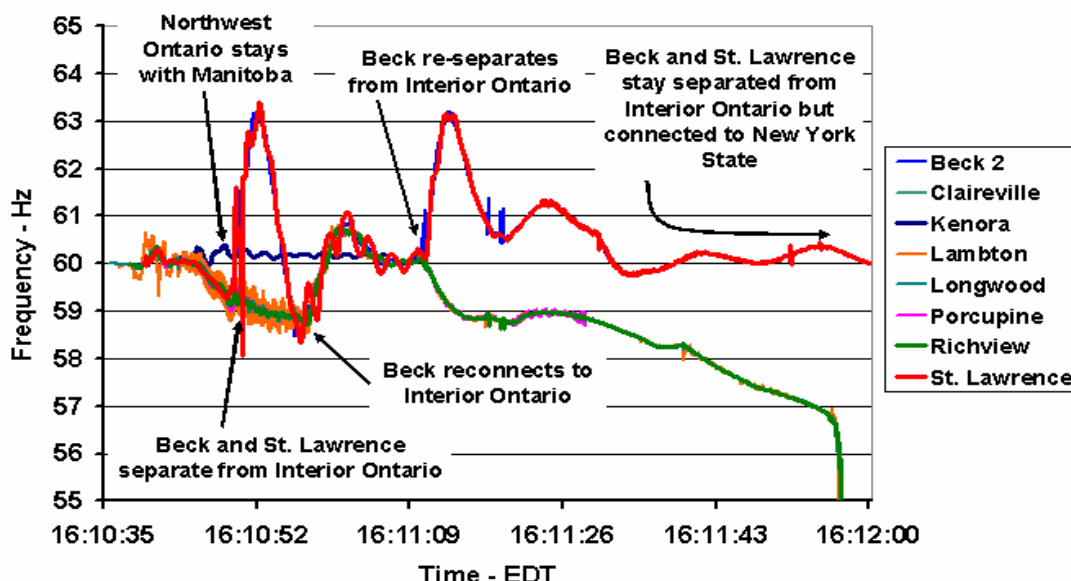
Figure IV.31 — Separation of Ontario and Western New York

The Ontario system separated from the western New York island just west of Niagara Falls and west of St. Lawrence at 16:10:50. This separation was due to relay operations that disconnected nine 230-kV lines within Ontario. These left most of Ontario isolated. Ontario's large Beck and Saunders hydro stations, along with some Ontario load, the NYPA Niagara and St. Lawrence hydro stations, and NYPA's 765-kV AC interconnection to their HVDC tie with Québec, remained connected to the western New York system, supporting the demand in upstate New York. From 16:10:49 to 16:10:50, frequency in Ontario declined below 59.3 Hz, initiating automatic UFLS (3,000 MW). This load shedding dropped about 12 percent of Ontario's remaining load. Between 16:10:50 and 16:10:56, the isolation of Ontario's 2,300 MW Beck and Saunders hydro units onto the western New York island, coupled with UFLS, caused the frequency in this island to rise to 63.4 Hz due to excess generation relative to the load remaining within the island. This is shown in Figure VI.31. The high frequency caused trips of five of the U.S. nuclear units within the island, and the last one tripped on the second frequency rise.

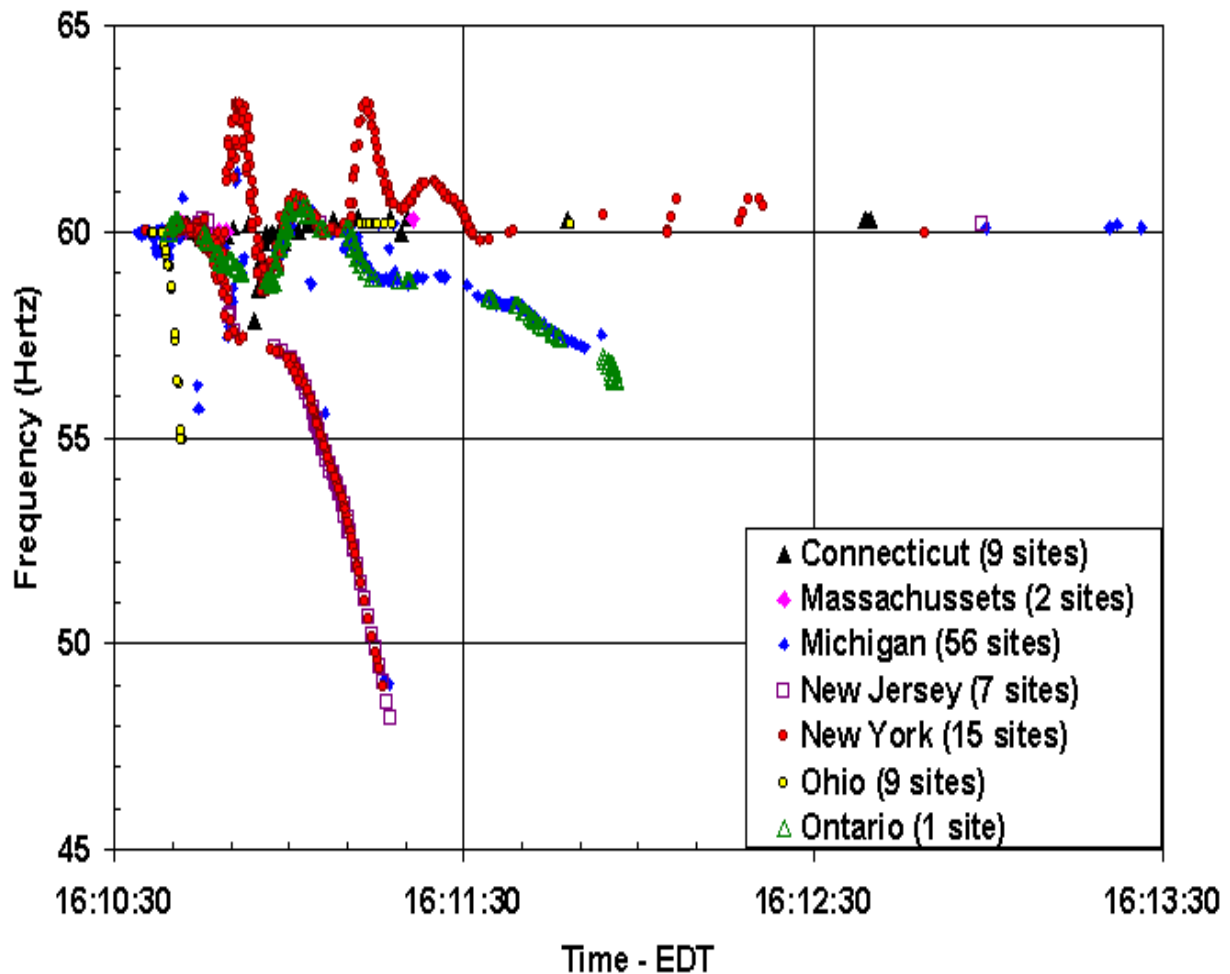
Figure IV.32 — Electric Islands Reflected in Frequency Plot

Figure IV.32 shows frequency data collected by the distribution-level monitors of Softswitching Technologies, Inc. (a commercial power quality company serving industrial customers) for the area affected by the blackout. The data reveal at least five separate electrical islands in the Northeast as the cascade progressed. The two paths of red circles on the frequency scale reflect the Albany area island (upper path) versus the New York City island, which declined and blacked out much earlier.
