NORTH AMERICAN ELECTRIC RELIABILITY COUNCIL

Technical Analysis of the August 14, 2003, Blackout: *What Happened, Why, and What Did We Learn?*

**Report to the NERC Board of Trustees
by the NERC Steering Group**

July 13, 2004

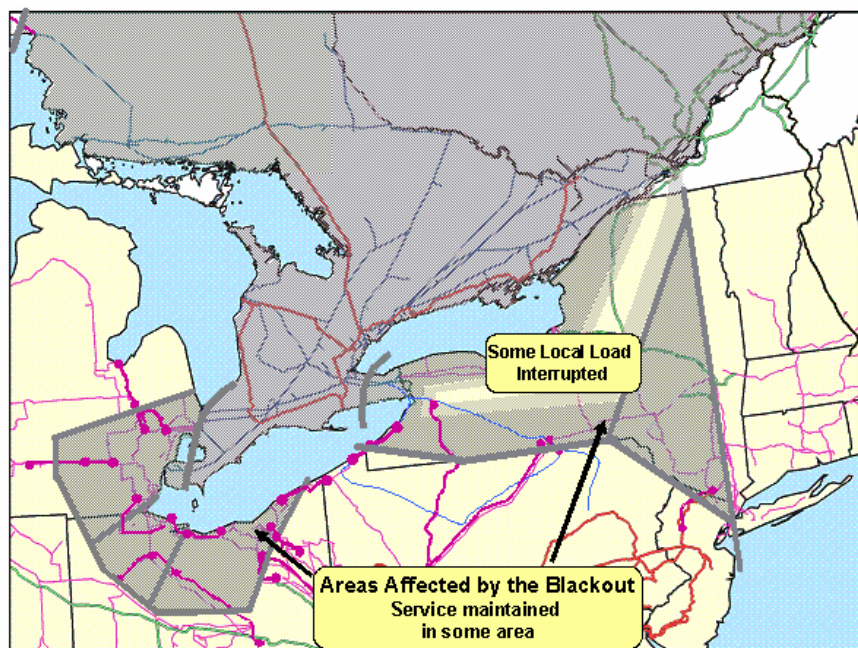
Figure IV.33 — Areas Affected by the Blackout

Most of the Northeast (the area shown in gray in Figure VI.33) had now blacked out. Some isolated areas of generation and load remained on-line for several minutes. Some of those areas in which a close generation-demand balance could be maintained remained operational.

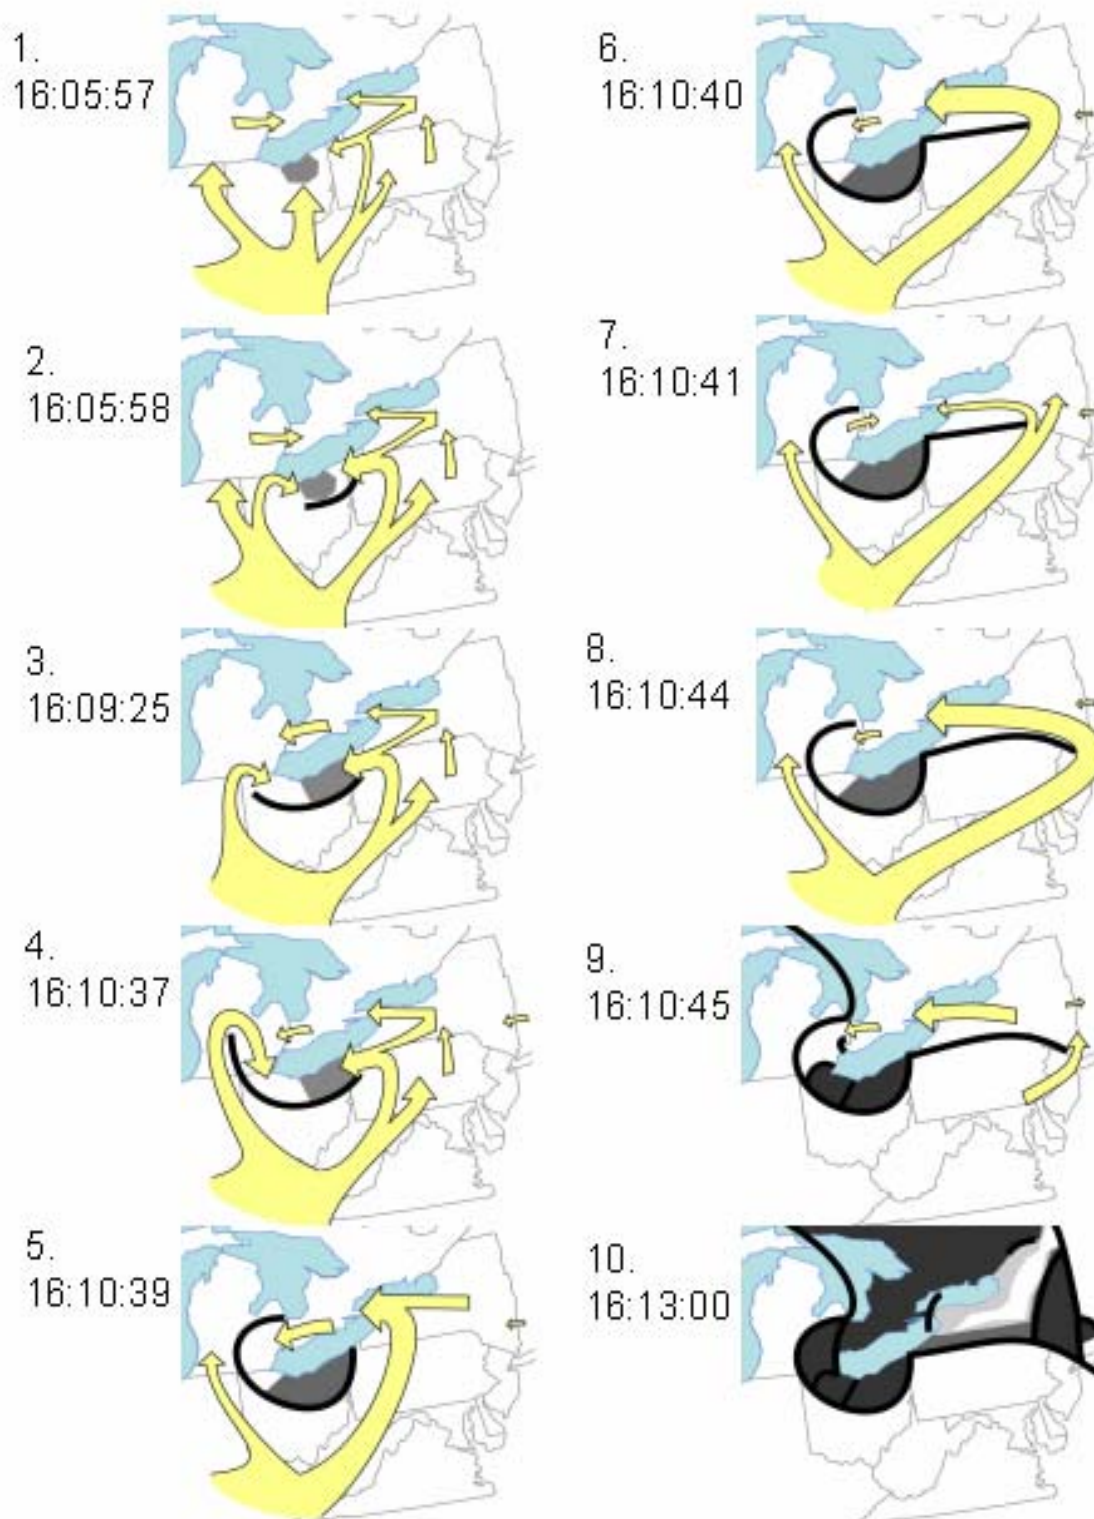
Figure IV.34 — Cascade Sequence Summary

The entire cascade sequence is summarized graphically in figure VI.34.
