# Evaluation and Repair of Concrete Structures

Manual  
No. 1110-2-2002

30 June 1995

**Engineering and Design  
EVALUATION AND REPAIR OF CONCRETE STRUCTURES**

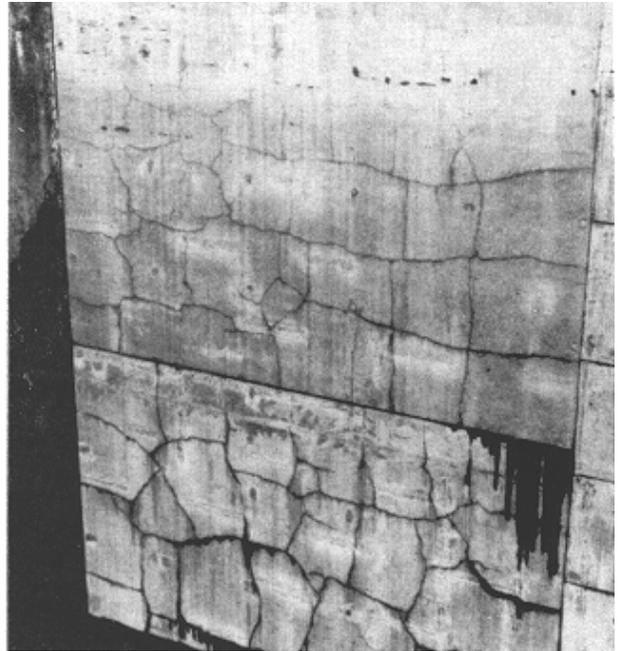
**Figure 2-5. Pattern cracking caused by restrained volume changes**

(a) Surface appearance of cracks. The surface appearance of cracks can give the first indication of the cause of cracking. Pattern cracks (Figures 2-5 through 2-7) are rather short cracks, usually uniformly distributed and interconnected, that run in all directions. Pattern cracking indicates restraint of contraction of the surface layer by the backing or inner concrete or possibly an

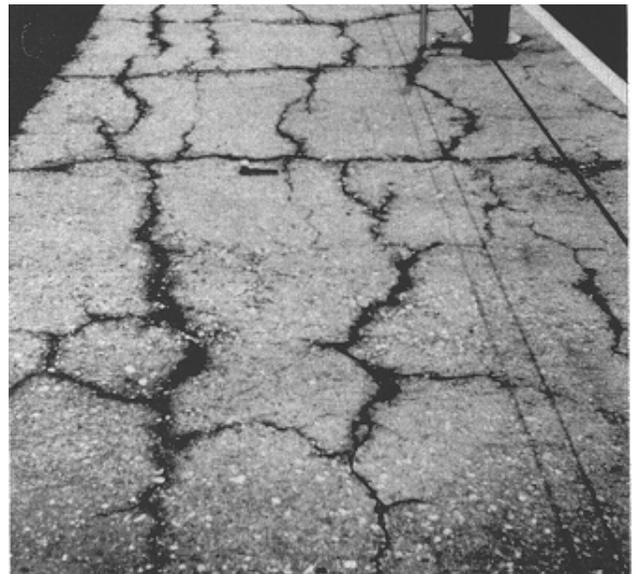
**Figure 2-6. Pattern cracking resulting from alkali-silica reaction**

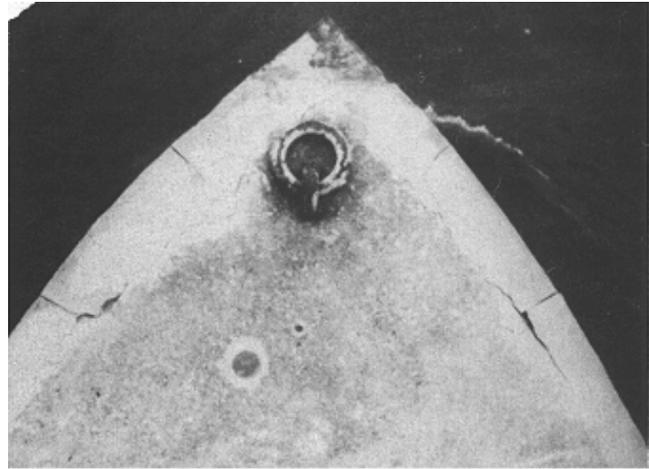
Figure 2-9. Isolated cracks as a result of restraint in the direction perpendicular to the crack

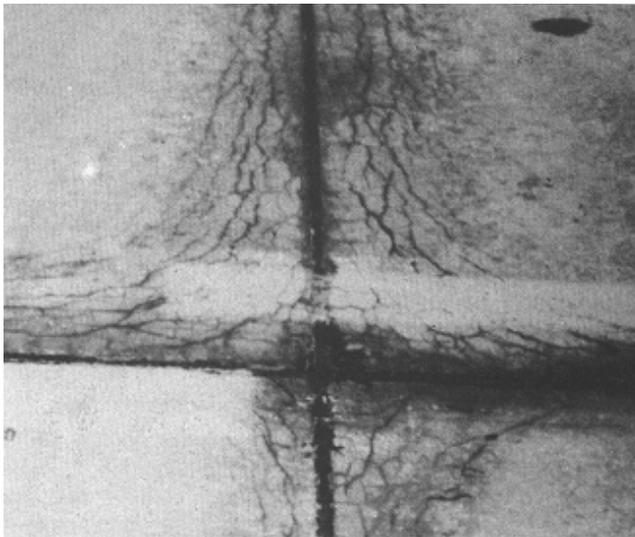
Figure 2-8. D-cracking in a concrete pavement

increase of volume in the interior of the concrete. Other terms used to describe pattern cracks are map cracks, crazing, and checking (see Glossary, Appendix B, for definitions). Another type of pattern crack is D-cracking. Figure 2-8 shows typical D-cracking in a concrete pavement. D-cracking usually starts in the lower part of a concrete slab adjacent to joints, where moisture accumulates, and progresses away from the corners of the slab. Individual cracks (Figures 2-9 through 2-11) run in definite directions and may be multiple cracks in parallel at definite intervals. Individual cracks indicate tension in the direction perpendicular to the cracking. Individual cracks are also frequently referred to as isolated cracks. Several terms may be used to describe the direction that an individual or isolated crack runs. These terms include diagonal, longitudinal, transverse, vertical, and horizontal.

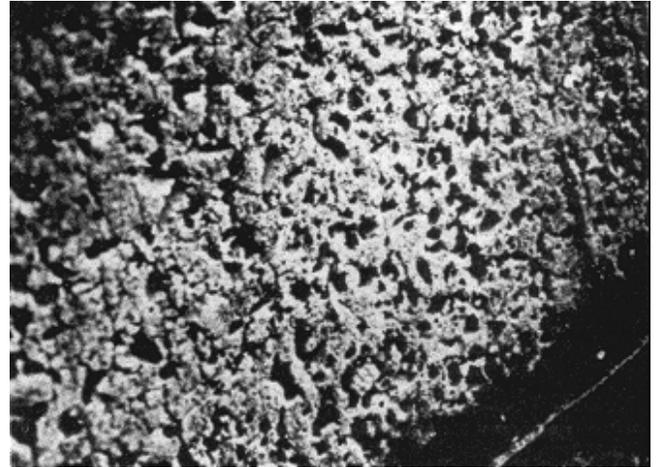
**Figure 2-12. Disintegration of concrete caused by exposure to aggressive water**

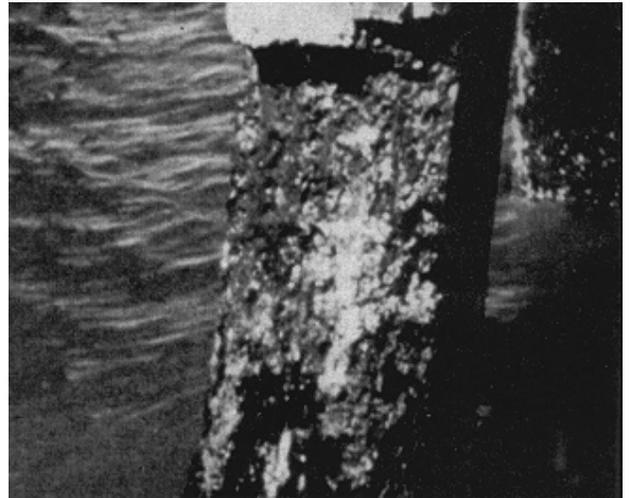
**Figure 2-13. Disintegration of concrete caused by exposure to acidic water**

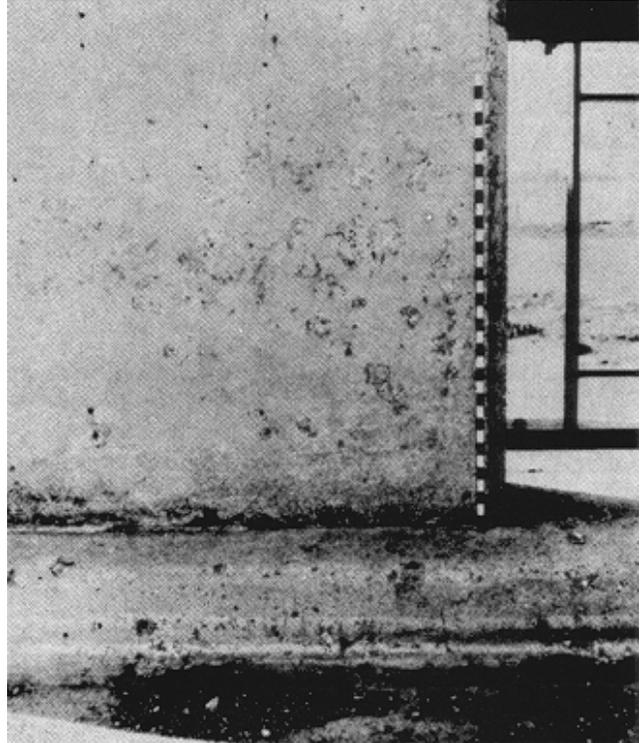
Figure 2-16. Light scaling

(a) Scaling. Scaling is the localized flaking or peeling away of the near-surface portion of the hardened concrete or mortar. Scaling is frequently a symptom of freezing and thawing damage. Degrees of concrete scaling may be defined as follows (ACI 201.1R). Light spalling is loss of surface mortar without exposure of coarse aggregate (Figure 2-16). Medium spalling is loss of surface mortar up to 5 to 10 mm (0.2 to 0.4 in.) in depth and exposure of coarse aggregate (Figure 2-17). Severe spalling is loss of surface mortar 5 to 10 mm (0.2 to 0.4 in.) in depth with some loss of mortar surrounding aggregate particles 10 to 20 mm (0.4 to 0.8 in.) in depth, so that

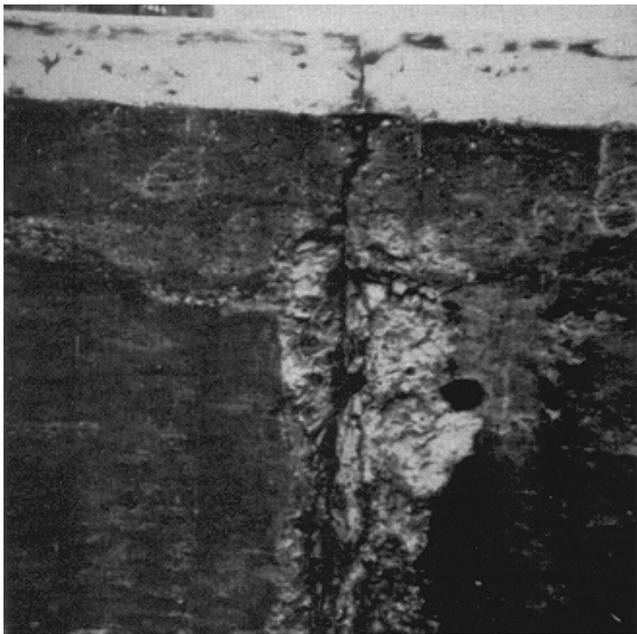
Figure 2-15. Disintegration at a monolith joint as a result of repeated cycles of freezing and thawing and barge impact

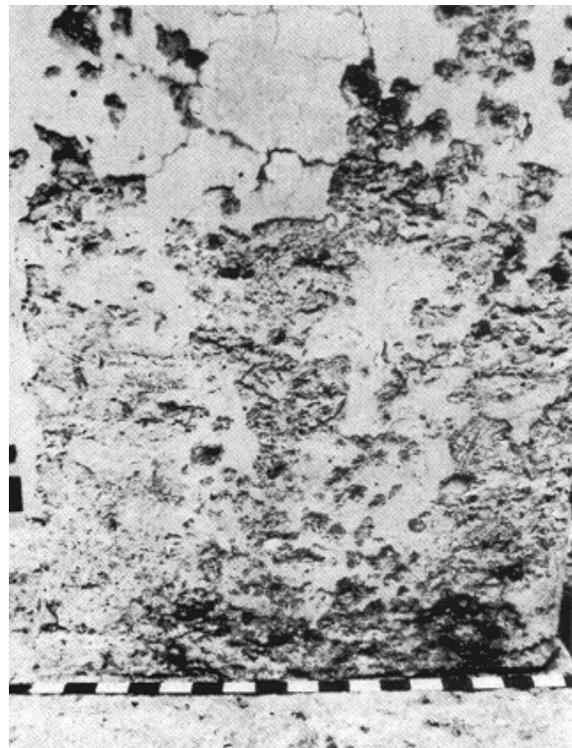
Figure 2-17. Medium scaling

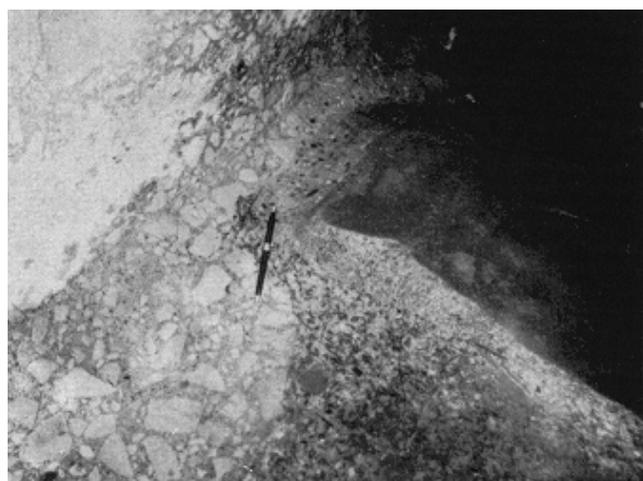
Figure 2-20. Smooth, worn, abraded concrete surface caused by abrasion of waterborne debris

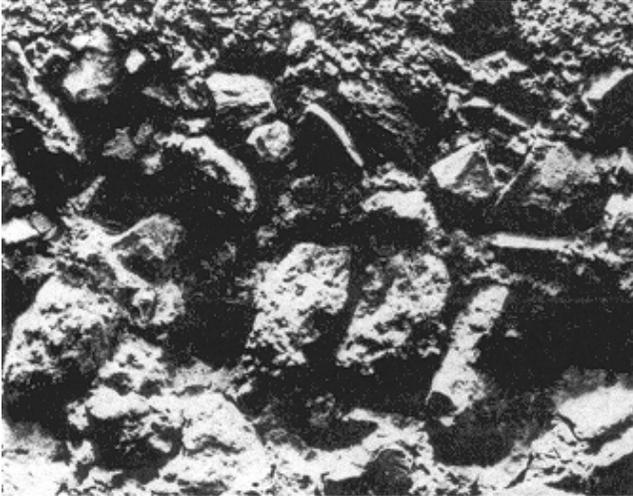
**Figure 2-21. Rough, pitted concrete surface caused by cavitation**

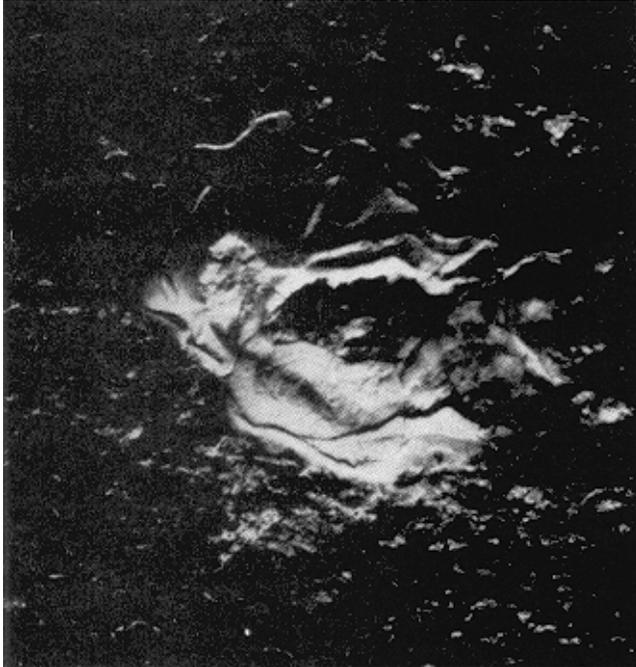
Figure 2-25. Exudation

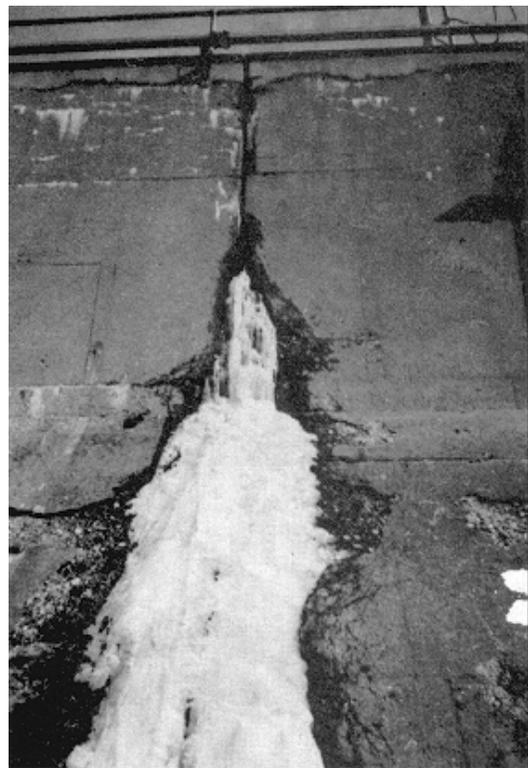
Figure 2-28. Water seepage through joint

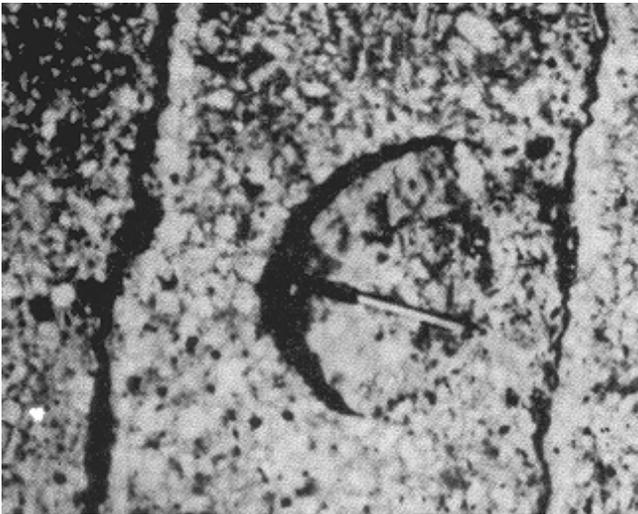
Figure 2-29. Small spall

(a) Small spall. Not greater than 20 mm (0.8 in.) in depth nor greater than 150 mm (6 in.) in any dimension (Figure 2-29).

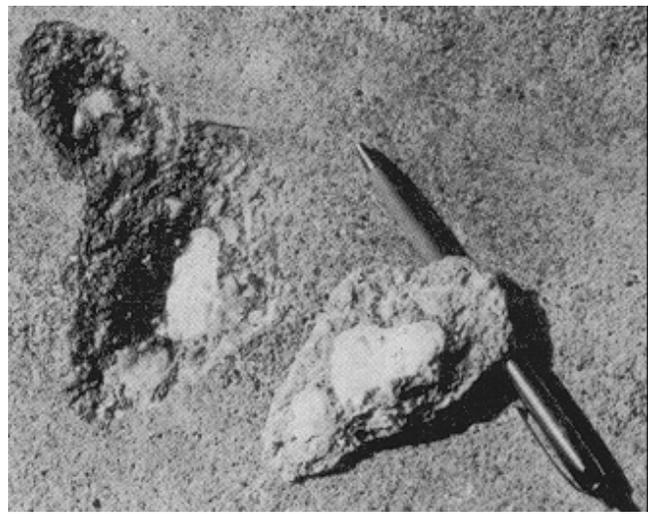
Figure 2-31. Popout

in saturated coarse aggregate particles near the surface freezes, expands, and pushes off the top of the aggregate particle and the superjacent layer of mortar, leaving shallow pits. Chert particles of low specific gravity, limestone containing clay, and shaly materials are well known for this behavior. Popouts are easily recognizable by the shape of the pit remaining in the surface and by a portion

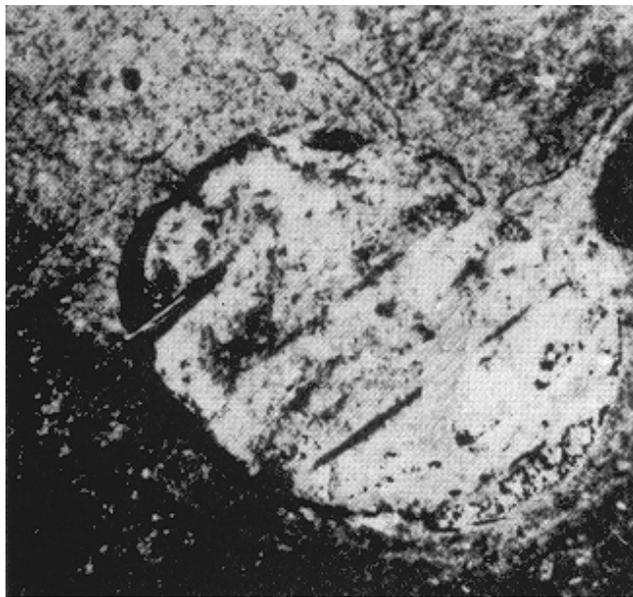
Figure 2-30. Large spall

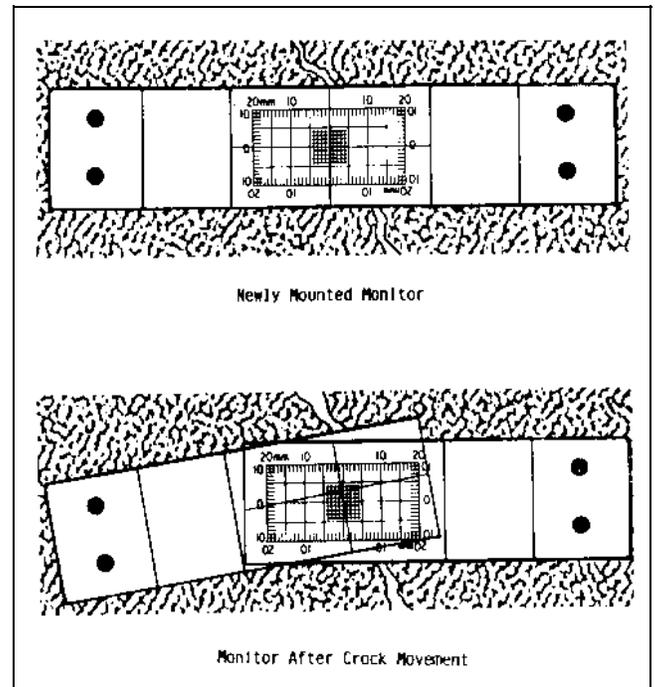
Figure 2-33. Crack monitor

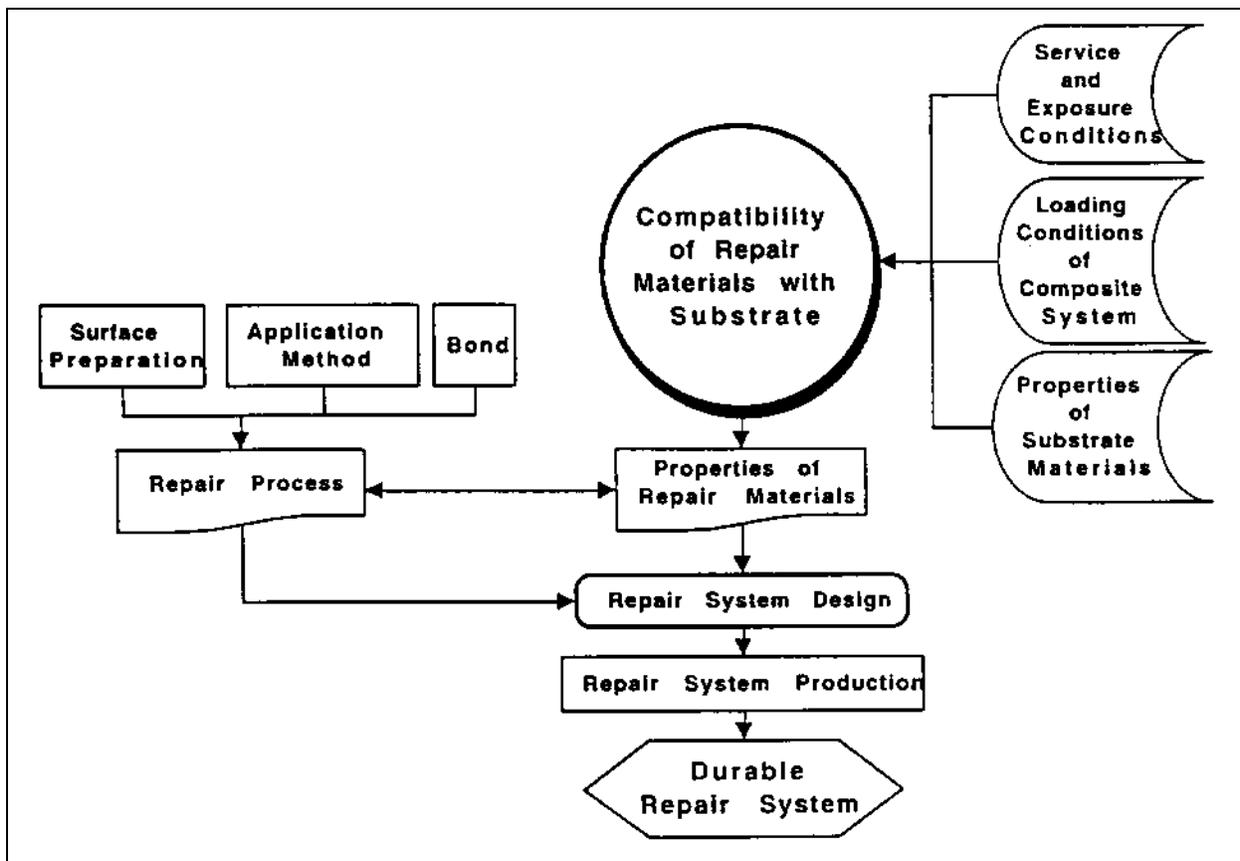
Figure 4-1. Factors affecting the durability of concrete repair systems (Emmons and Vaysburd 1995)

Dimensional compatibility is one of the most critical components of concrete repair. Restrained contraction of repair materials, the restraint being provided through bond to the existing concrete substrate, significantly increases the complexity of repair projects as compared to new construction. Cracking and debonding of the repair material are often the result of restrained contractions caused by volume changes. Therefore, the specified repair material must be dimensionally compatible with the existing concrete substrate to minimize the potential for failure. Those material properties that influence dimensional

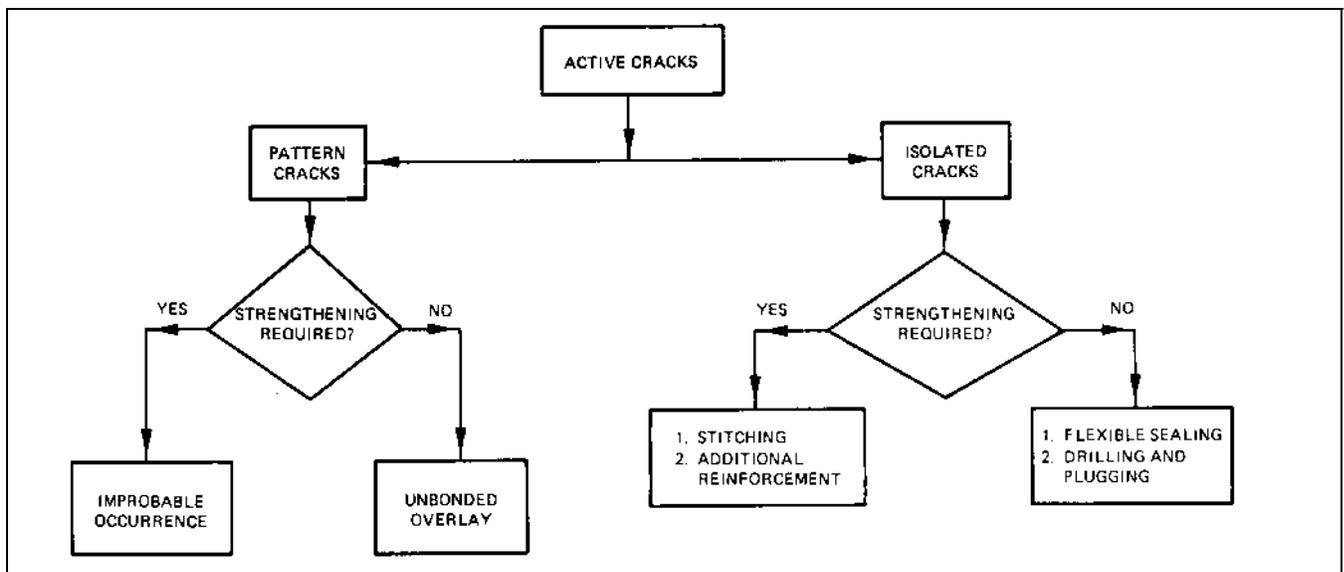
Figure 4-3. Selection of repair method for active cracks (after Johnson 1965)

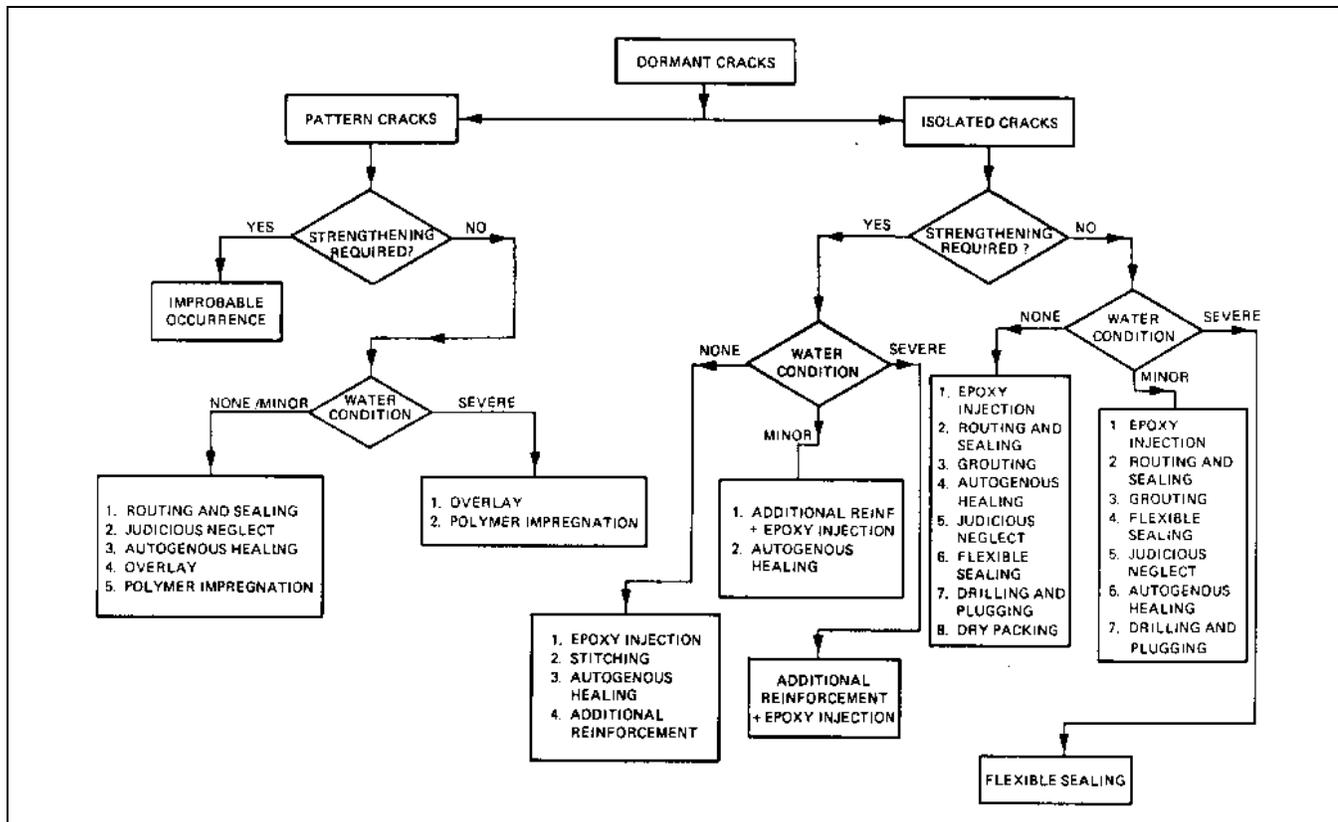
Figure 4-4. Selection of repair method for dormant cracks (after Johnson 1965)

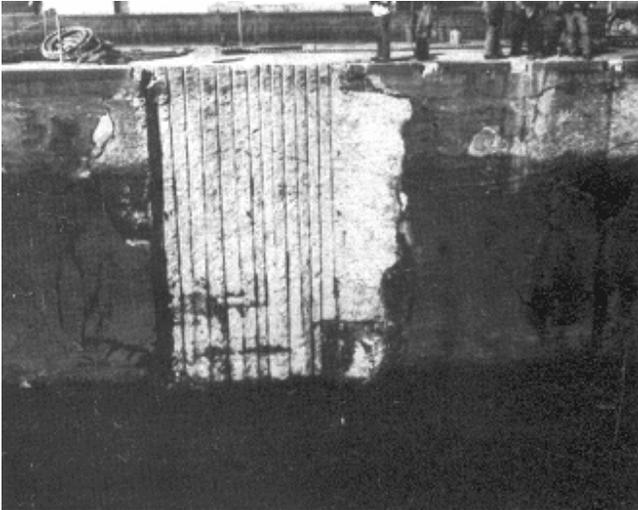
**Figure 5-1. Surface removal of deteriorated concrete by explosive blasting**

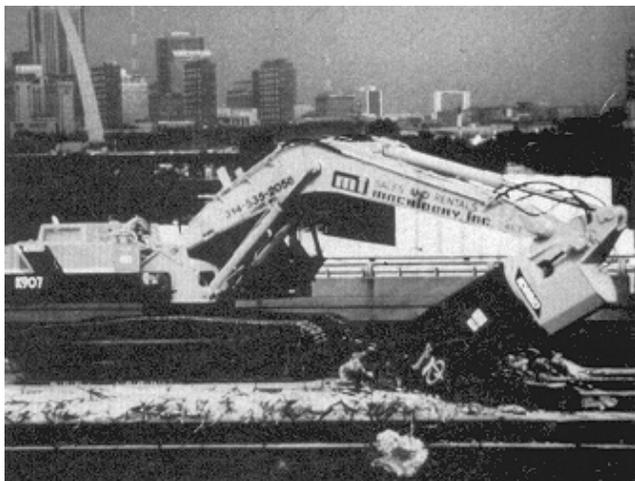
**Figure 5-2. Boom-mounted concrete crusher**

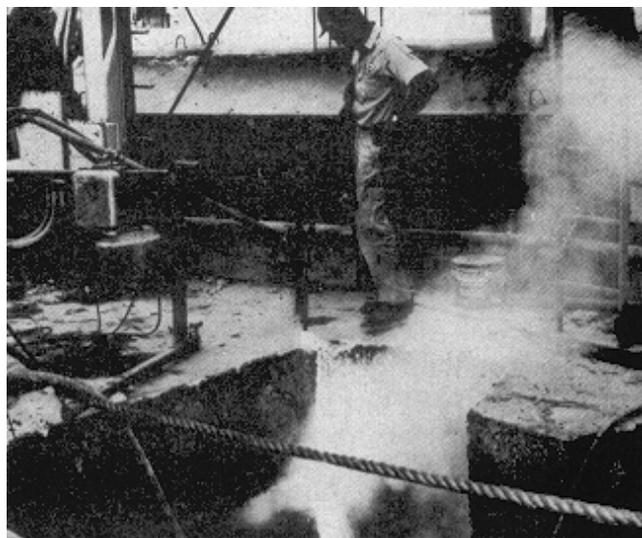
Figure 5-5. Powder torch

(5) *Thermal cutting.* Thermal-cutting methods are applicable for making cutouts through heavily reinforced decks, beams, walls, and other reinforced members where site conditions allow efficient flow of molten concrete from cuts. Flame tools (Figure 5-5) are typically employed for cutting depths of 600 mm (24 in.) or less, and lances (Figure 5-6), for greater depths. Thermal cutting tools are of limited commercial availability and are costly to use. The concrete that remains has a layer of thermal damage with more extensive damage occurring around steel reinforcement. Personnel must be protected from heat and hot flying rock produced by the cutting operation. Additional safety precautions are required because of the hazards associated with the storage, handling, and use of compressed and flammable gases. The

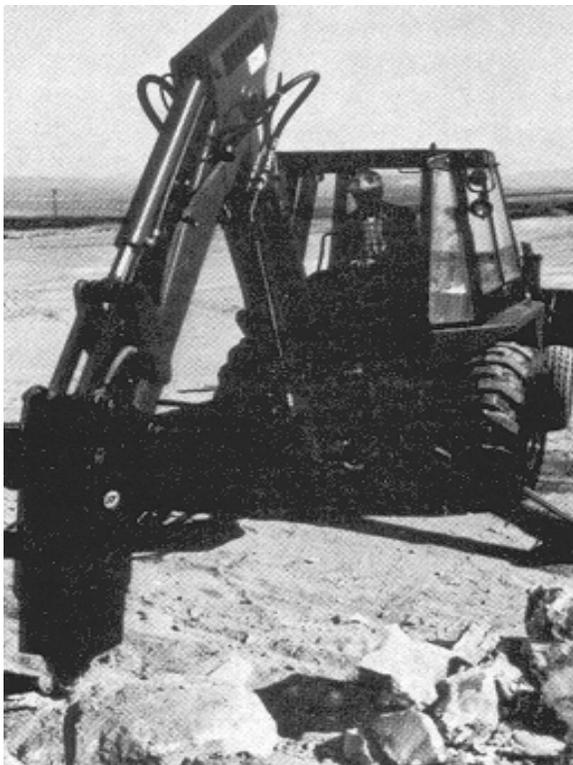
**Figure 5-7. Boom-mounted breaker**

(1) Boom-mounted breakers. Boom-mounted impact breakers are applicable for both full- and partial-depth removals where production rates required are greater than can be economically achieved by the use of hand-held breakers. The boom-mounted breakers are somewhat similar to the hand-held breakers except that they are considerably more massive. The tool is normally attached to the hydraulically operated arm of a backhoe or excavator (Figure 5-7) and can be operated by compressed air or hydraulic pressure. The reach of the hydraulic arm enables the tool to be used on walls at a considerable distance above or below the level of the machine. Boom-mounted breakers are a highly productive means of removing concrete. However, the blow energy delivered to the concrete should be limited to protect the structure being repaired and surrounding structures from damage resulting from the high cyclic energy generated. Saw cuts

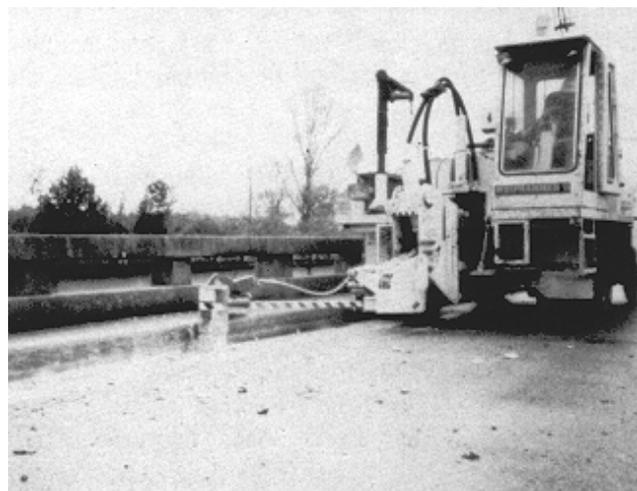
**Figure 5-8. Spring-action hammer (mechanical sledgehammer)**

(2) Spring-action hammers. Spring-action hammers (sometimes referred to as mechanical sledgehammers) are boom-mounted tools that are applicable for breaking concrete pavements, decks, walls, and other thin members where production rates required are greater than can be economically achieved with the use of hand-held breakers. Hammers are more applicable for total demolition of a concrete member than for removal to rehabilitate or repair. The arm of the hammer is hydraulically powered, and the impact head is spring powered. The spring is compressed by the downward movement of the arm of the backhoe or excavator and its energy released just prior to impact. There are truck units available that make it easier to move between projects. The operation of the hammer and advancement of the truck during removal are controlled from a cab at the rear of truck (Figure 5-8). The blow energy delivered to the concrete should be limited to protect the structure being repaired and surrounding structures from damage caused by the high cyclic energy generated. Saw cuts should be employed at removal boundaries to reduce the occurrence of feathered edges. The concrete that remains may be damaged (microcracking) along with the exposed reinforcing steel.

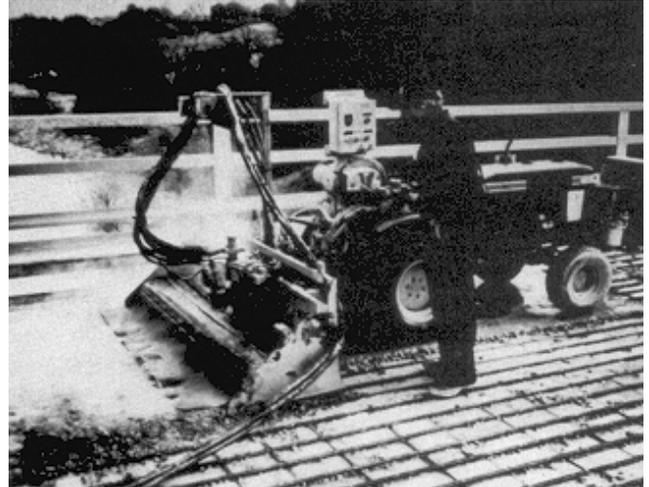
Figure 5-10. Hydromilling (water-jet blasting)

(1) Hydromilling. Hydromilling (also known as hydrodemolition and water-jet blasting) is applicable for removal of deteriorated concrete from surfaces of decks (Figure 5-10) and walls where removal depth is 150 mm (6 in.) or less. This method does not damage the concrete that remains and leaves the steel reinforcing undamaged for reuse in the replacement concrete. Its major limitations are that the method is costly, productivity is significantly reduced when sound concrete is being removed, and the removal profile varies with changes in depth of deterioration. Holes through members (blowouts) are a common occurrence when removal is near full depth of a member. This method requires a large source of potable water (the water demand for some units exceeds 4,000 L/hr (1,000 gal/hr)). An environmental impact statement is required if waste water is to enter a waterway. Personnel must wear hearing protection because of

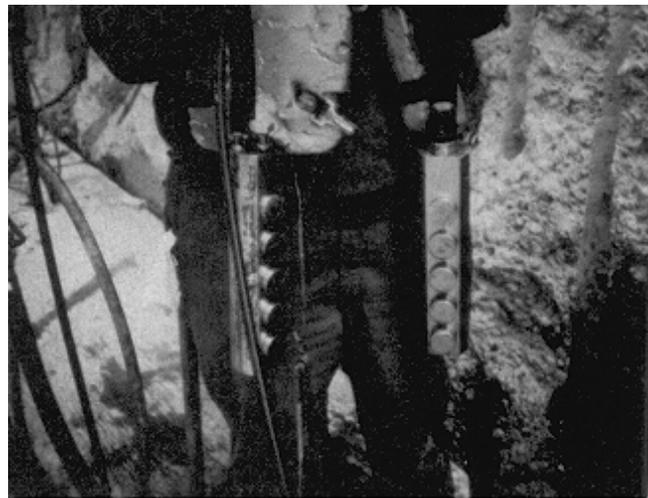
Figure 5-13. Piston-jack splitter

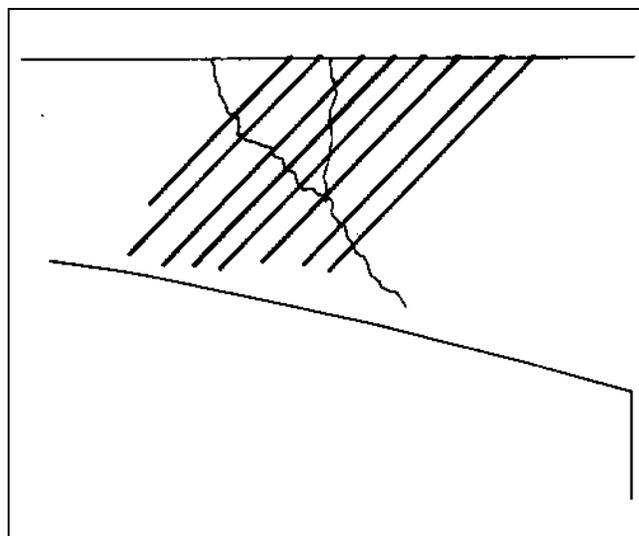
**Figure 6-1. Crack repair using conventional reinforcement with drillholes 90 deg to the crack plane**

(a) This technique consists of sealing the crack, drilling holes 19 mm (3/4 in.) in diam at 90 deg to the crack plane (Figure 6-1), cleaning the hole of dust, filling the hole and crack plane with an adhesive (typically epoxy) pumped under low pressure 344 to 552 KPa (50 to 80 psi), and placing a reinforcing bar into the drilled hole. Typically, No. 4 or 5 bars are used, extending at least 0.5 m (1.6 ft) on each side of the crack. The adhesive

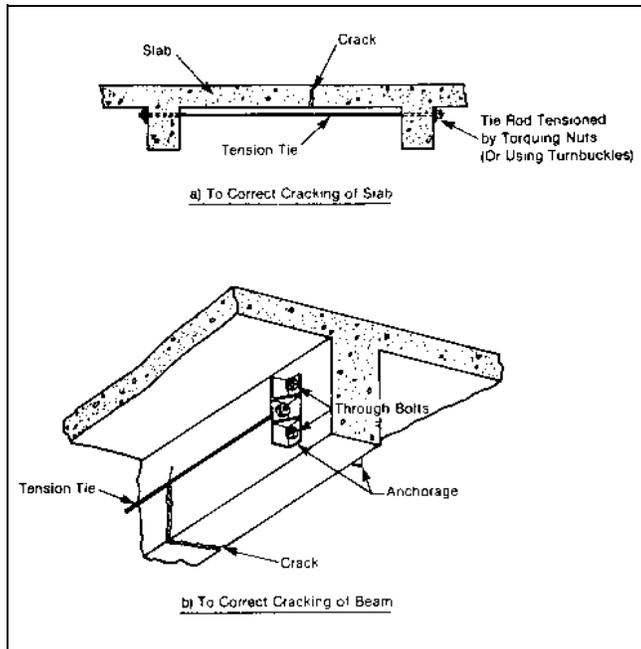
Figure 6-2. Crack repair with use of external prestressing strands or bars to apply a compressive force

(2) Prestressing steel. This technique uses prestressing strands or bars to apply a compressive force (Figure 6-2). Adequate anchorage must be provided for the prestressing steel, and care is needed so that the problem will not merely migrate to another part of the structure. The effects of the tensioning force (including eccentricity) on the stress within the structure should be carefully analyzed. For indeterminate structures posttensioned according to this procedure, the effects of secondary moments and induced reactions should be considered.

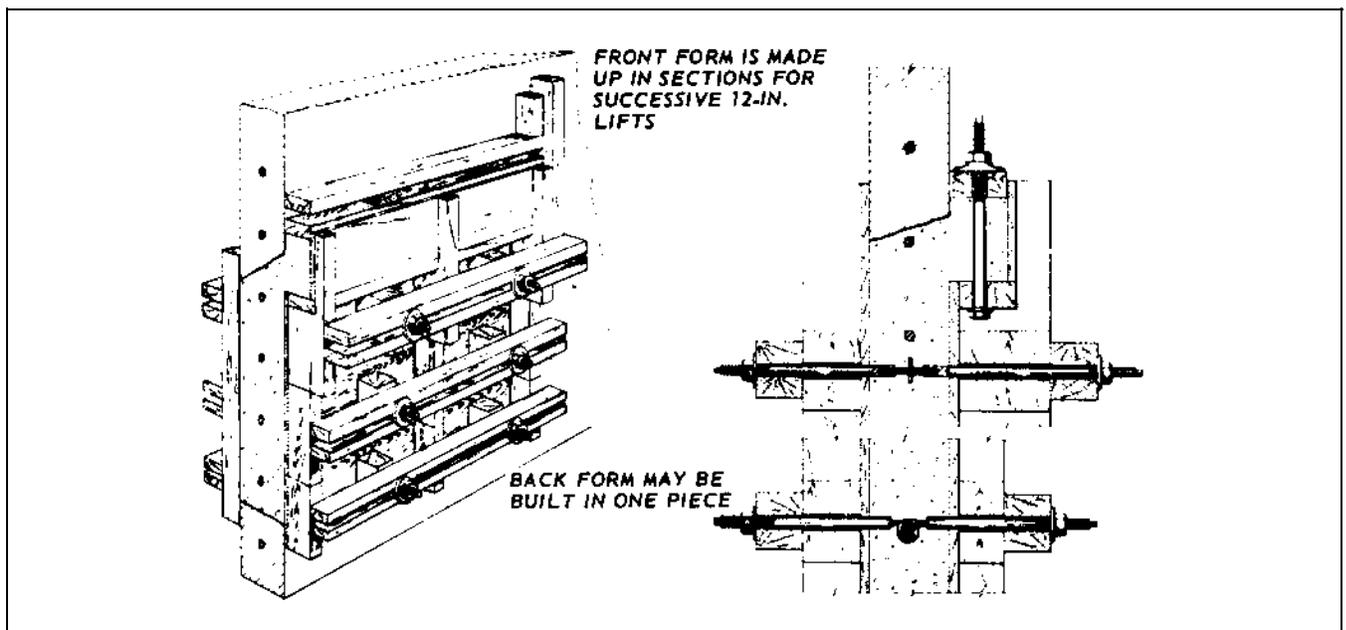
Figure 6-3. Detail of form for concrete replacement in walls after removal of all unsound concrete

(3) Forming will usually be required for massive repairs in vertical surfaces. The front form and the back form, where one is required, should be substantially constructed and mortar-tight. The back form may be assembled in one piece, but the front panel should be constructed as placing progresses so that the concrete can be conveniently placed in lifts. The contact surface should be dry at the time of patching. Small, thin repairs (less than 50 mm (2 in.) thick) should receive a bonding coat while thicker placements usually do not require a bonding coat (see paragraph 5-3a(2)(f)). The surface is first carefully coated with a thin layer of mortar, not exceeding 3 mm (1/8 in.) in thickness, containing sand passing the No. 16 sieve, and having the same w/c as the concrete to be used in the replacement. Hand-rubbing the mortar into the surface is effective. Epoxy resin

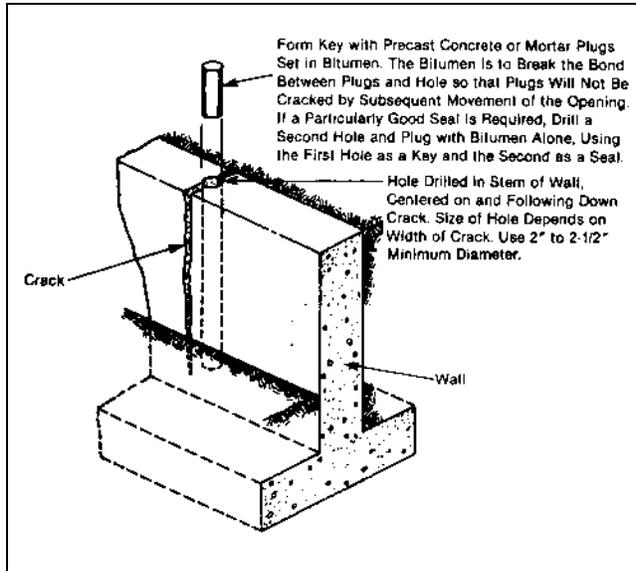
Figure 6-5. Repair of crack by drilling and plugging

*a. Description.* Drilling and plugging a crack consists of drilling down the length of the crack and grouting it to form a key (Figure 6-5).

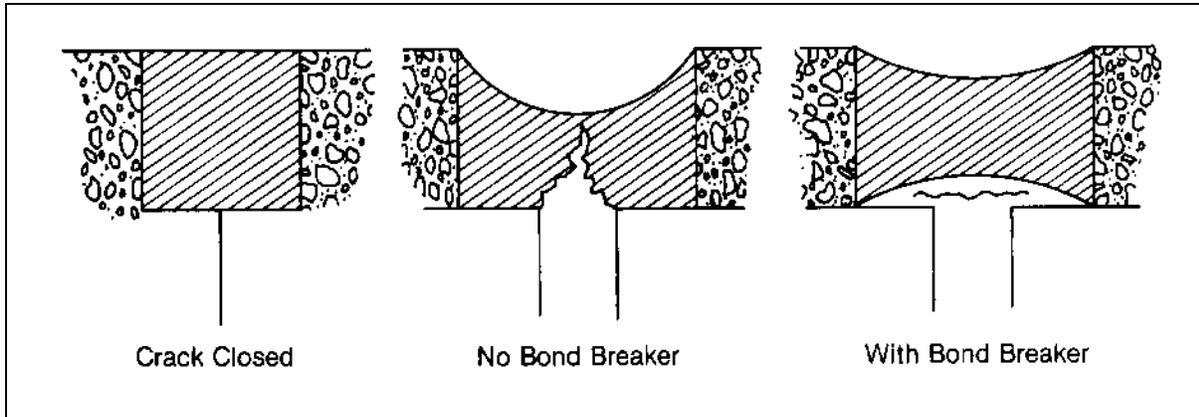
Figure 6-6. Effect of bond breaker involving a field-molded flexible sealant

(1) A bond breaker should be provided at the bottom of the slot to allow the sealant to change shape without a concentration of stress on the bottom (Figure 6-6). The bond breaker may be a polyethylene strip, pressure sensitive tape, or other material which will not bond to the sealant before or during cure.

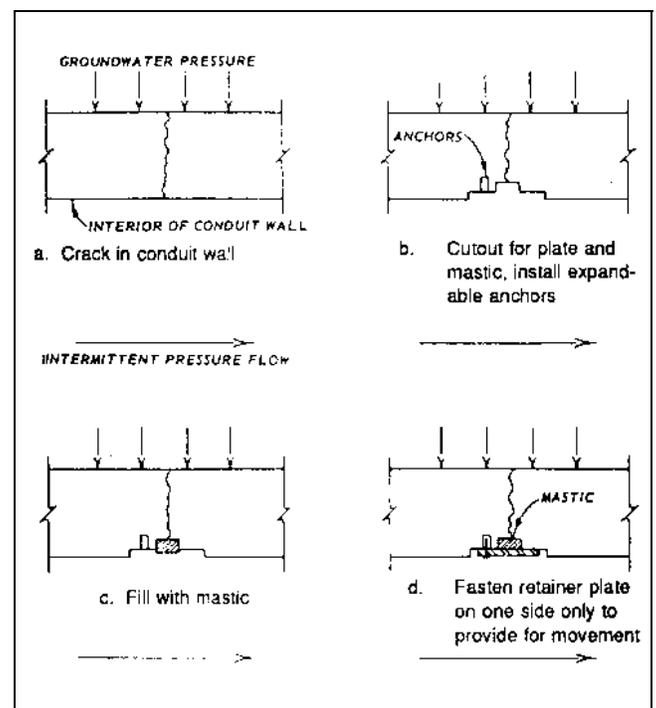
Figure 6-8. Repair of crack by use of a retainer plate to hold mastic in place against external pressure

necessary to cut the concrete surface adjacent to the crack and to place the retaining cap flush with the original flow lines (Figure 6-8).

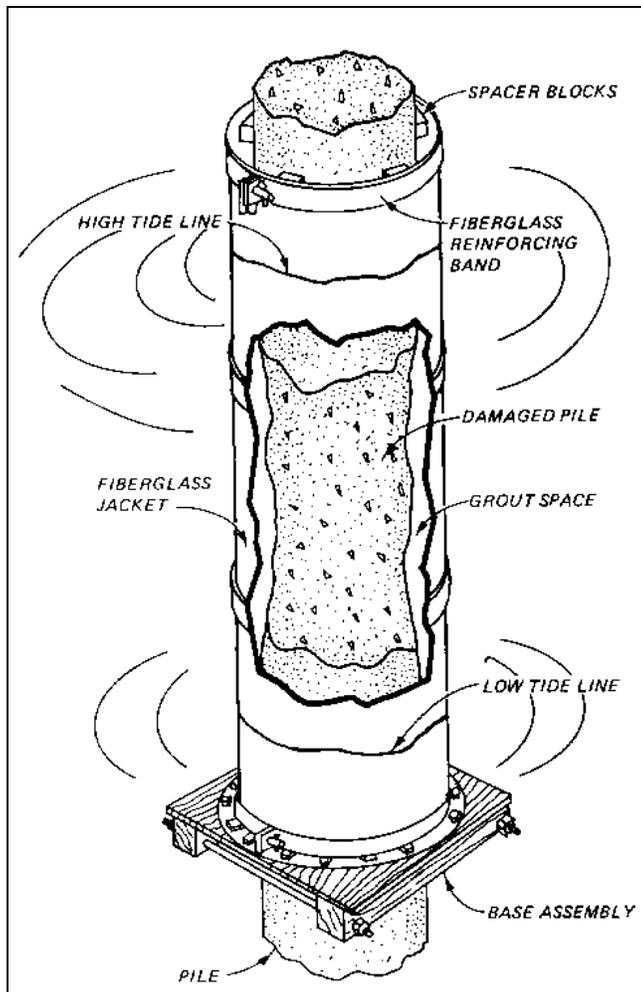
**Figure 6-9. Typical preformed fiberglass jacket being used in repair of a concrete pile**

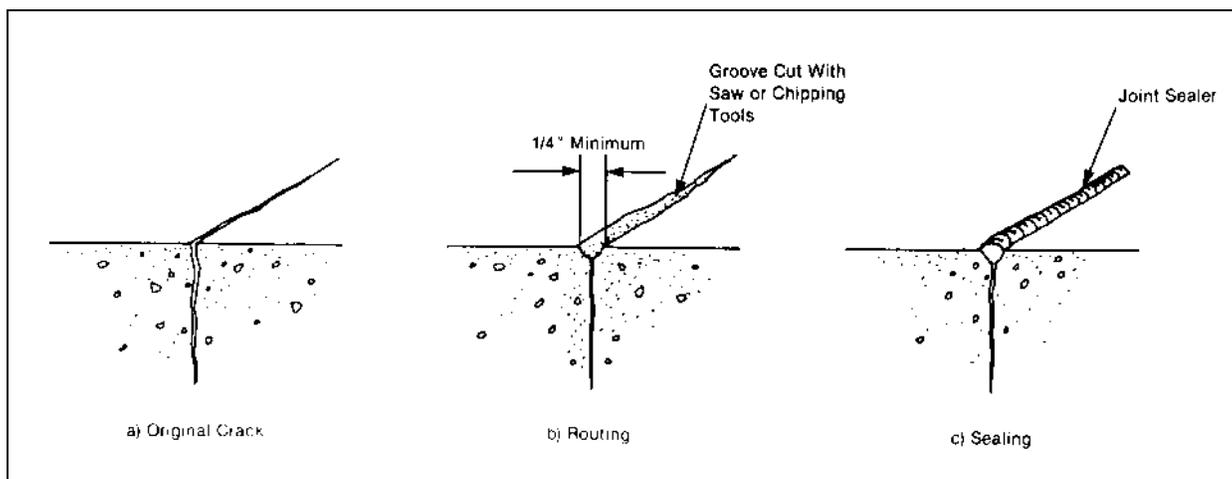
Figure 6-10. Repair of crack by routing and sealing

*a. Description.* This method involves enlarging the crack along its exposed face and filling and sealing it with a suitable material (Figure 6-10). The routing operation may be omitted but at some sacrifice in the permanence of the repair. This is the simplest and most common method for sealing dormant cracks.

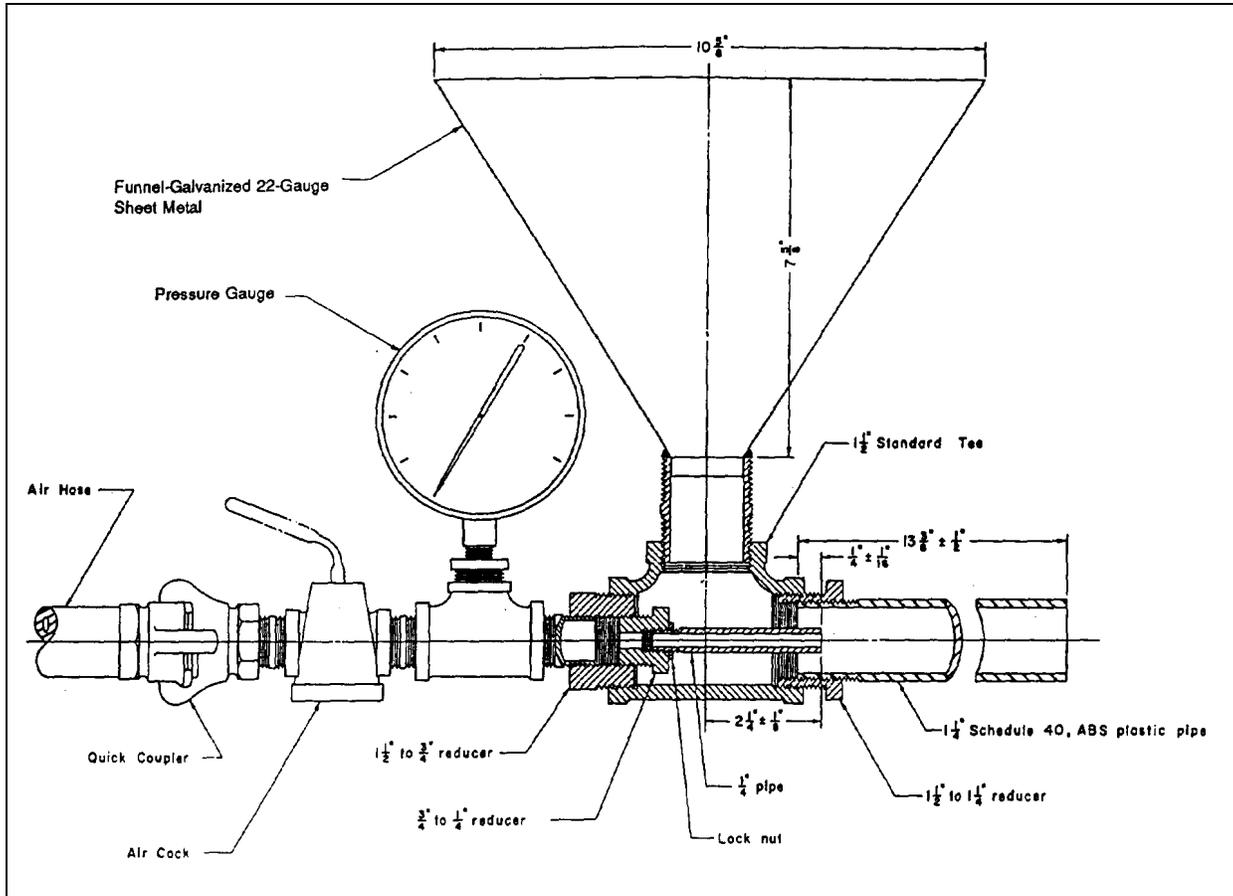
Figure 6-11. Mortar gun for concrete repair (U.S. Army Engineer Division, Missouri River 1974)

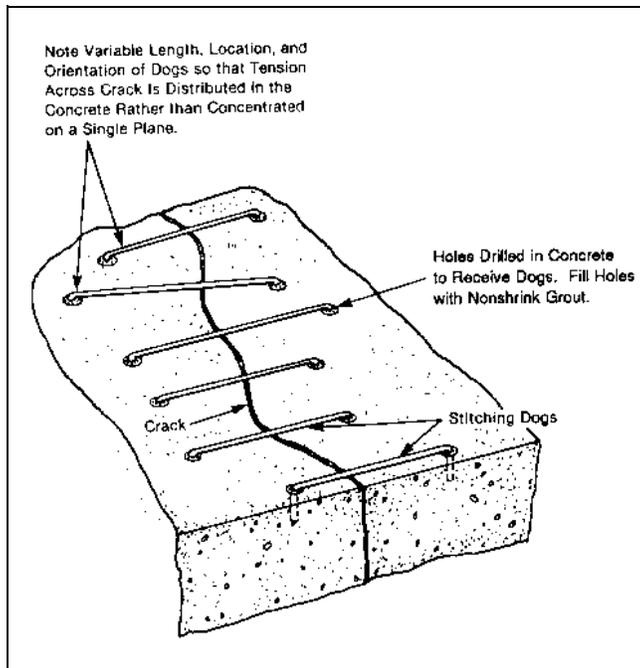
Figure 6-13. Repair of a crack by stitching

*b. Applications and limitations.* Stitching may be used when tensile strength must be reestablished across major cracks. Stitching a crack tends to stiffen the structure, and the stiffening may accentuate the overall structural restraint, causing the concrete to crack elsewhere. Therefore, it may be necessary to strengthen the adjacent

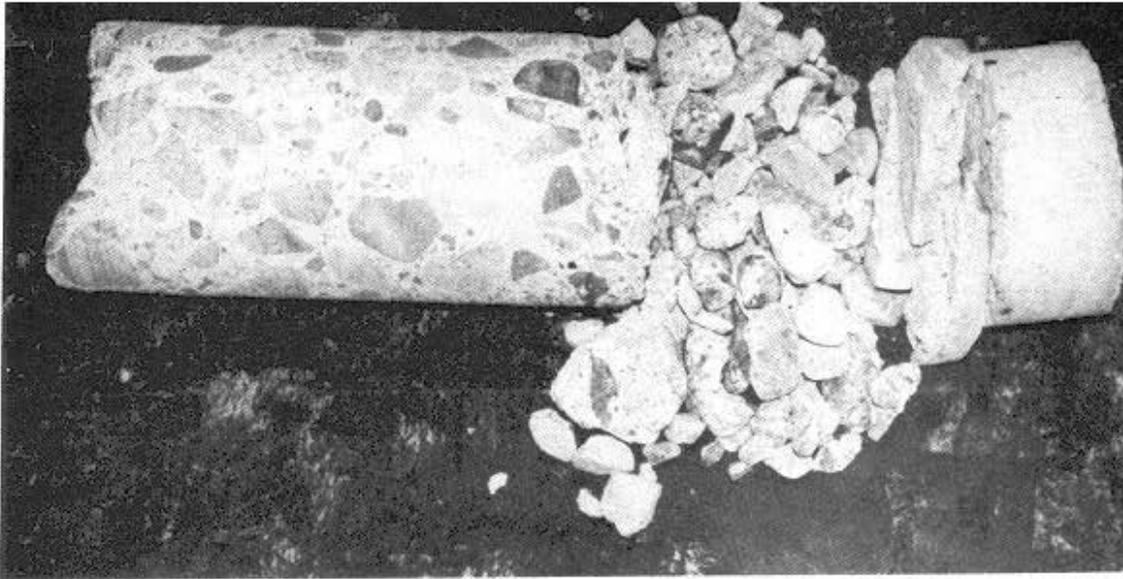
a. Concrete deterioration immediately behind shotcrete overlay

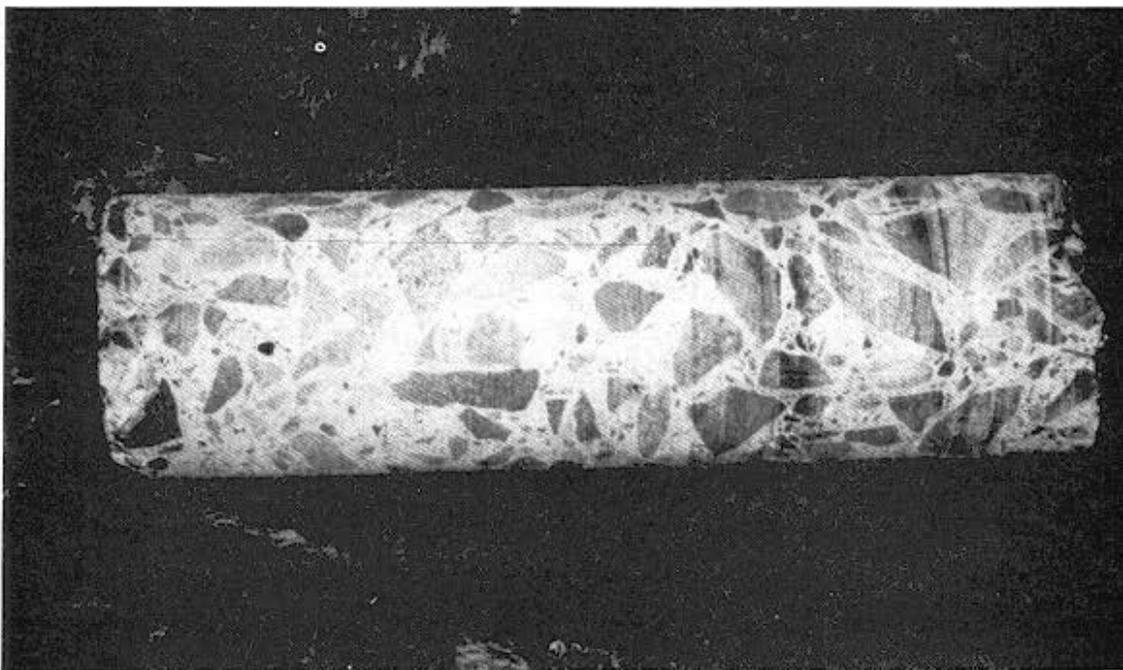
b. Concrete not refaced with shotcrete

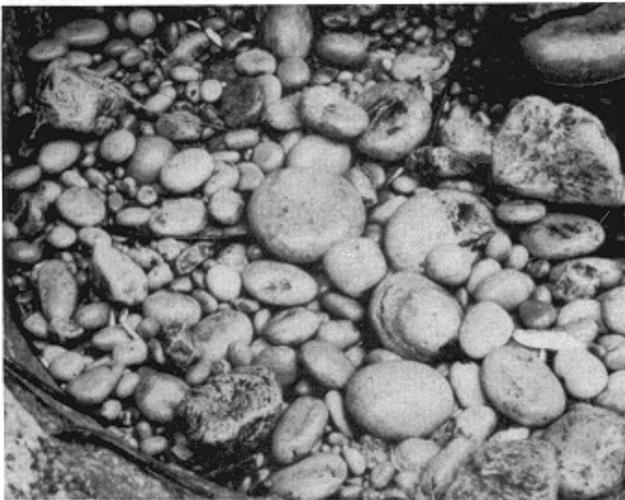
b. Debris in scour holes
