# Evaluation and Repair of Concrete Structures

Manual  
No. 1110-2-2002

30 June 1995

**Engineering and Design  
EVALUATION AND REPAIR OF CONCRETE STRUCTURES**

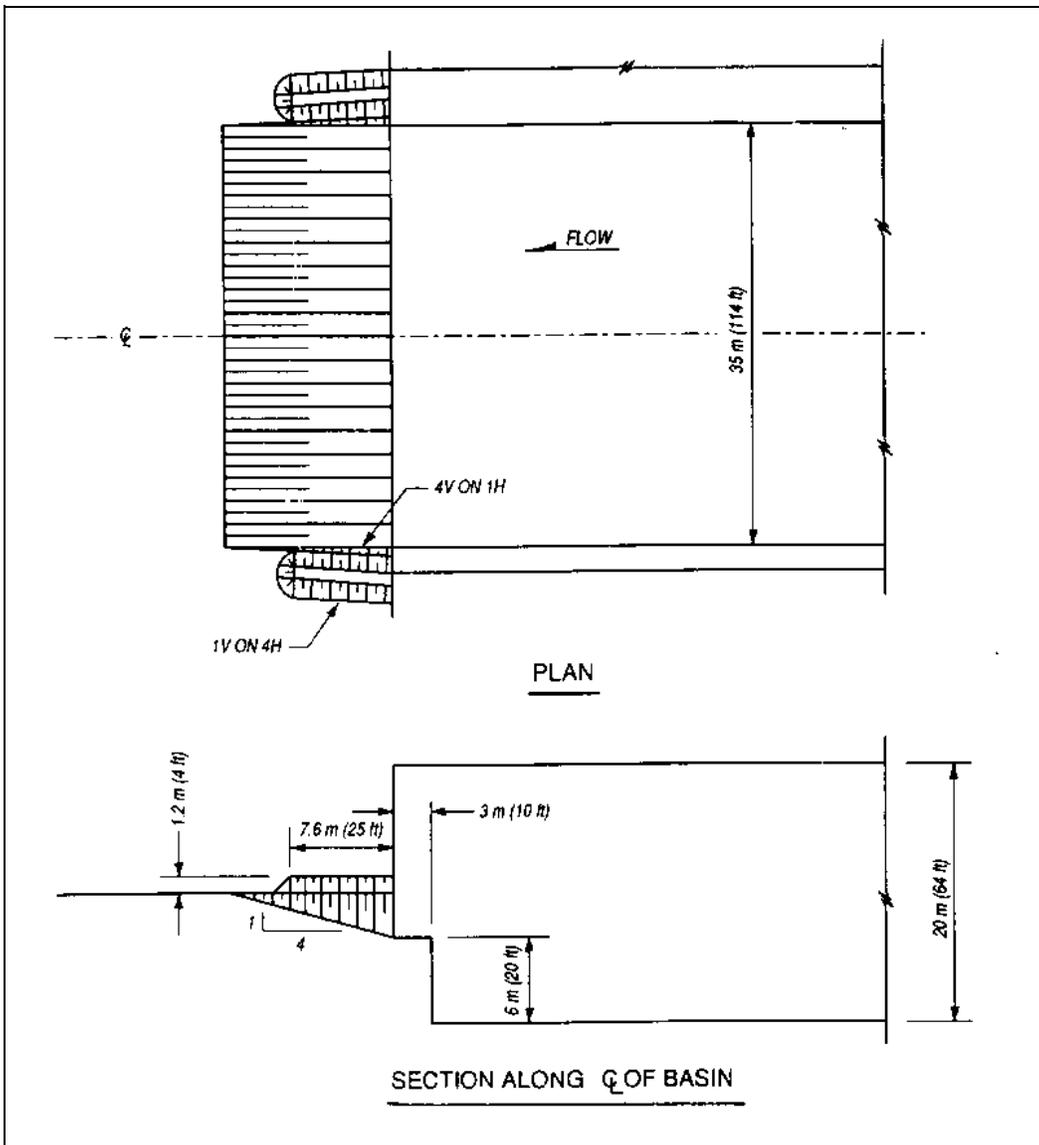
Figure 8-37. Stilling basin wall extension fills, Dworshak Dam

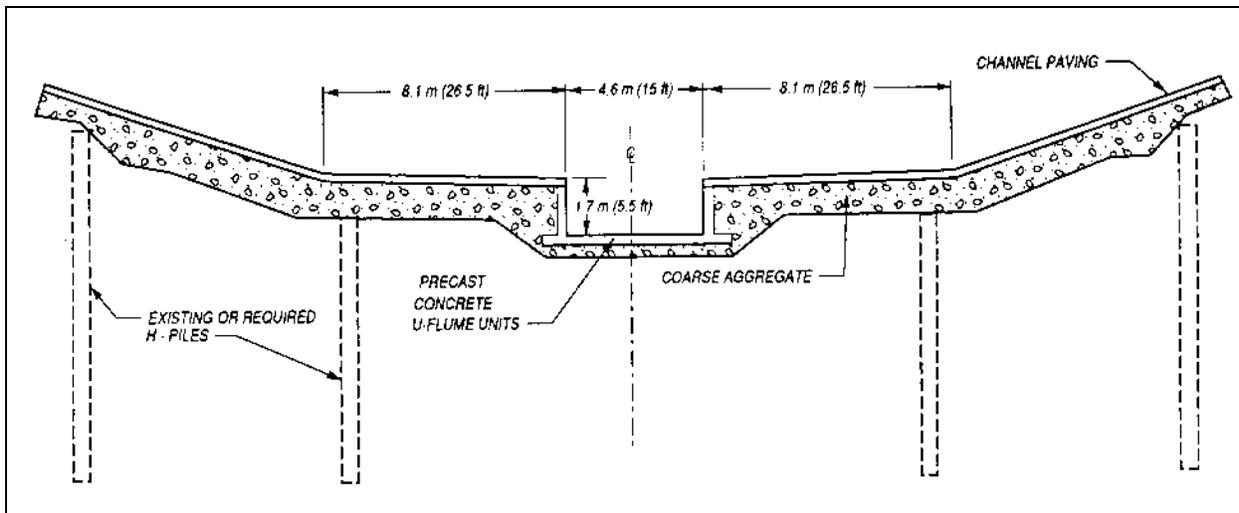
Figure 8-46. Cross section of precast low-flow channel, Blue River Channel (after Mitscher 1992)

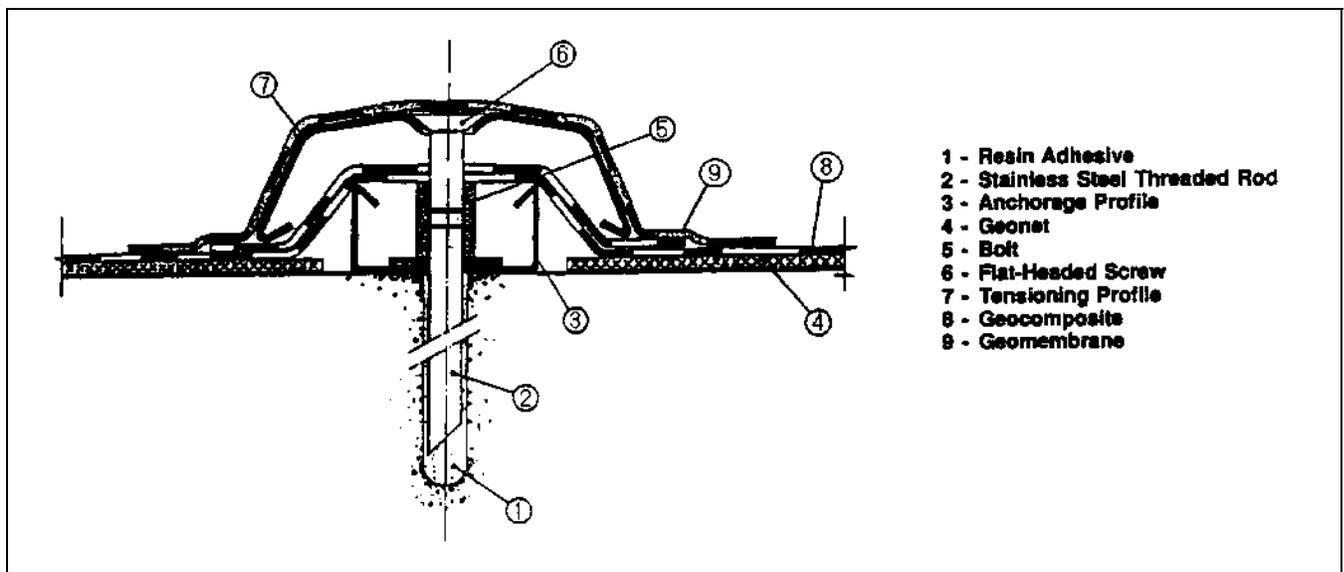
Figure 8-58. Detail of vertical anchorage and drainage profile
