Ethical Issues from the Tacoma
Narrows Bridge Collapse

J. Paul Guyer, P.E., R.A.

Course No 0005487
2 PDH HOURS

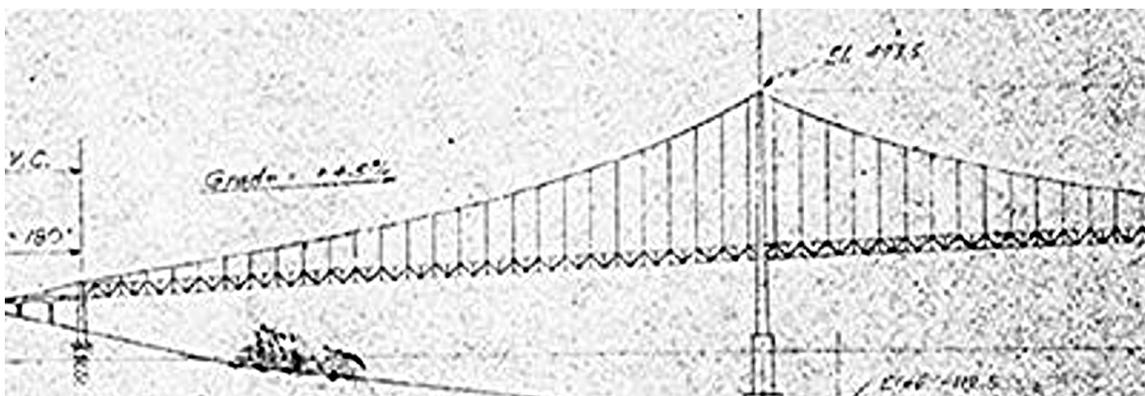
Figure 3

The Eldridge Design
(Washington State DOT records)

With the prospect of federal funding now in view, the Washington Department of Highways, under the direction of engineer Clark Eldridge, prepared plans for a suspension bridge using convention suspension bridge design practices as they were known at that time....specifically, the roadway deck was supported by deep (25-foot) truss girders to stiffen it. The Authority submitted the Eldridge design to the federal Public Works Administration (PWA) with a request for \$11 million.

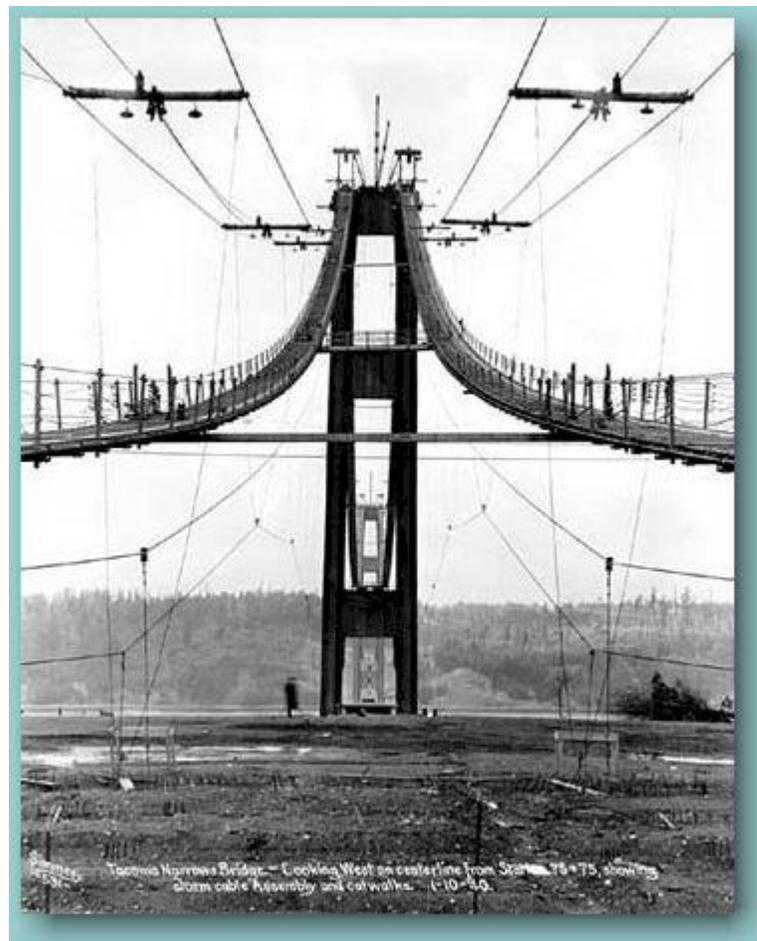
Figure 4

Tacoma Narrows Bridge Under Construction
(University of Washington Libraries, Special Collections, PH Coll. 11.19)

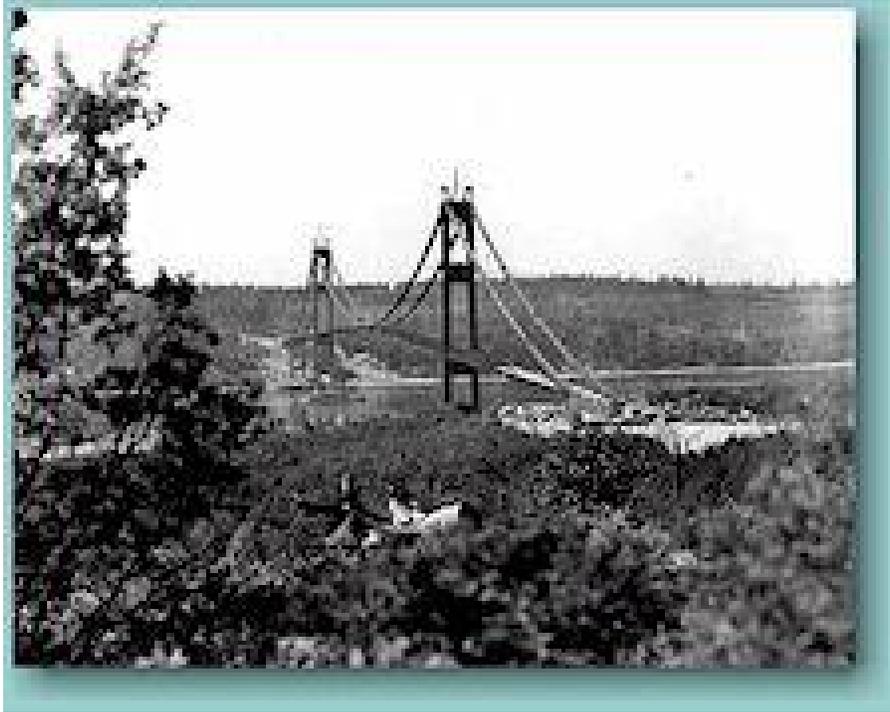
Figure 5

Tacoma Narrows Bridge Under Construction

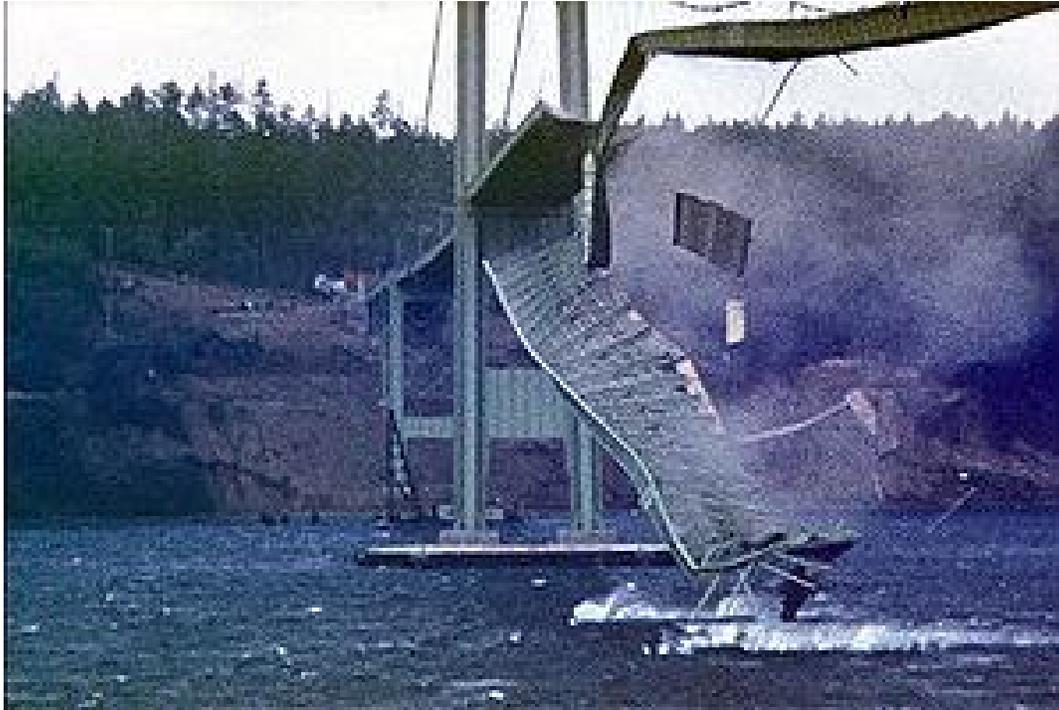
Figure 7

Collapse of the Tacoma Narrows Bridge on November 7, 1940
(University of Washington Libraries. Manuscripts, Special Collections, University Archives Division, PH Coll. 290.36)

On the morning of November 7, 1940 the wind was blowing through the Narrows at a steady speed of about 42 miles per hour. At 10 AM the bridge began to oscillate severely in the torsional mode and the bridge was closed to traffic. At 11:10 AM the center span collapsed.

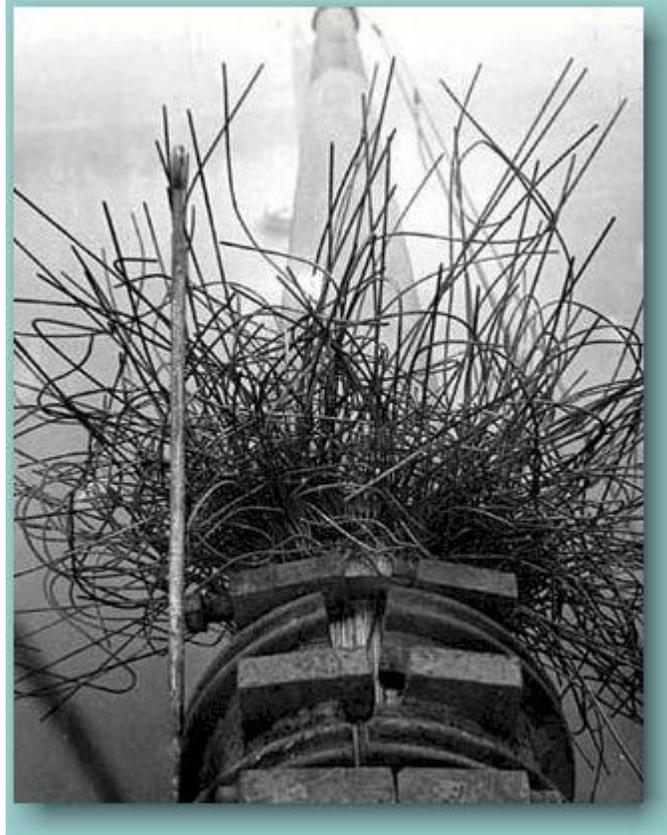
Figure 8

Broken Cable

The amplitude of the motion produced by the fluttering increased beyond the strength of the suspender cables. Once several cables failed, the weight of the deck transferred to the adjacent cables that broke in turn until the central deck collapsed.

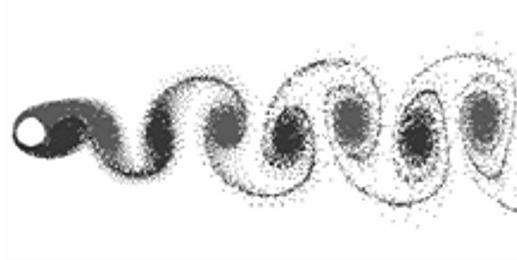
Figure 9
Vortex Shedding

The frequency of the vortices in the von Kármán vortex street is called the Strouhal frequency f_s , and is given by

Where U is the flow velocity, D is a characteristic length of the non-streamlined body and S is the dimensionless Strouhal number, which depends on the body in question. For Reynolds Numbers greater than 1000, the Strouhal number is approximately equal to 0.21. In the case of the Tacoma Narrows, D was approximately 8 feet and S was 0.20.

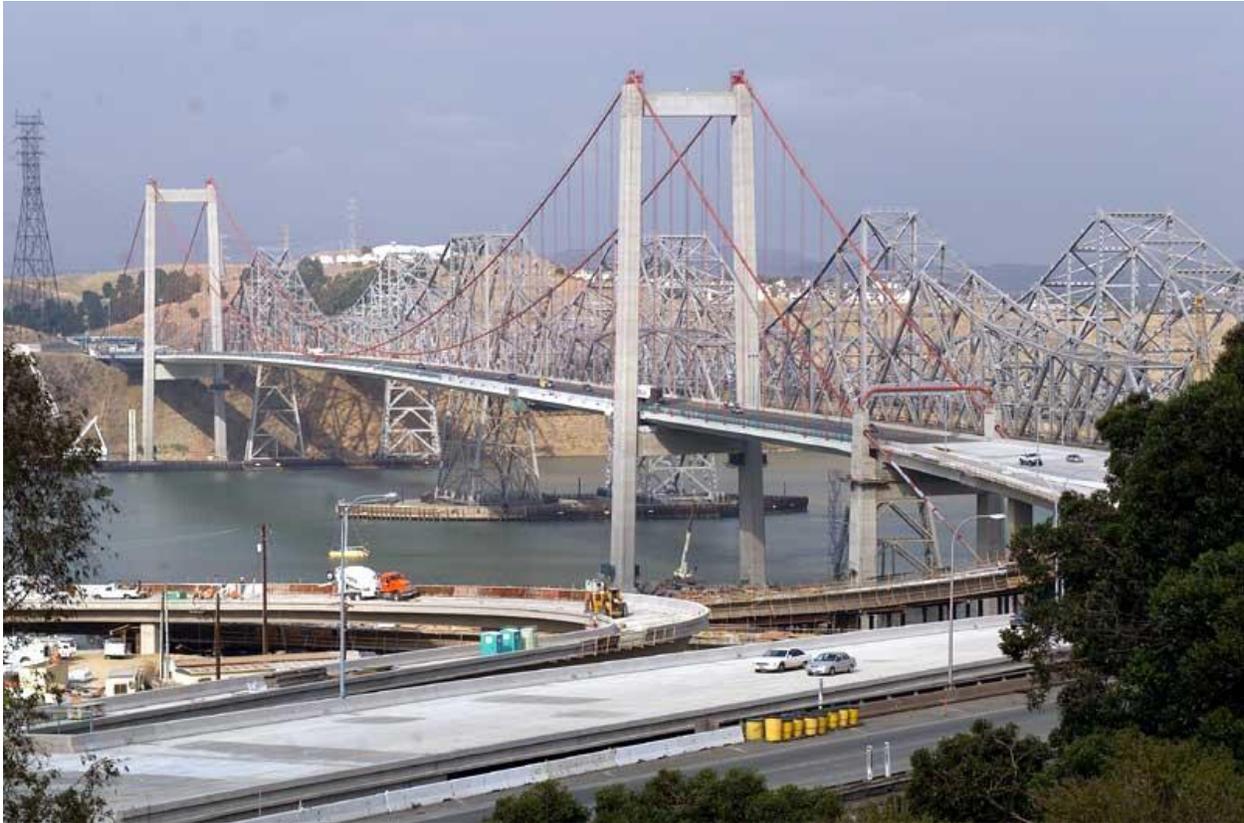
Figure 9

The “third” Carquinez Bridge
(the “first” and “second” bridges are seen beyond; the “first” was subsequently demolished)
(California Department of Transportation)

Today, of course, modeling studies are a primary design tool used by bridge engineer's to design major bridges. And computers using numerical methods such as finite-elements provide a greatly enhanced modeling tool in some instances. The "third" Carquinez Bridge west of Sacramento and completed in 2003 is an example of the state of the art in suspension bridge design. Wind tunnel testing and computer modeling were important tools employed in the design process. Note the slender, solid roadway support girders, similar to those in the Tacoma Narrows bridge design.
