Ethical Issues from the St. Francis Dam Failure

PDHLibrary Course No 0006036
2 PDH HOURS

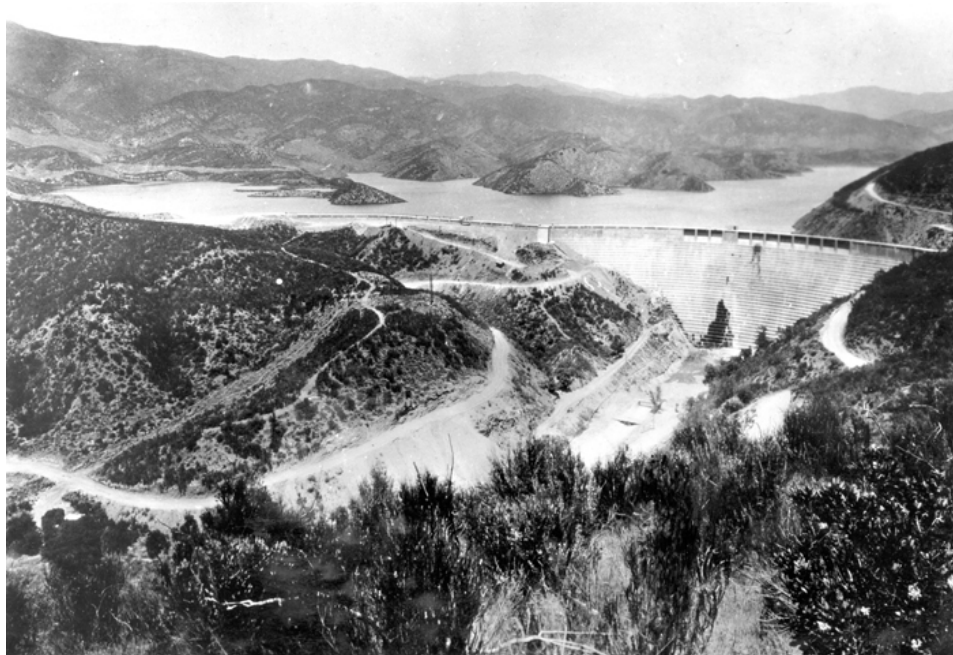
Figure 1

St. Francis Dam

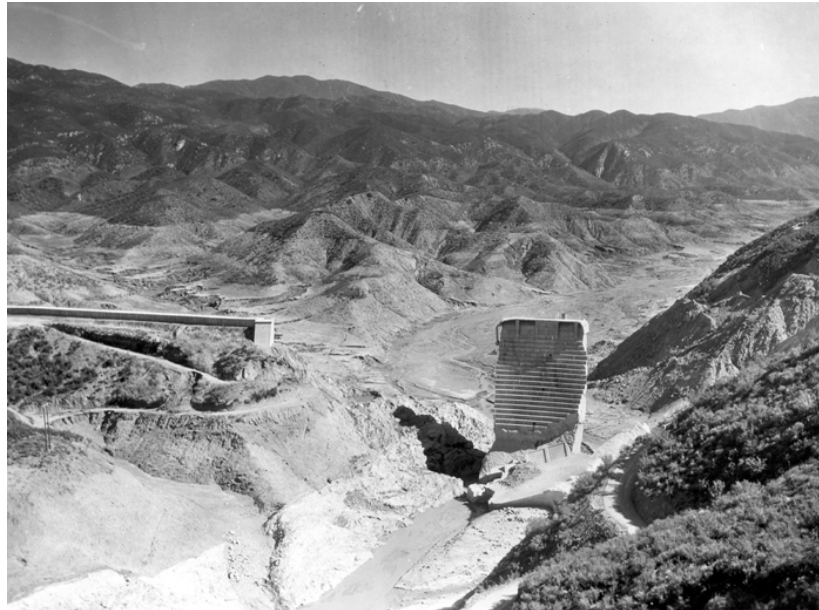
Figure 3

St. Francis Dam, March 17, 1928
(Attribution: U.S. Geological Survey Photographic Library)

The dam broke into several large concrete blocks, some of which were carried almost 1/2 mile downstream, while the center section of the dam remained standing. The upright center section was subsequently demolished. The St. Francis Dam was not rebuilt, although Bouquet Reservoir in nearby Bouquet Canyon and Castaic Dam in the town of Castaic were subsequently built as replacements for the St. Francis Dam.

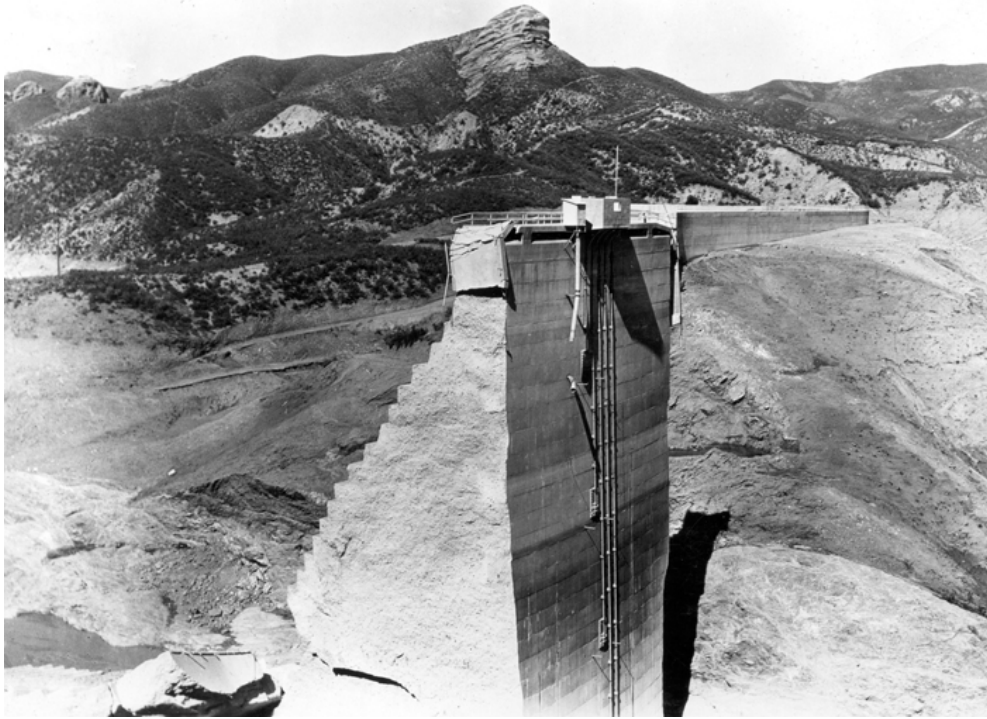
St. Francis Dam, March 17, 1928
(Attribution: U.S. Geological Survey Photographic Library)
Figure 4

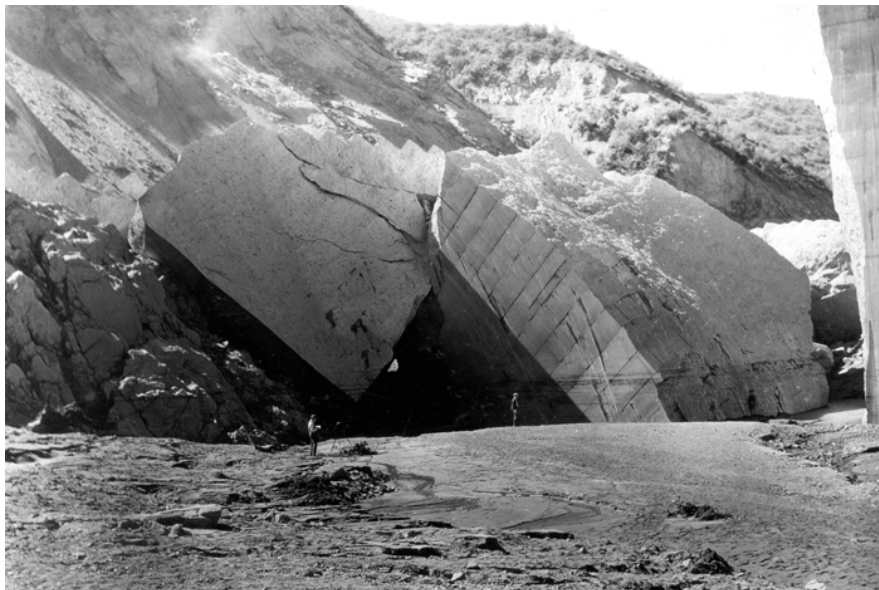
St. Francis Dam, Concrete Debris Blocks
(Attribution: U.S. Geological Survey Photographic Library)
Figure 5

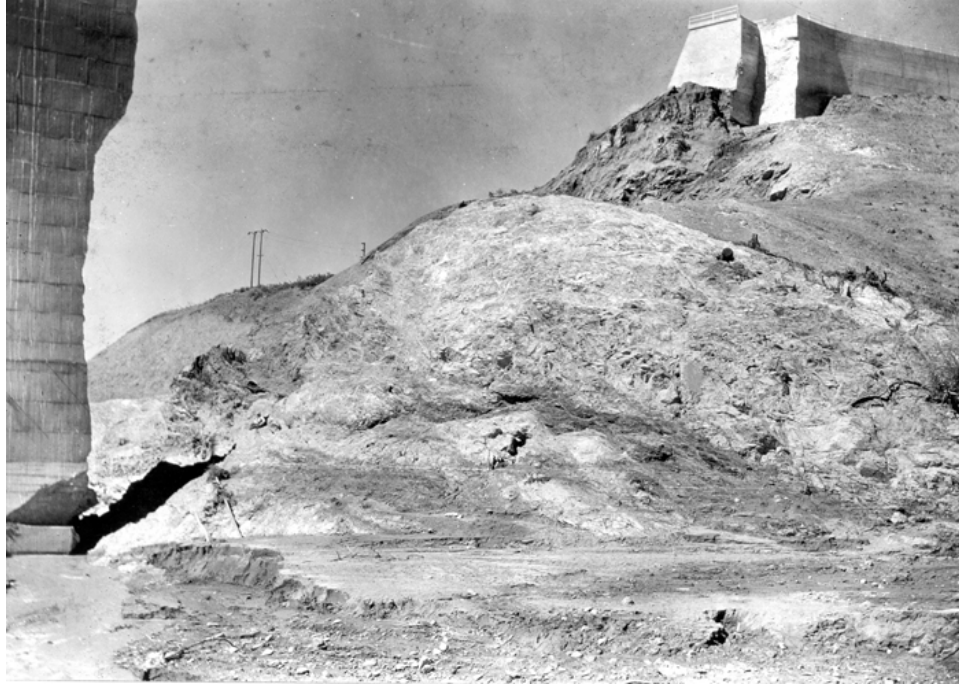
St. Francis Dam, Former West Abutment
 (Attribution: U.S. Geological Survey Photographic Library)
Figure 6

The Los Angeles Coroner's Inquest concluded the disaster was primarily caused by the unsuitable soil conditions on which the eastern abutment of the dam was built, but which would have been impossible for the geologists of the 1920s to detect. Therefore, the inquest determined responsibility for the disaster lay with the governmental organizations which oversaw the dam's construction and the dam's designer and engineer, William Mulholland. Mulholland, however, was cleared of any charges since it was determined that neither he nor anyone at the time could have known of the instability of the rock formations on which the dam was built. The hearings also recommended, "the construction and operation of a great dam should never be left to the sole judgment of one man, no matter how eminent." It has also been suggested that raising the height of the dam 20 feet (as described above) during construction failed to recognize that accompanying design changes might be needed (such as increasing the width of the base of the dam).

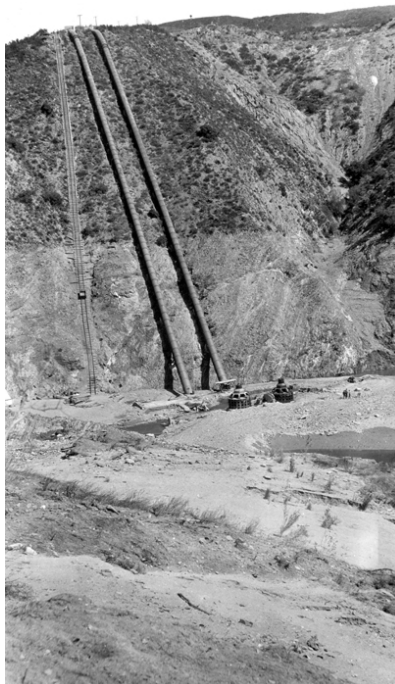
Remains of downstream powerhouse
 (Attribution: U.S. Geological Survey Photographic Library)
Figure 7

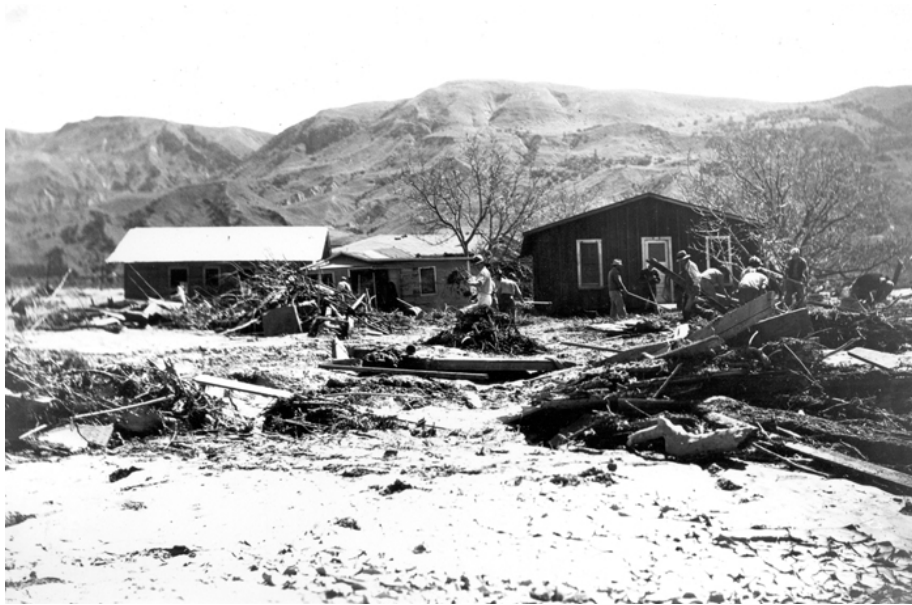
Flood damage at Santa Paula
(Attribution: U.S. Geological Survey Photographic Library)
Figure 8

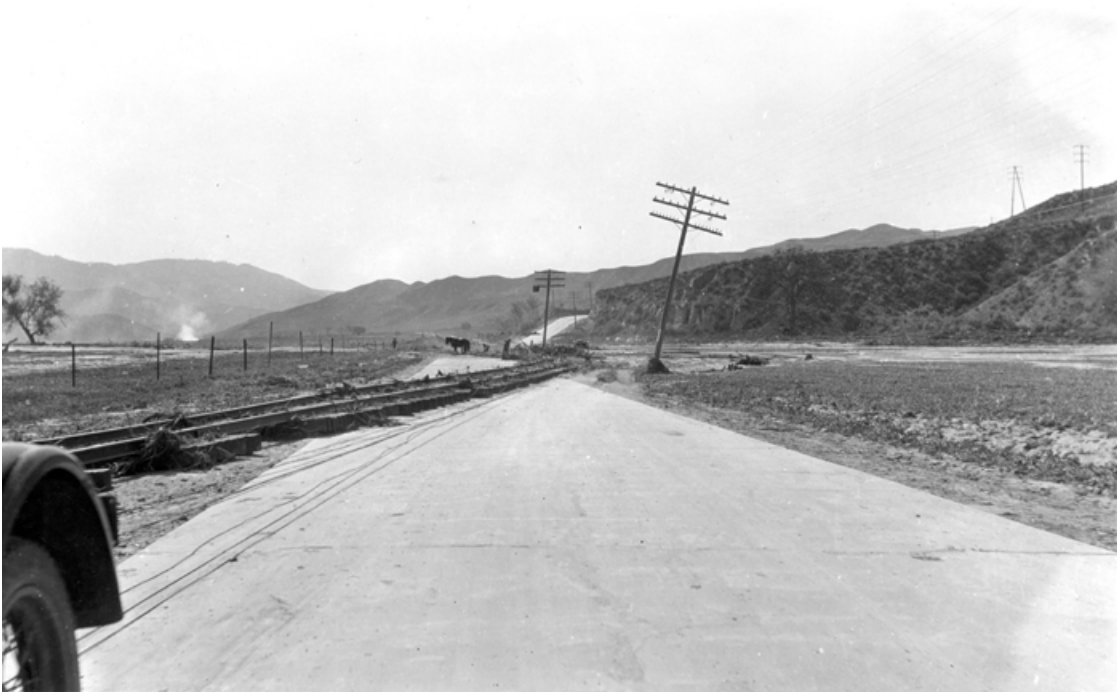
Dislocated railroad tracks
(Attribution: U.S. Geological Survey Photographic Library)
Figure 9

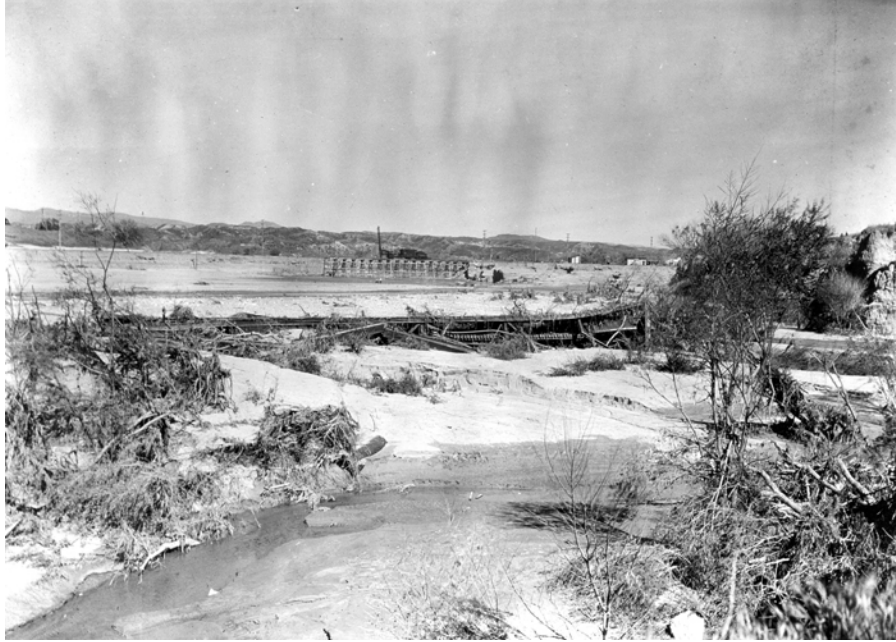
Highway damage
(Attribution: U.S. Geological Survey Photographic Library)
Figure 10

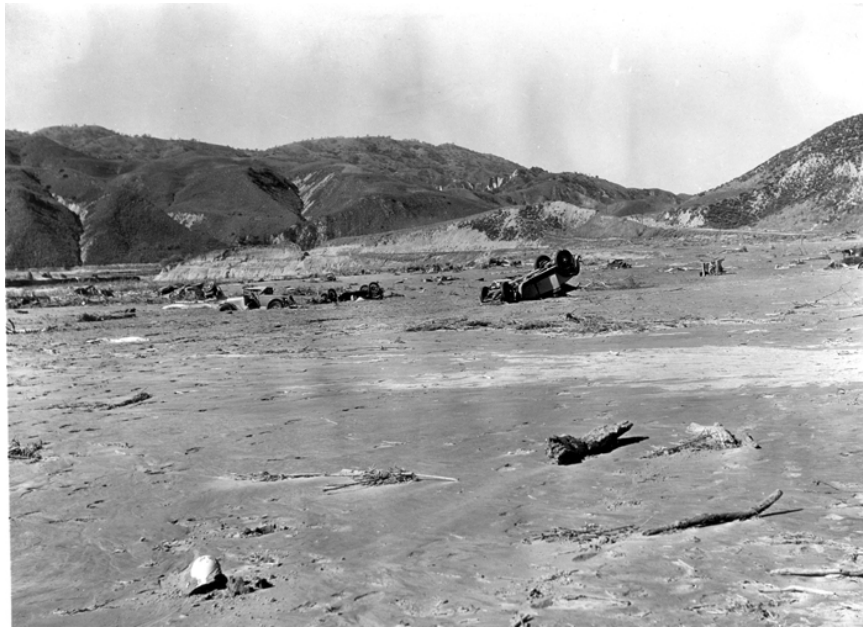
Flood damage
(Attribution: U.S. Geological Survey Photographic Library)
Figure 11
