A Guide to Tornado Protection Selecting Refuge Areas in Buildings

PDHLibrary Course No 2019022
8 PDH HOURS

FEMA P-431, Second Edition / October 2009

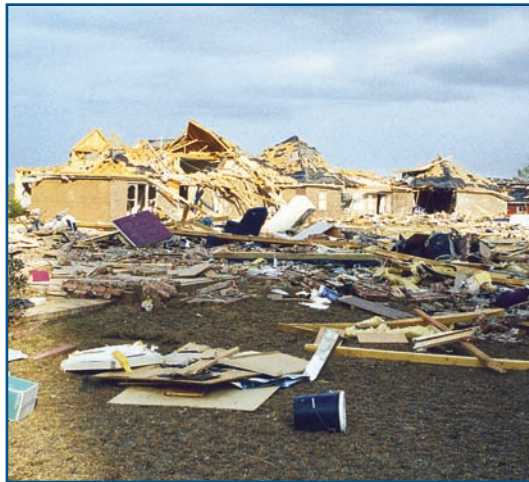
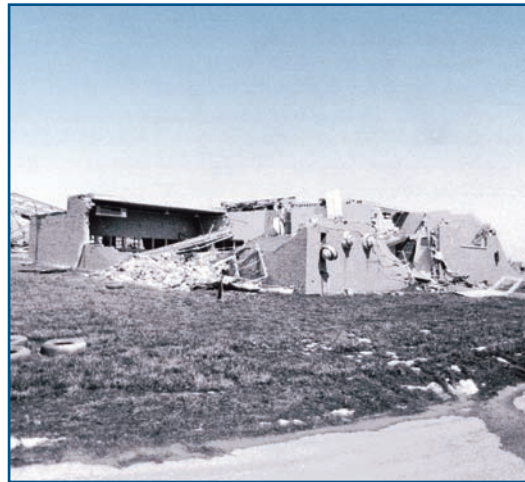
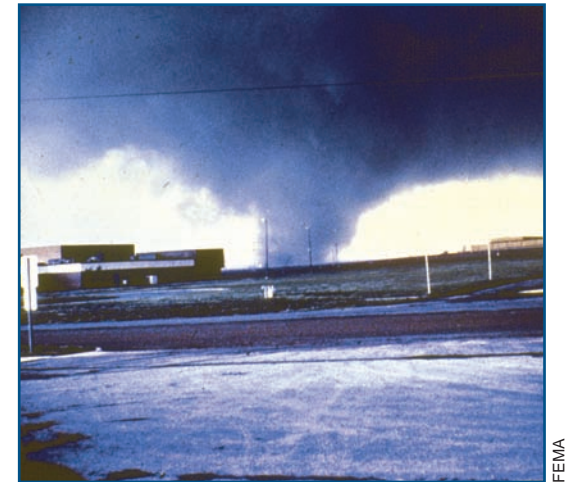
Figure 1-3 Tornado occurrence by time of day.

The **time of day** when tornadoes are most likely to occur is the mid-afternoon, between 3:00 p.m. and 6:00 p.m. (Figure 1-3). Occasionally, severe tornadoes have been recorded in the early morning or late evening.

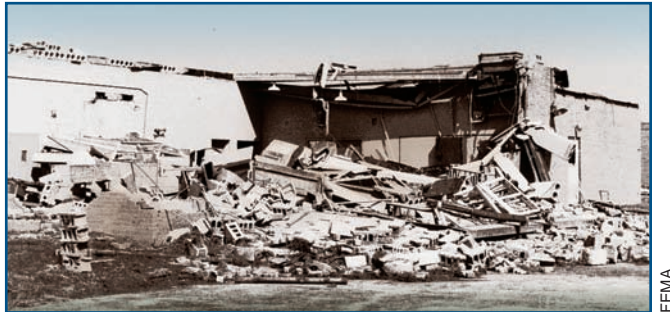
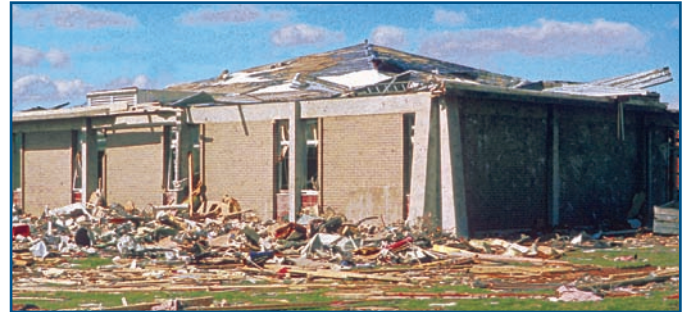
Figure 1-6
Typical tornado rotation.

Rotation is generally counterclockwise in the northern hemisphere (Figure 1-6). About 10 percent of tornadoes have been known to rotate clockwise.

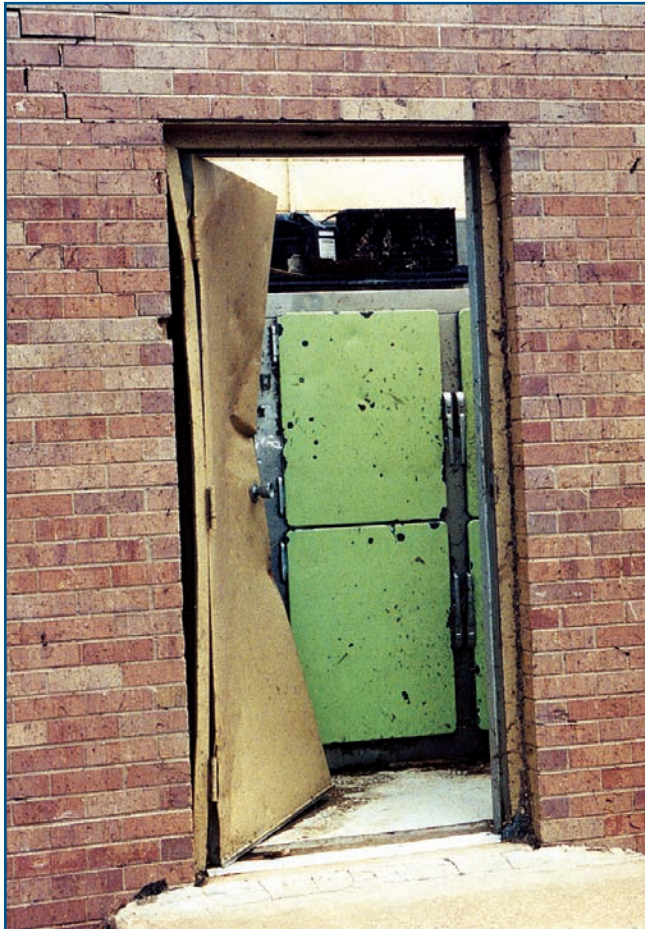
Figure 2-2

Example of damage from a windborne missile. A 2-inch by 6-inch board penetrated a refrigerator.

The extreme winds in tornadoes pick up and carry debris from damaged buildings and objects located in the path of the winds (see Figures 2-2 and 2-3). Even heavy, massive objects such as cars, tractor trailers, and buses can be moved by extreme winds and cause collateral damage to buildings. Light objects become flying debris, or missiles, that can penetrate doors, walls, and roofs; heavier objects can roll and cause crushing-type damage.

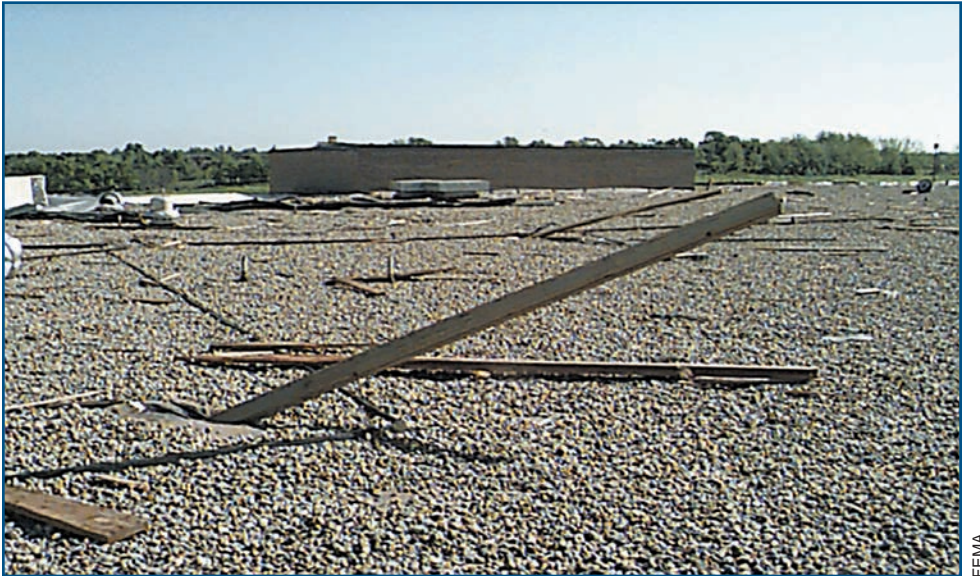
Figure 2-4

Example of damage from windborne missiles. Medium and small missiles penetrating through the roof of a high school. The missile protruding from the roof in the foreground is a double 2-inch by 6-inch wood board. The portion sticking out of the roof is 13 feet long. This missile penetrated a ballasted ethylene propylene diene monomer (EPDM) membrane, approximately 3 inches of polyisocyanurate roof insulation, and the steel roof deck. The missile lying on the roof just beyond it is a 2-inch by 10-inch, 16-foot-long wood board. The missile protruding from the roof in the background is a 2-inch by 6-inch, 16-foot-long wood board.

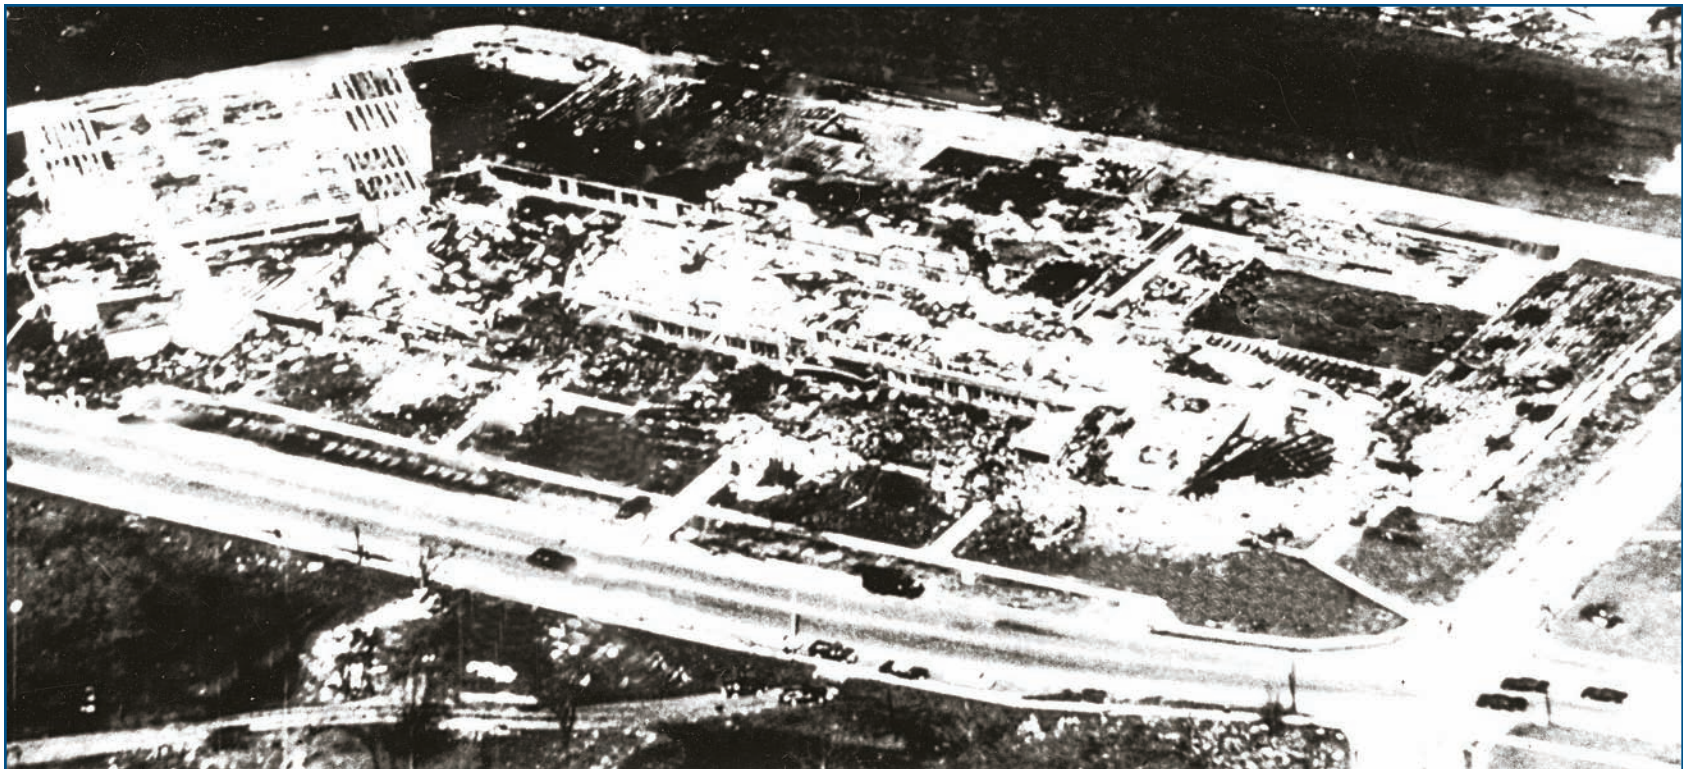
Figure 3-2 Xenia Senior High School, Xenia, Ohio.

The tornado passed directly over the school, engulfing the entire building and the adjacent fieldhouse to the south (Figure 3-2).

The enclosure walls failed on the west and south sides, allowing the winds to enter the building. The roofs collapsed over the three large spans—the auditorium, the boys' gym, and the girls' gym. The lightweight roof over the original two-story building was torn off by the extreme winds.

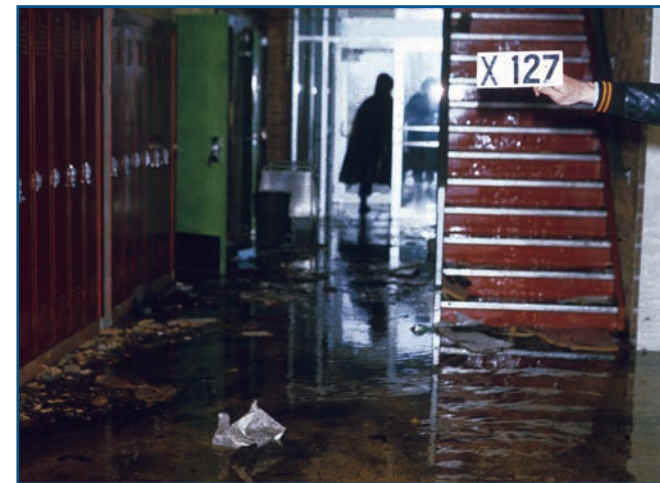
Figure 3-3
Surviving interior hallway. This is an example of the type of area that may provide refuge for building occupants during a tornado.

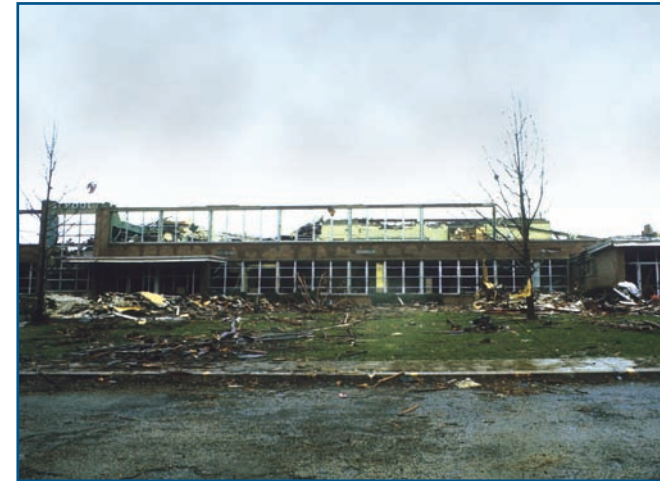
Figure 3-5
Loss of lightweight roof over the original two-story building.

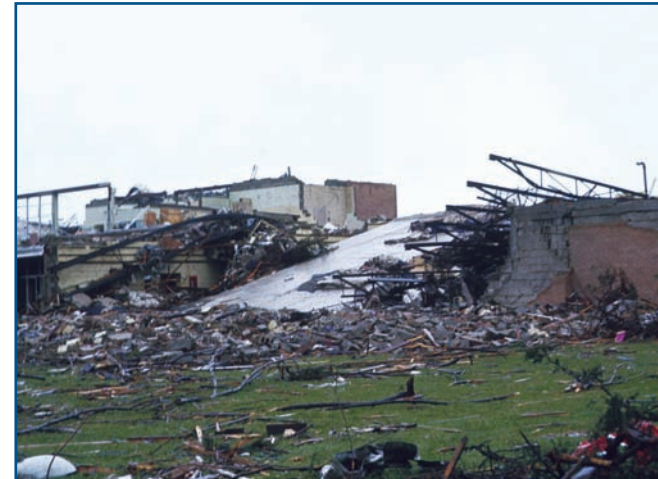
Figure 3-7
Collapsed gymnasium walls and roof, where open-web roof joists were supported on unreinforced masonry walls.

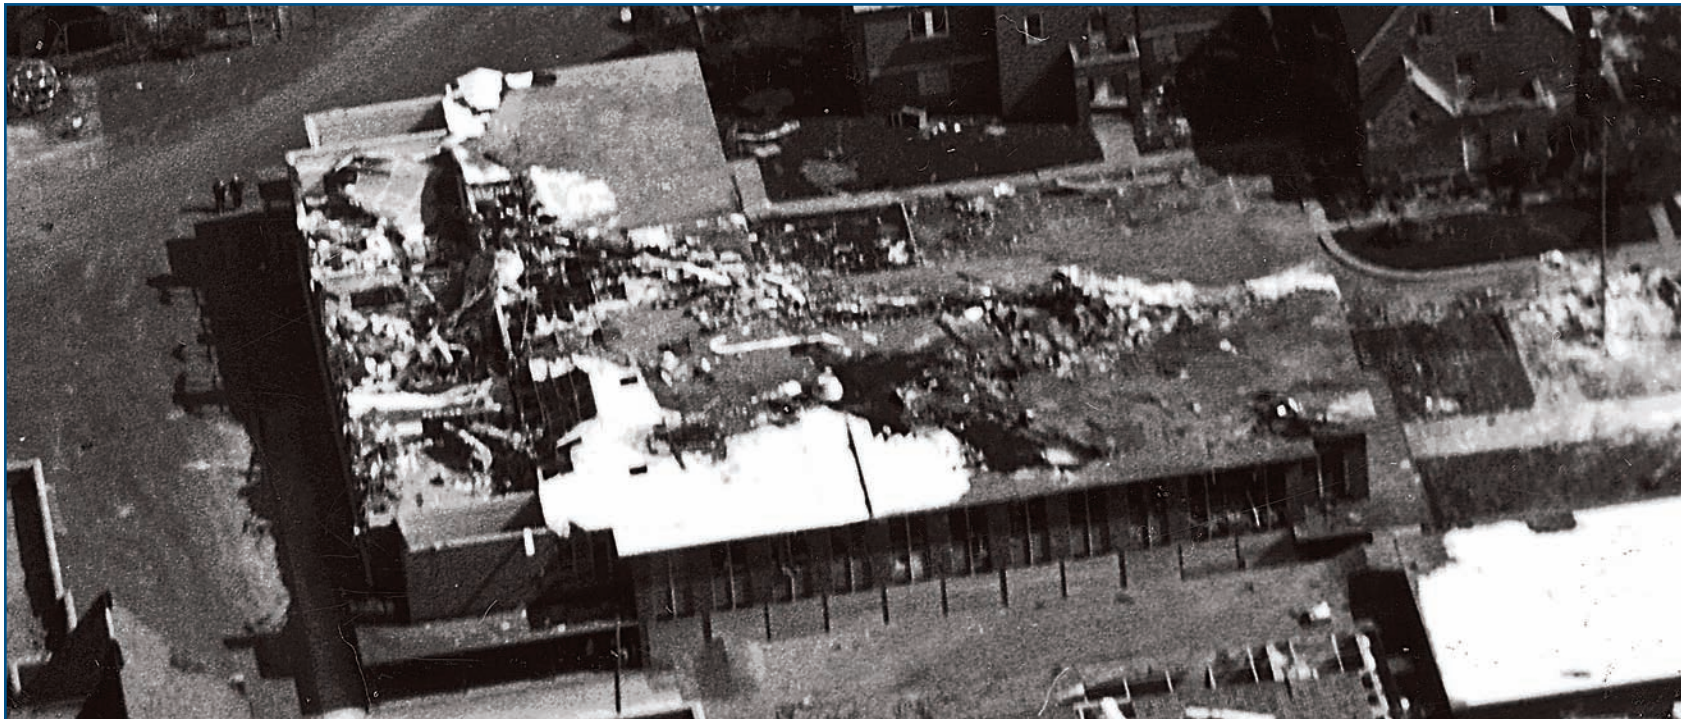
Figure 3-8 St. Augustine Elementary School, Kalamazoo, Michigan.

The tornado winds lifted part of the roof and collapsed the second-floor piers in one wing of the school building (Figures 3-8, 3-9, and 3-10). The wind and windborne debris blew in most of the windows, and windborne debris was found in the classrooms (Figure 3-11). The exterior solid-core wood doors stayed in place and kept the debris out. Wired glass windows near the exterior doors remained intact. The interior doors to the classrooms remained in place although the hinges were damaged. The school was damaged to an extent where demolition was required.

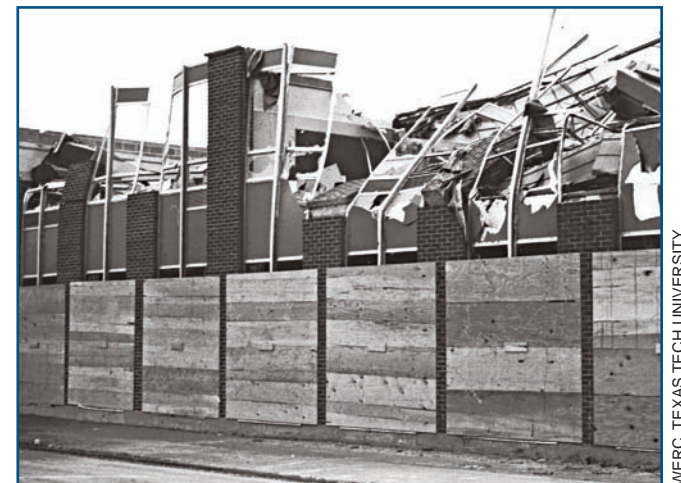
Figure 3-9
Collapsed second floor of St. Augustine Elementary School building.

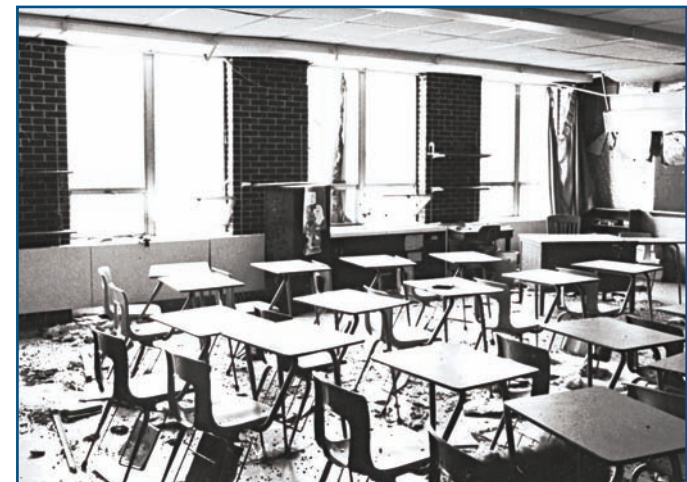
Figure 3-11
Broken windows and debris in classroom of St. Augustine Elementary School building.

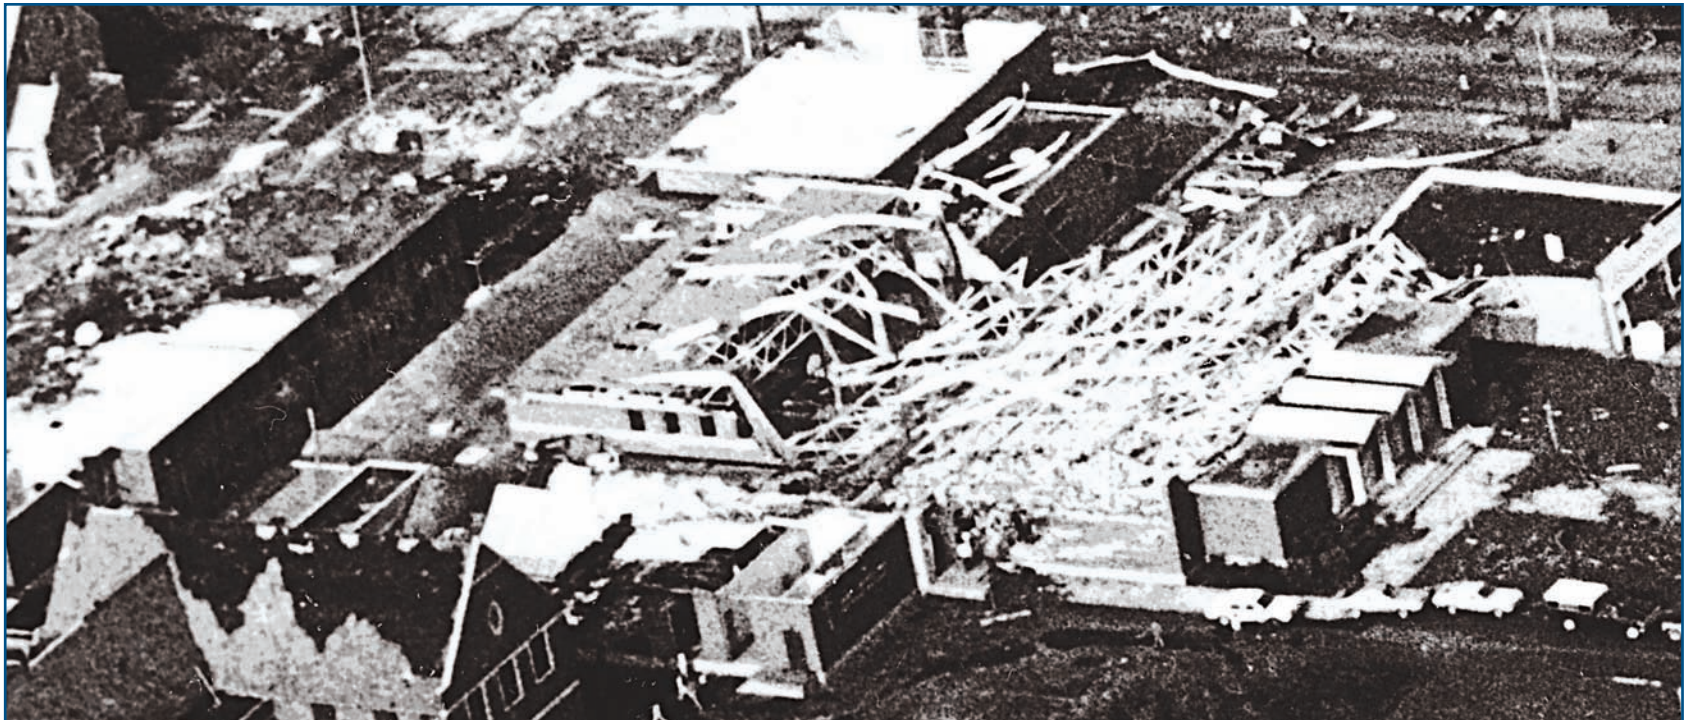
Figure 3-13 St. Augustine Elementary School Gymnasium, Kalamazoo, Michigan.

The structural system consisted of loadbearing masonry walls constructed of 12-inch concrete masonry units and 4-inch face brick. The walls were not reinforced in the vertical direction. The roof structure consisted of long-span steel joists spanning 80 feet between the walls and spaced 6 feet apart. The steel roof deck was connected to the joists with puddle welds.

The building was destroyed (Figures 3-13 and 3-14). The loadbearing west wall collapsed inward, and the east wall fell outward. The roof fell in the building when the walls collapsed.

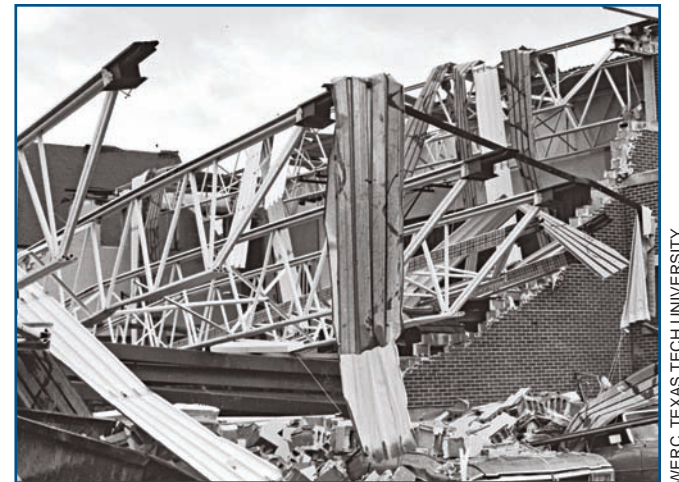
Figure 3-14
***Collapsed St. Augustine Elementary School
Gymnasium building.***

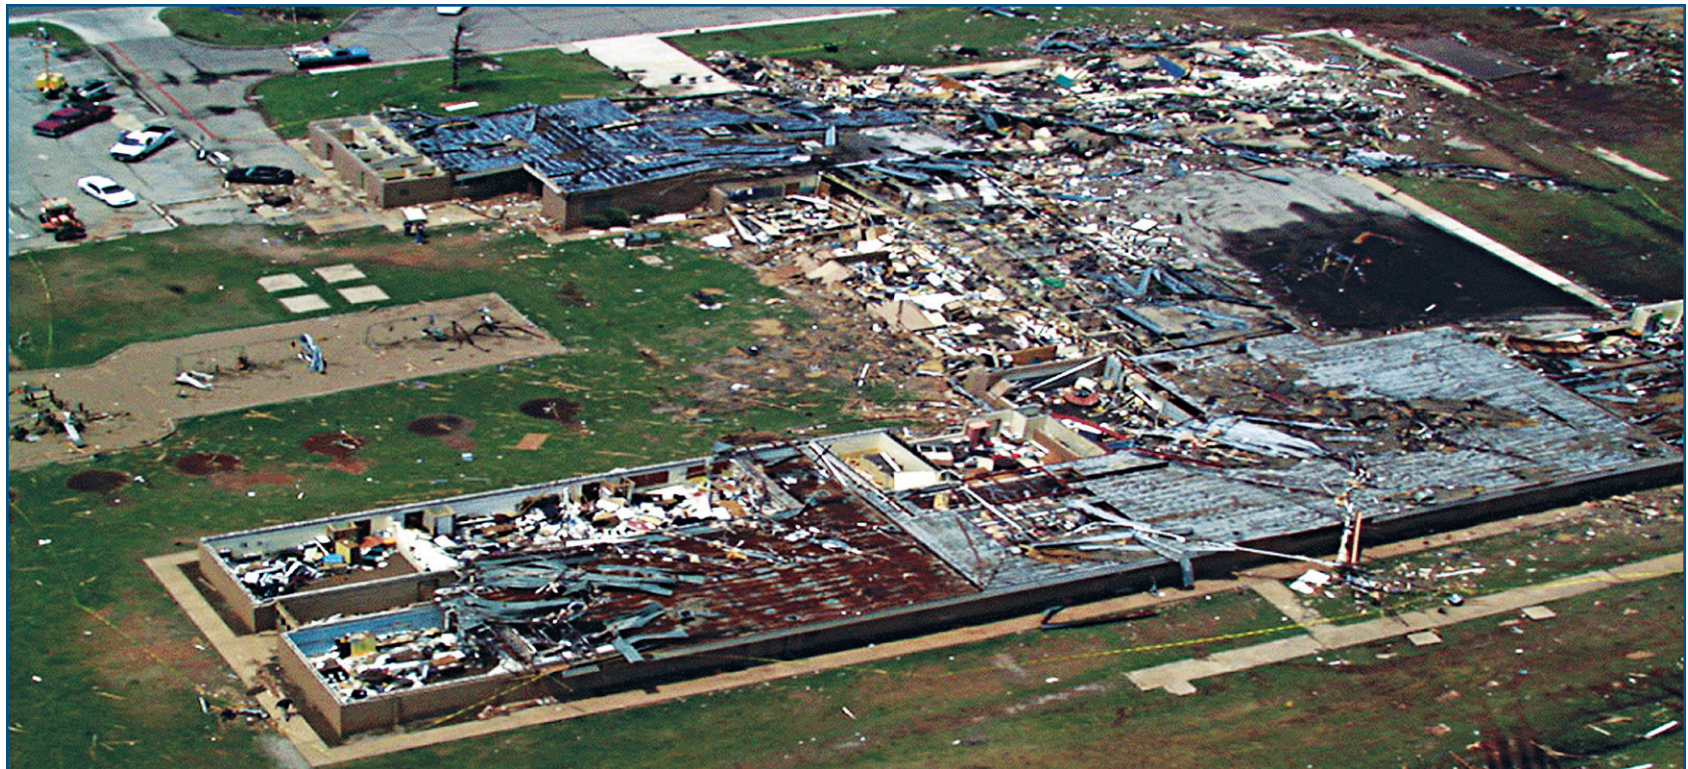
Figure 3-15 Kelly Elementary School, Moore, Oklahoma.

The tornado hit after school hours and passed just to the north of the site. Damage to the school building was both severe and extensive (Figure 3-15). As discussed in the Lessons Learned section in this case study, the remaining structure was demolished and the school was rebuilt. The new school includes structural elements designed to provide increased wind resistance.

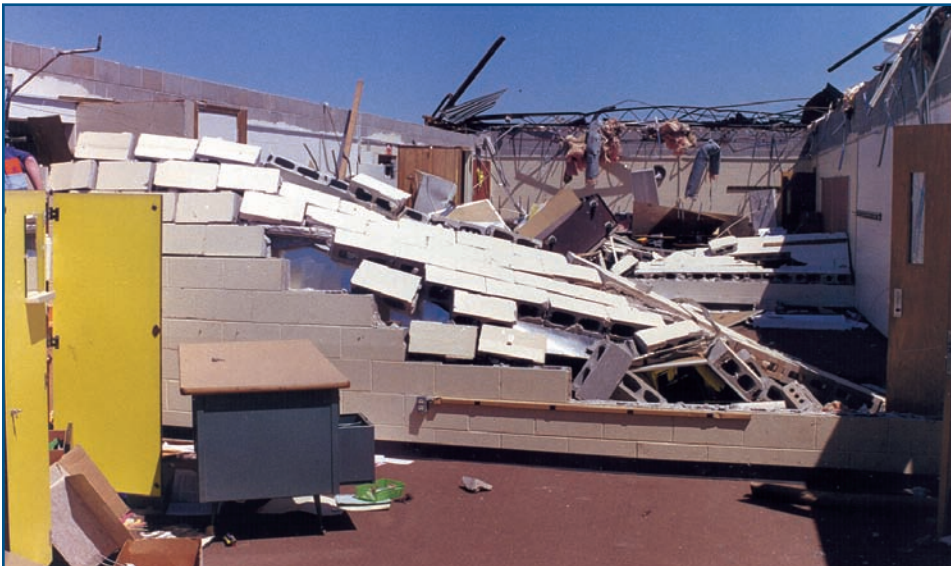
Figure 3-17
Interior and exterior unreinforced masonry walls were damaged when reinforced bond beams failed.

Unreinforced masonry walls failed when the roof system was lifted or removed by tornado winds (Figures 3-17, 3-18, and 3-19). Figures 3-17 and 3-19 show failed interior and exterior walls, respectively. Figure 3-18 shows the separation of the reinforced bond beam (indicated by circles) from the upper part of a corridor wall. The inclusion of clerestory windows in some corridor walls contributed to their failure under loads imposed by tornado winds (Figure 3-20).

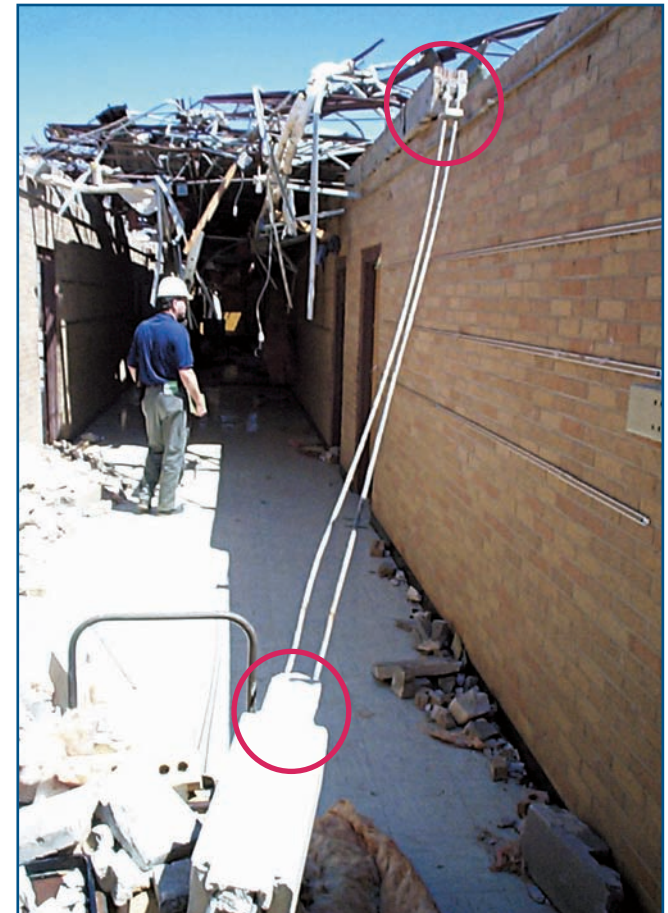
Figure 3-18
Corridor area. Separation of reinforced bond beam (indicated by circles) from supporting wall.

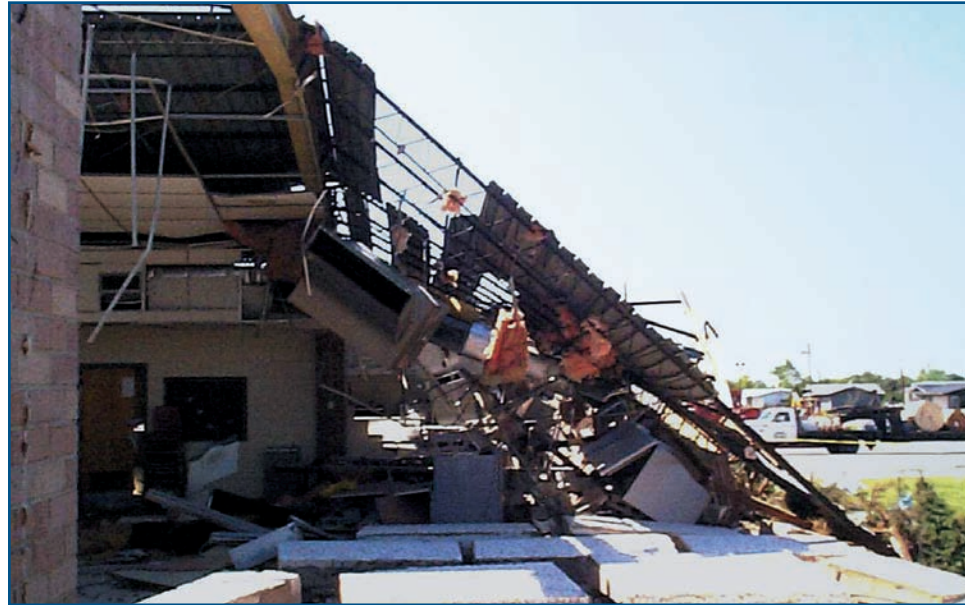
Figure 3-19
Collapsed roof structure and exterior wall.

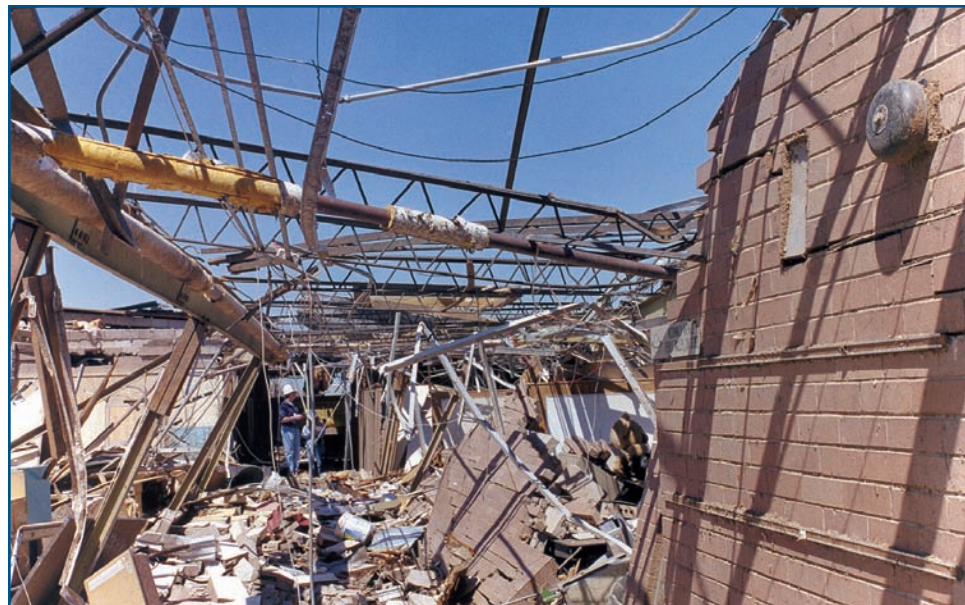
Figure 3-20
Failed interior corridor walls. These walls consisted of unreinforced brick masonry infill between steel-frame members. The brick masonry extended to a height of approximately 7 feet. Clerestory windows extended from the top of the masonry to the tops of the walls.

Hall corridors were the designated areas of refuge (see Figure 3-16). The corridor walls were of lightweight steel frame with masonry infill. The infill extended to a height of approximately 7 feet. Above this height were clerestory windows that extended to the tops of the walls. Had the halls been occupied during the tornado, many injuries and deaths would have occurred (see Figure 3-20, later in this chapter).

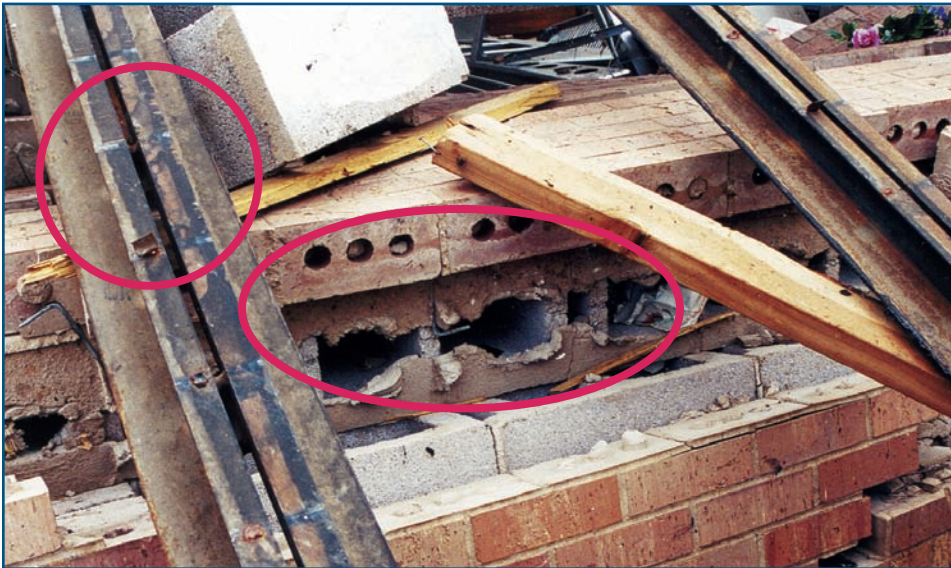
Figure 3-21
Failed roof structure showing broken welds between metal roof deck and tops of joists (upper circle) and lack of vertical reinforcement (bottom circle).

Inspection of the roof damage revealed that the roof decking failed at the points where it was welded to the tops of the steel trusses. Although the spacing of the welds appeared to be consistent with standard practice, the welds were not strong enough to resist the wind uplift forces (Figure 3-21).

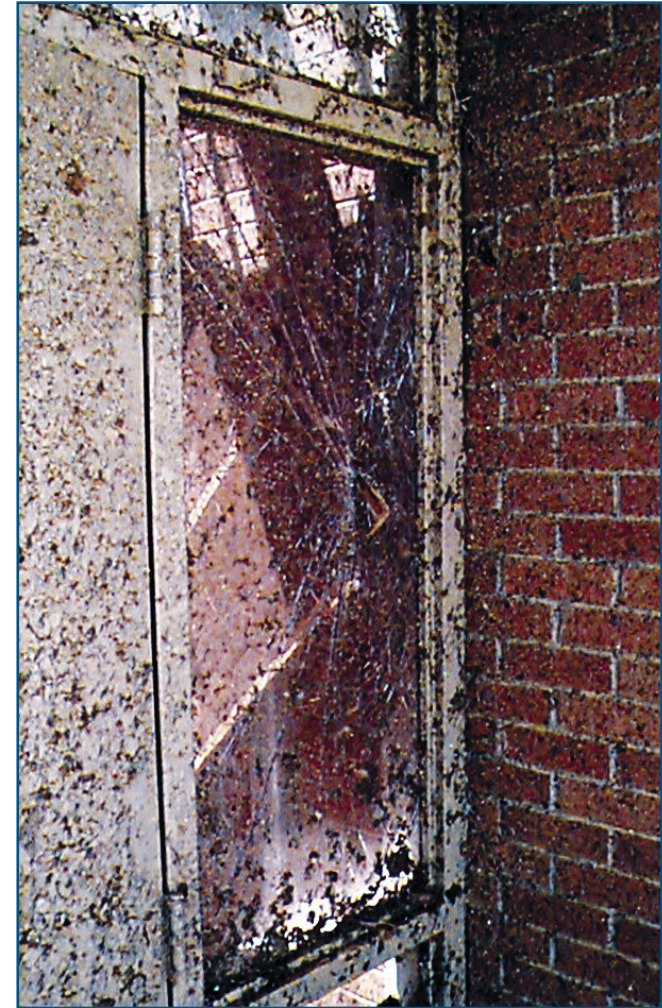
Figure 3-22
Impact performance of laminated glass. The corner of a table penetrated this laminated glass window, but the glass remained in its frame.

Damage was also caused by the impact of windborne missiles. Figure 2-3, in Chapter 2, shows a steel door that appeared to have been opened by the impact of a heavy object. This door led into an area where the roof was missing. The opening created by this breached door may have allowed wind to enter the building and create internal pressure that increased the load on the building envelope. Figure 3-22 shows damage to a laminated glass window hit by a table.

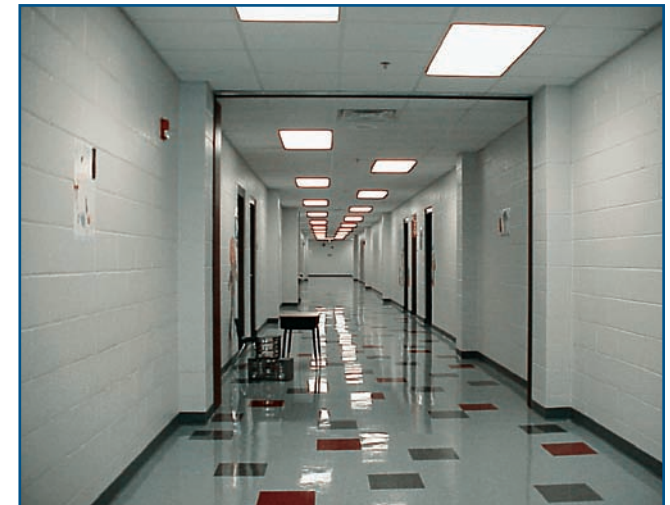
Figure 3-24
Corridor (designated safe area) in reconstructed Kelly Elementary School.

Because the damage to Kelly Elementary School was so great, the school was demolished and completely rebuilt. The new building, although constructed on the same footprint, incorporated several structural improvements specifically designed to provide improved resistance to extreme winds and create refuge areas for the school's occupants. As in the original building, the central corridors of the three wings are the designated refuge areas (Figures 3-23 and 3-24).

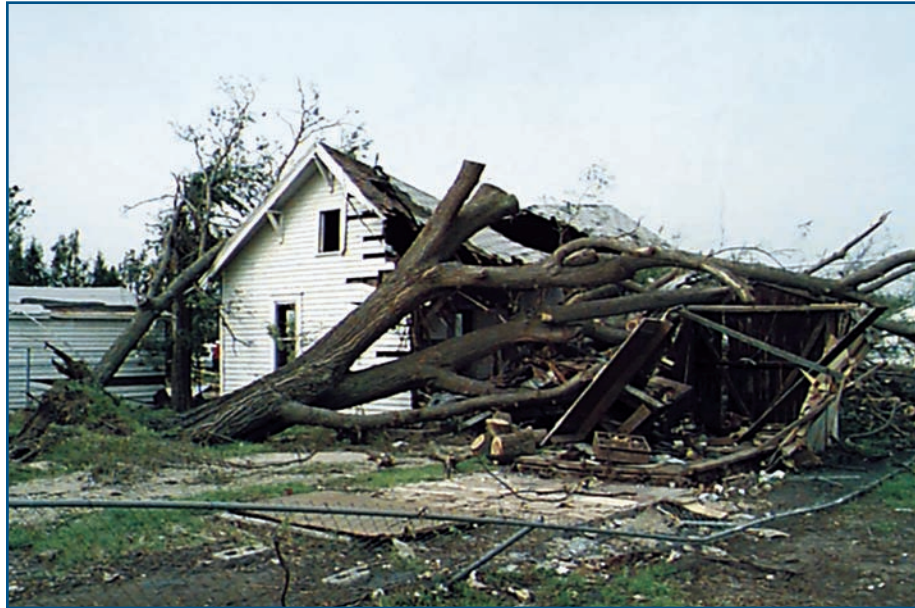
Figure 4-2

Two trees toppled by tornado winds damaged this house in Haysville, Kansas.

building collapse (see Figures 4-2 and 4-3). In addition to falling, these elements can also be blown a considerable distance (see Figure 4-4).

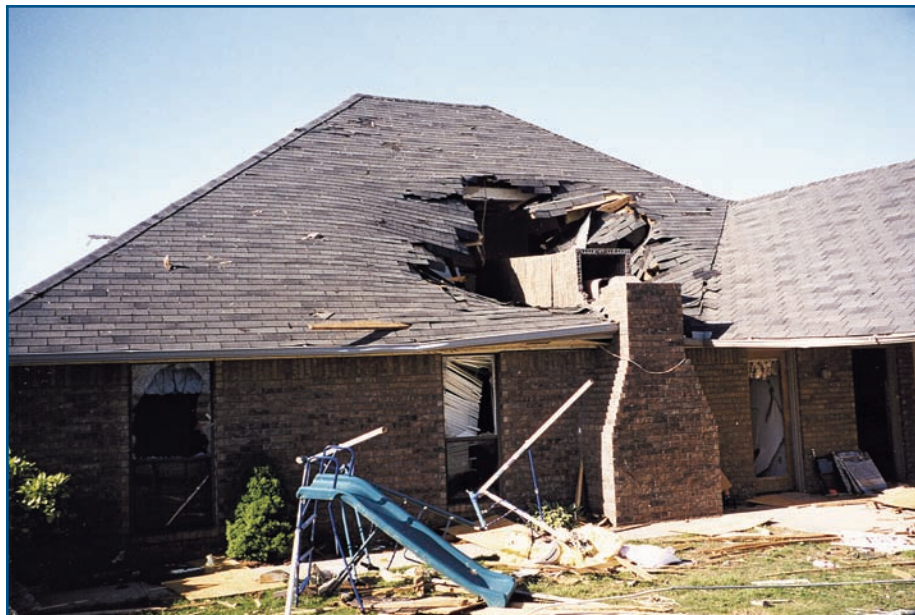
Figure 4-3

Failure of brick chimney under tornado winds damaged the room of this house in Moore, Oklahoma.

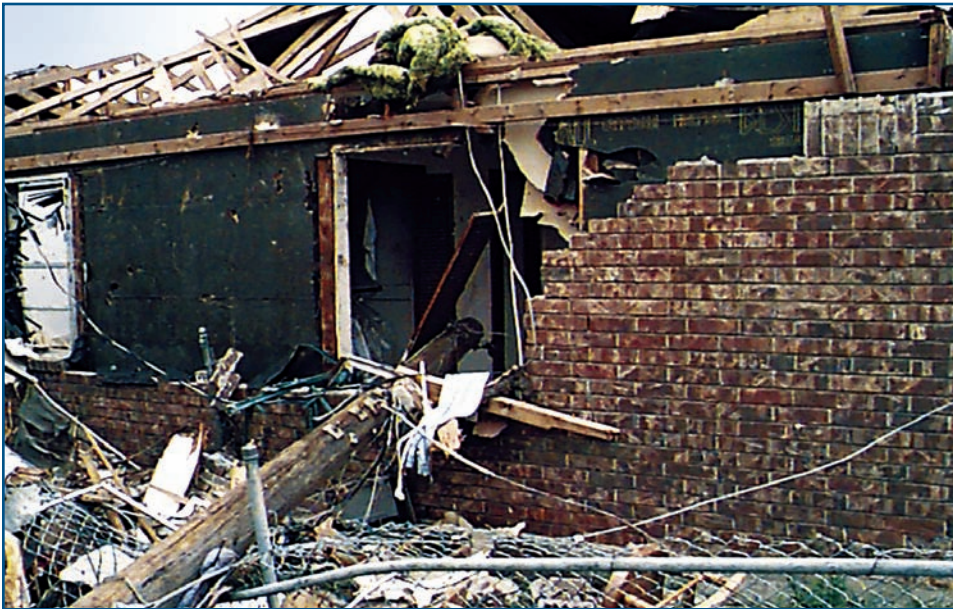
Figure 4-4

This power pole penetrated a window and extended several feet into the house after being blown 40 feet from its original location.

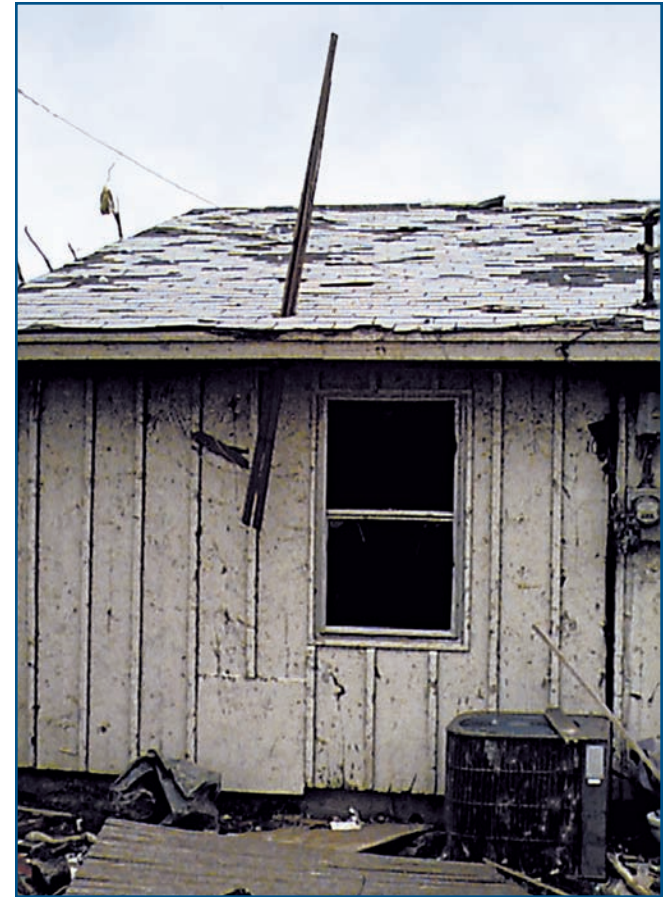
Figure 4-5

This photograph illustrates the importance of overhead protection in refuge areas. The missile shown here fell nearly straight down.

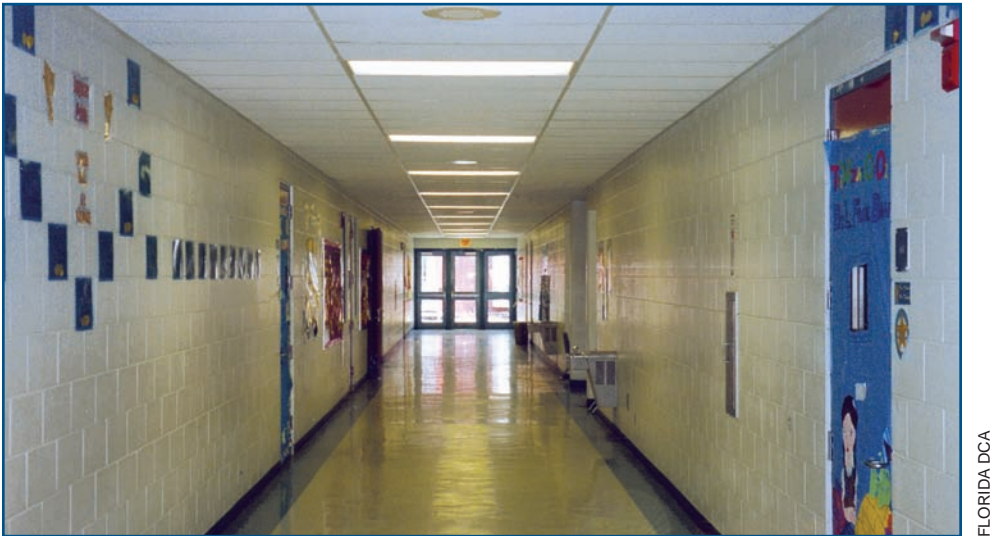
Figure 4-9
Interior central corridor – typical of the corridors in Buildings 200, 400, 600, and 800.

In each of the eight buildings, exterior and interior loadbearing concrete block masonry walls support the roof above. These walls are reinforced with vertical steel spaced at 2 feet 8 inches on center. Figure 4-10 shows a cross-section of one of the loadbearing corridor walls in Buildings 200,

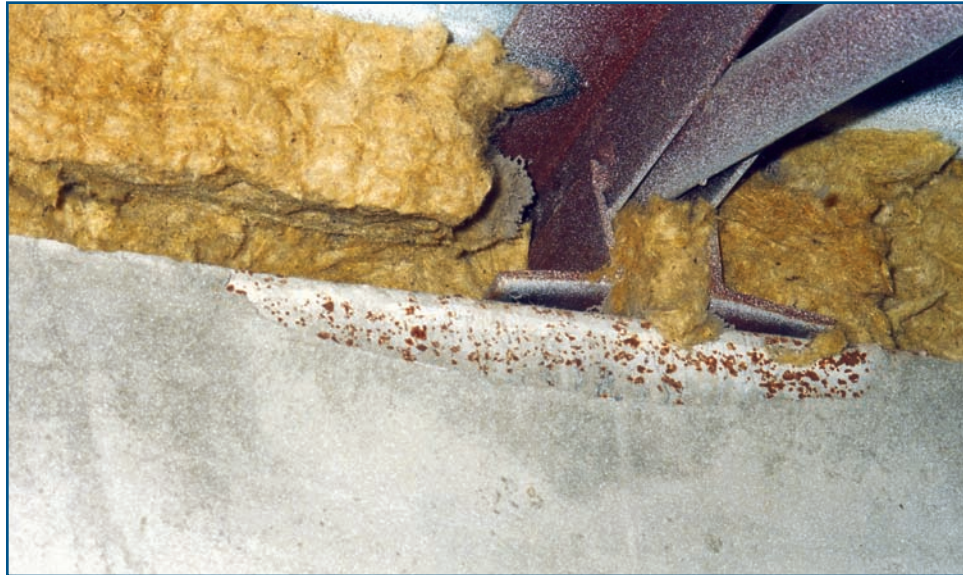
Figure 4-13 Typical roof truss connection to exterior wall in the example school.

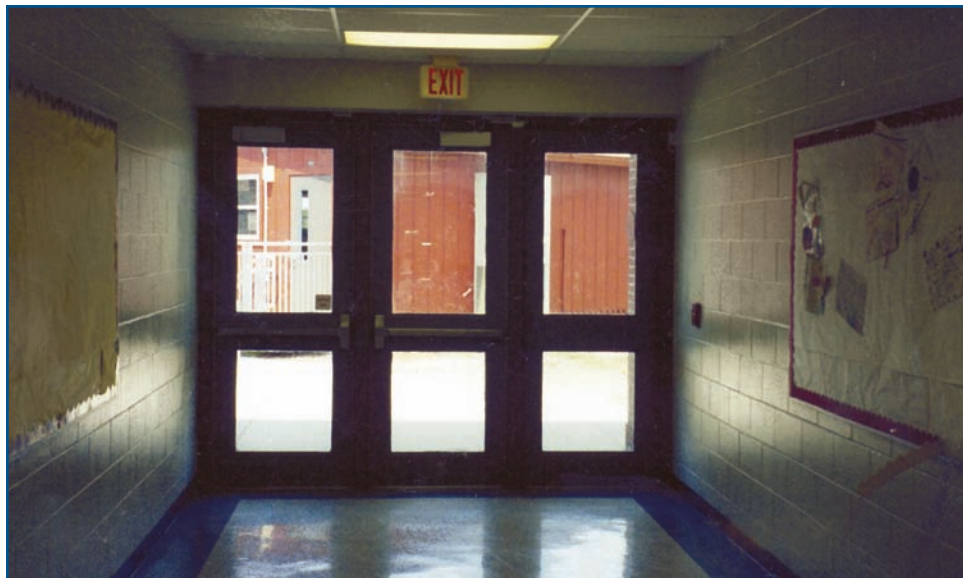
*Figure 4-14
Exterior corridor doors in the example school.*

The exterior windows in all eight buildings have aluminum frames and tempered glass. The exterior doors—including the exterior corridor doors in Buildings 200, 400, 600, and 800 (Figure 4-14)—are insulated metal-framed units with large windows. The doors from the corridors to the classrooms in these four buildings are wood with small windows (Figure 4-15).
