Ethical Issues from the Kansas City  
Hyatt Hotel Collapse

J. Paul Guyer, P.E., R.A.

Figure 2  
The Hyatt Regency Hotel in Kansas City

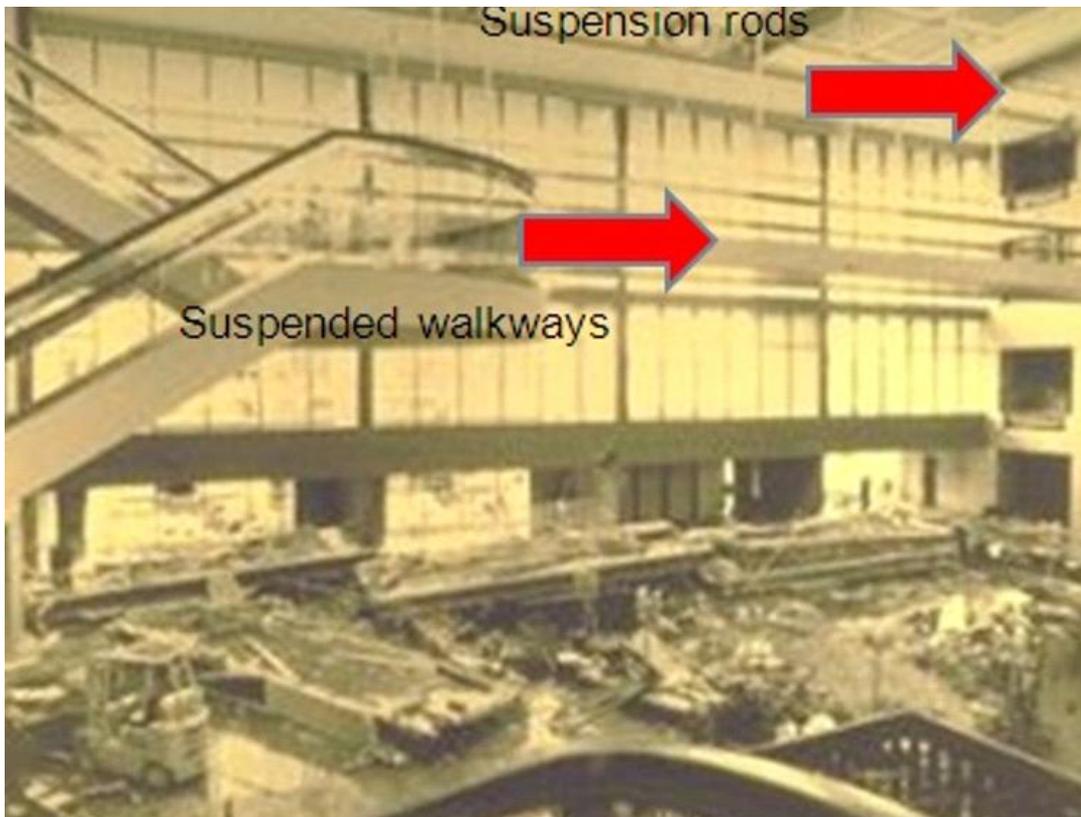
Figure 5  
Suspended Walkways at the Atrium Lobby

The structural failure occurred at two of the three suspended walkways that traversed from one side to the other of the atrium lobby. Walkways that failed were directly in line with each other and crossed from one side to the other at the second and fourth floors.

The third walkway, at the third floor, was offset from the other two and was not involved in the failure.

The fourth floor walkway failed, collapsed onto the second floor walkway, both crashed to the lobby floor, and 114 people were killed and 200 injured.
