NORTH AMERICAN ELECTRIC RELIABILITY COUNCIL

Technical Analysis of the August 14, 2003, Blackout: *What Happened, Why, and What Did We Learn?*

**Report to the NERC Board of Trustees
by the NERC Steering Group**

July 13, 2004

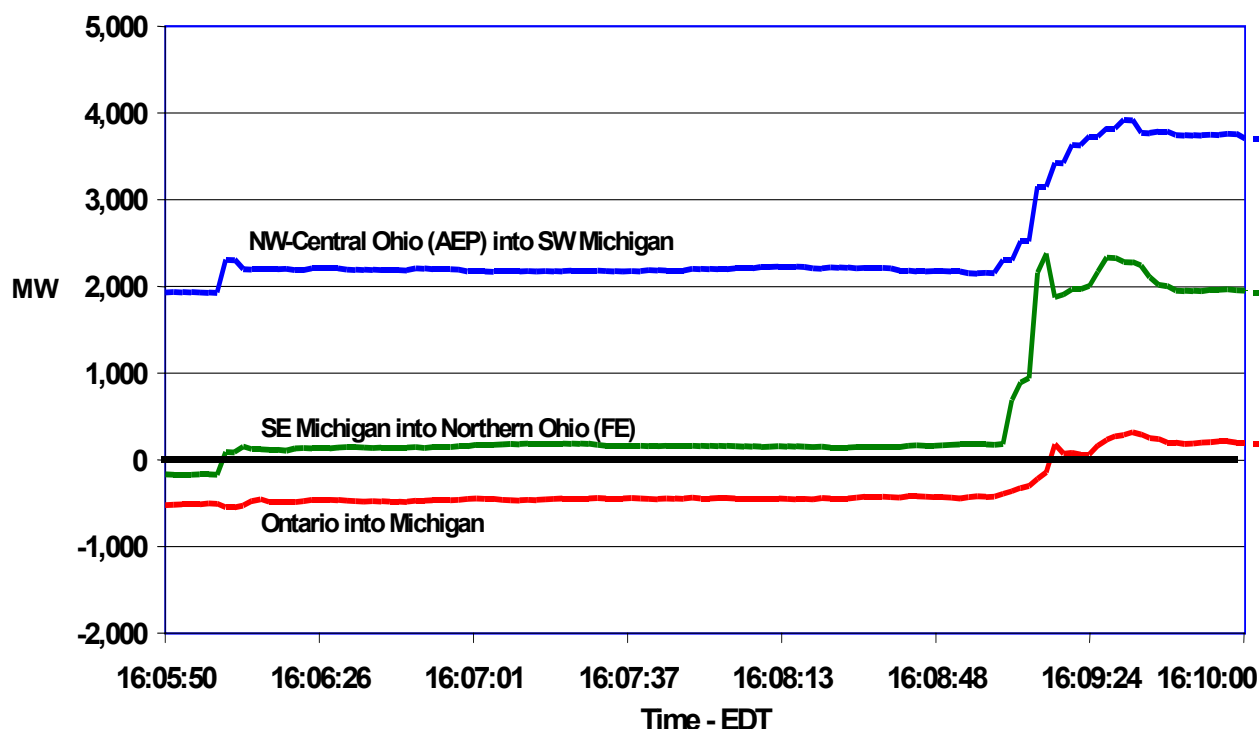
Figure IV.6 — Line Flows Into Michigan

During the period between the Sammis-Star trip and the trip of East Lima-Fostoria 345-kV line at 16:09:06.3, the system was still in a steady-state condition. Although one line after another was overloading and tripping within Ohio, this was happening slowly enough under relatively stable conditions that the system could readjust; after each line loss, power flows would redistribute across the remaining lines. This is illustrated in Figure IV.6, which shows the megawatt flows on the MECS interfaces with AEP (Ohio), FE (Ohio), and Ontario. The graph shows a shift from 150 MW of imports to 200 MW of exports from the MECS system into FE at 16:05:57 after the loss of Sammis-Star, after which this held steady until 16:08:59, when the loss of East Lima-Fostoria Central cut the main energy path from the south and west into Cleveland and Toledo. Loss of this path was significant, causing flow from MECS into FE to jump from 200 MW up to 2,300 MW, where it swung dynamically before stabilizing.

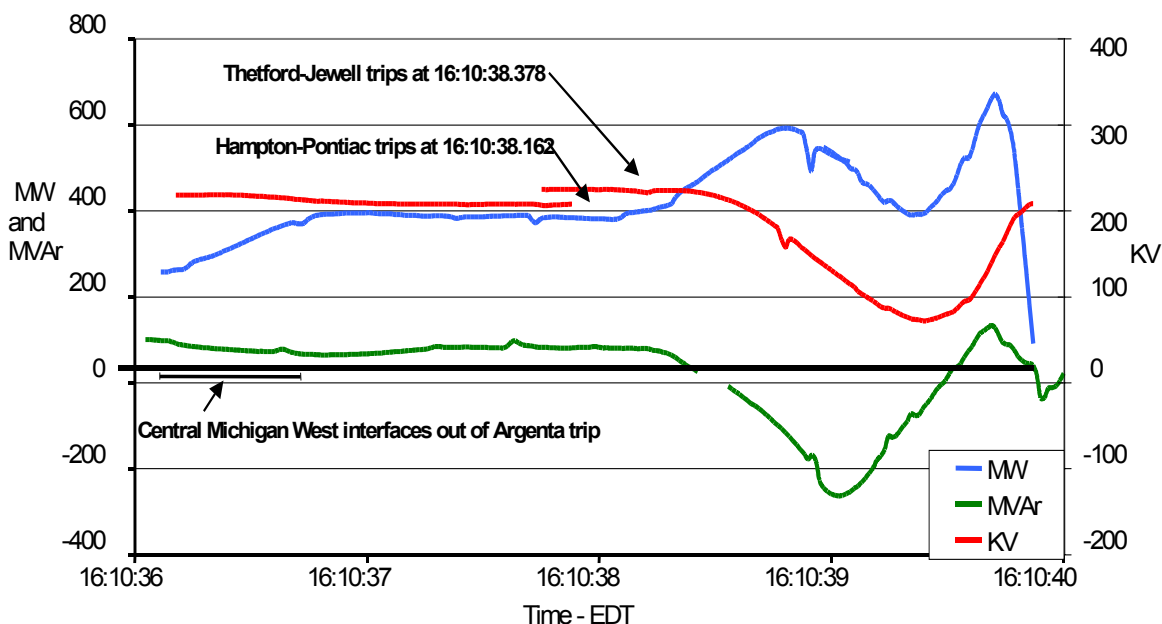
Figure IV.14 — Flows on Keith-Waterman 230-kV Ontario-Michigan Tie Line

trigger for a sudden 3,700 MW power surge from Ontario into Michigan. When Thetford-Jewell tripped, power that had been flowing into Michigan and Ohio from western Michigan, western Ohio, and Indiana was cut off. The nearby Ontario recorders saw a pronounced impact as flows into Detroit readjusted to flow in from Ontario instead.

On the boundary of northeastern Ohio and northwestern Pennsylvania, the Erie West-Ashtabula-Perry line was the last 345-kV link to the east for northern Ohio loads. When that line severed, all the power that moments before had flowed across Michigan and Ohio paths was now diverted in a counter-clockwise loop around Lake Erie through the single path left in eastern Michigan, pulling power out of Ontario, New York, and PJM.

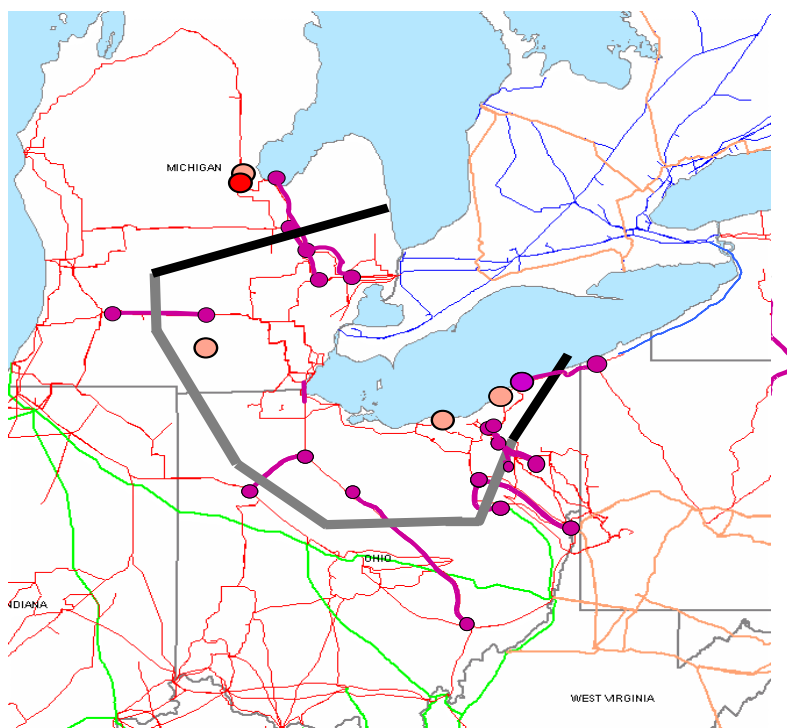
Figure IV.16 — Michigan Lines Trip and Ohio Separates From Pennsylvania, 16:10:36 to 16:10:38.6

- 16:10:38.2: Hampton-Pontiac 345-kV line tripped
- 16:10:38.4: Thetford-Jewell 345-kV line tripped
- 16:10:38.6: Erie West-Ashtabula-Perry 345-kV line tripped at Perry
- 16:10:38.6: Large power surge to serve loads in eastern Michigan and northern Ohio swept across Pennsylvania, New Jersey, and New York through Ontario into Michigan

Perry-Ashtabula was the last 345-kV line connecting northern Ohio to the east along the southern shore of Lake Erie. This line tripped at the Perry substation on a zone 3 relay operation and separated the northern Ohio 345-kV transmission system from Pennsylvania and all 345-kV connections. After this trip, the load centers in eastern Michigan and northern Ohio (Detroit, Cleveland, and Akron) remained connected to the rest of the Eastern Interconnection only to the north of Lake Erie at the interface between the Michigan and Ontario systems (Figure IV.16). Eastern Michigan and northern Ohio now had little internal generation left and voltage was declining. The frequency in the Cleveland area dropped rapidly, and between 16:10:39 and 16:10:50, underfrequency load shedding in the Cleveland area interrupted about 1,750 MW of load. However, the load shedding was not enough to reach a balance with local generation and arrest the frequency decline. The still-heavy loads in Detroit and Cleveland drew power over the only major transmission path remaining: the lines from eastern Michigan east into Ontario.

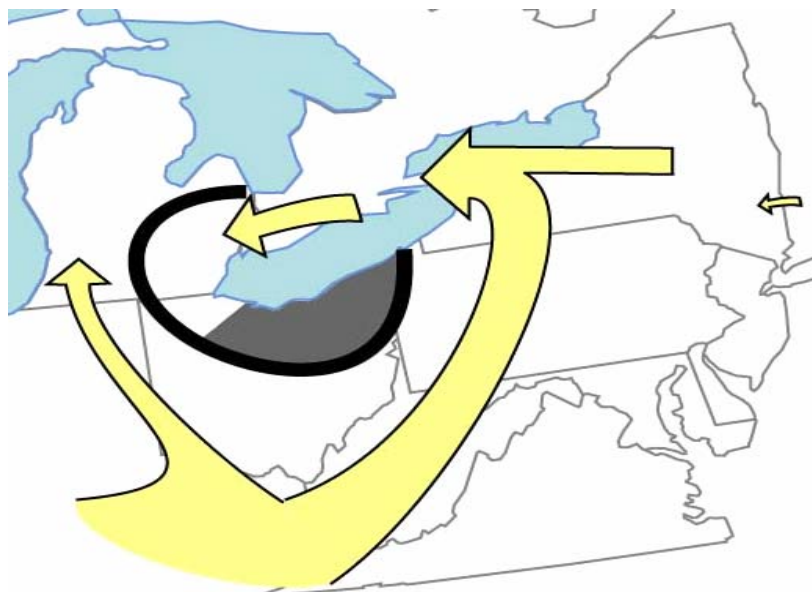
Figure IV.18 — Power Flows at 16:10:39

This power surge was of such a large magnitude that frequency was not the same across the Eastern Interconnection. The power swing resulted in a rapid rate of voltage decay. Flows into Detroit exceeded 3,700 MW and 1,500 Mvar; the power surge was draining real power out of the northeast, causing voltages in Ontario and New York to drop. At the same time, local voltages in the Detroit area were plummeting because Detroit had already lost 500 MW of local generation. The electric system in the Detroit area would soon lose synchronism and black out (as evidenced by the rapid power oscillations decaying after 16:10:43).

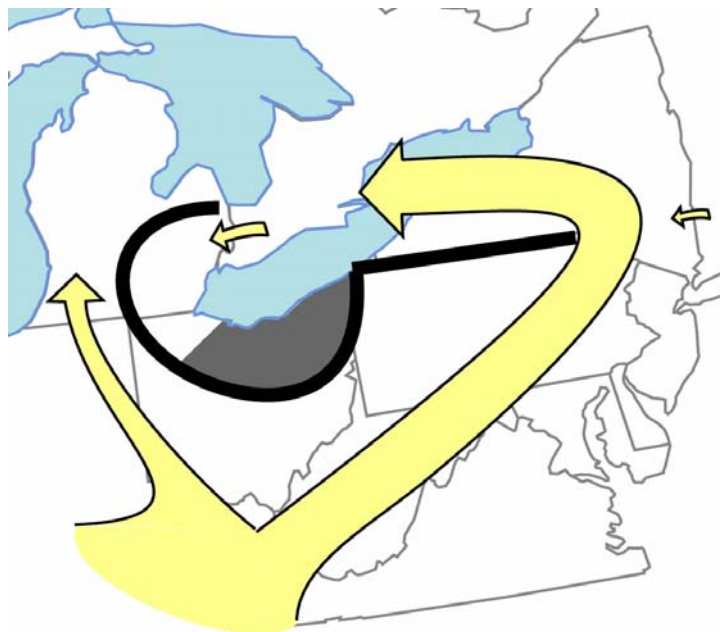
Figure IV.20 — Power Flows at 16:10:40

Two 345-kV lines tripped because of zone 1 relay action along the border between PJM and the NYISO due to the transient overloads and depressed voltage. After the separation from PJM, the dynamic surges also drew power from New England and the Maritimes. The combination of the power surge and frequency rise caused 380 MW of pre-selected Maritimes generation to trip off-line due to the operation of the New Brunswick Power “Loss of Line 3001” Special Protection System. Although this system was designed to respond to failures of the 345-kV link between the Maritimes and New England, it operated in response to the effects of the power surge. The link remained intact during the event.

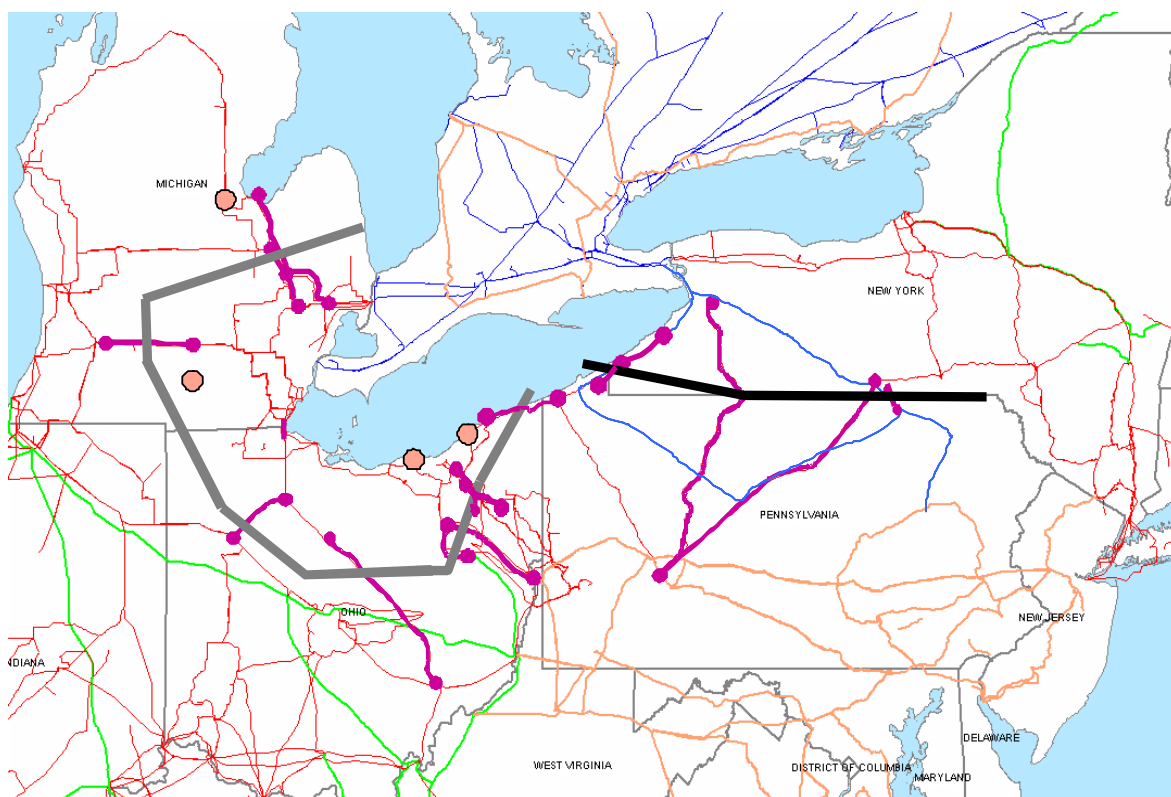
**Figure IV.24 — Western Pennsylvania Separates From New York,
16:10:39 to 16:10:44**

Watercure (177 miles) and Homer City-Stolle Road (207 miles) are relatively long lines with high impedances. Zone 1 relays do not have timers, and therefore operate nearly instantly when a power swing enters the relay target circle. For normal length lines, zone 1 relays have smaller target circles because the relay is measuring less than the full length of the line, but for a long line the greater impedance enlarges the relay target circle and makes it more likely to be hit by the power swing. The Homer City-Watercure and Homer City-Stolle Road lines do not have zone 3 relays.

Given the length and impedance of these lines, it was highly likely that they would trip and separate in the face of such large power swings. Most of the other interfaces between regions have shorter ties. For instance, the ties between New York and Ontario and Ontario to Michigan are only about two miles long, so they are electrically very short and thus have much lower impedance and trip less easily than these long lines. A zone 1 relay target on a short line covers a small distance so a power swing is less likely to enter the relay target circle at all, averting a zone 1 trip.

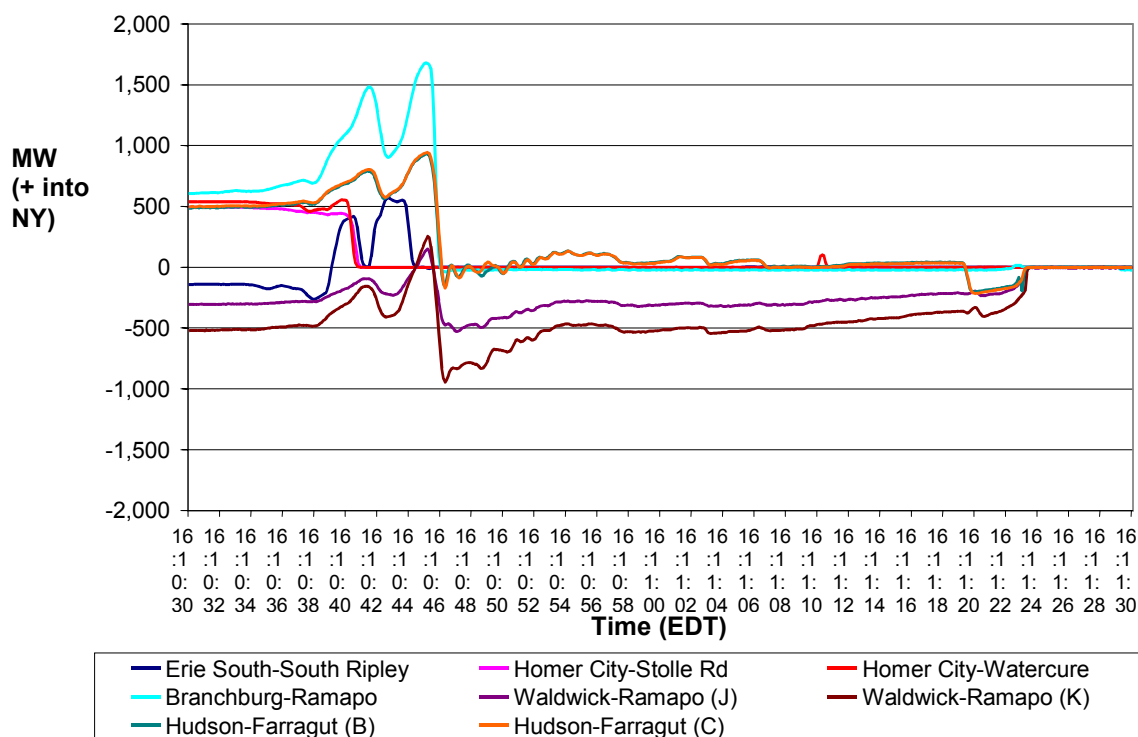
Figure IV.28 — PJM to New York Ties Disconnect

As shown in Figure IV.27, the 69-mile long Branchburg-Ramapo line and Ramapo transformer between New Jersey and New York was the last major transmission path remaining between the Eastern Interconnection and the area ultimately affected by the blackout. Figure IV.28 shows how that line disconnected at 16:10:45, along with other underlying 230 and 138-kV lines in northeastern New Jersey. Branchburg-Ramapo was carrying over 3,000 MVA and 4,500 amps with voltage at 79 percent before it tripped, either on a high-speed swing into zone 1 or on a direct transfer trip. The investigation team is still examining why the higher impedance 230-kV overhead lines tripped while the underground Hudson-Farragut 230-kV cables did not; the available data suggest that the lower impedance of underground cables made these less vulnerable to the electrical strain placed on the system.

This left the northeast portion of New Jersey connected to New York, while Pennsylvania and the rest of New Jersey remained connected to the rest of the Eastern Interconnection. Within northeastern New Jersey, the separation occurred along the 230-kV corridors, which are the main supply feeds into the northern New Jersey area (the two Roseland-Athenia circuits and the Linden-Bayway circuit). These circuits supply the large customer load in northern New Jersey and are a primary route for power transfers into New York City, so they are usually more highly loaded than other interfaces. These lines tripped west and south of the large customer loads in northeast New Jersey.

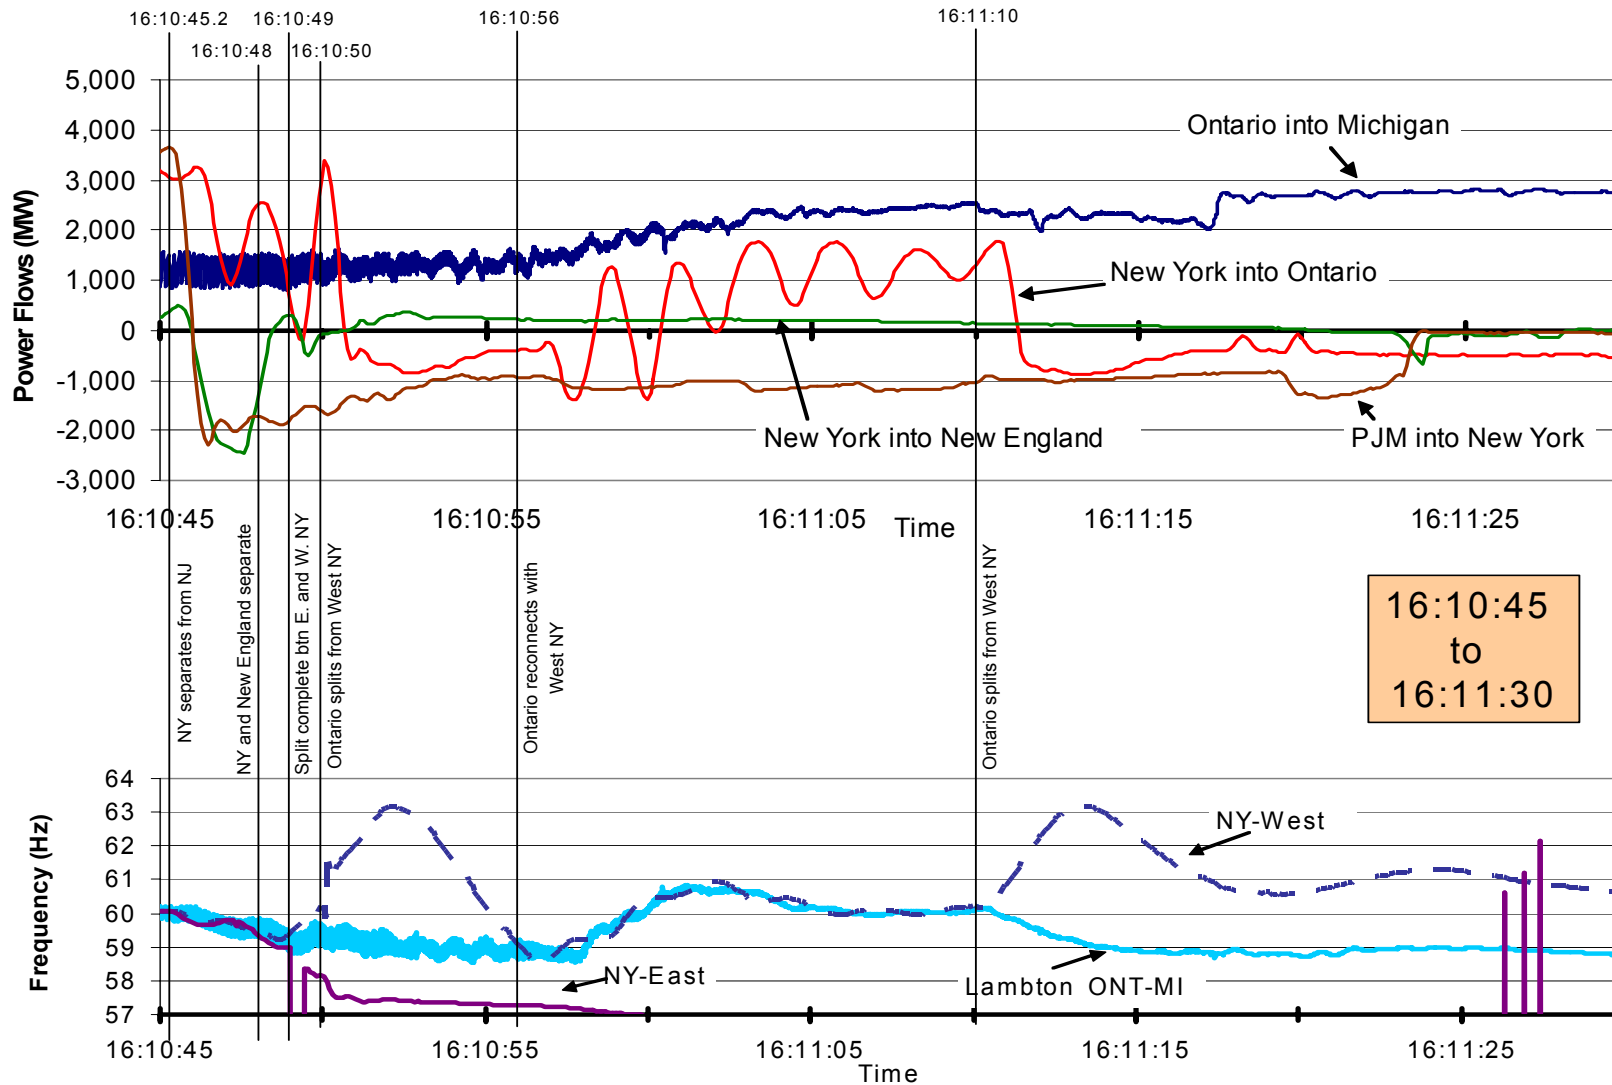
Figure IV.30 — Measured Power Flows and Frequency Across Regional Interfaces, 16:10:45 to 16:11:30, With Key Events in the Cascade

The entire northeastern system was experiencing large scale, dynamic oscillations during this period. Even if the UFLS and generation had been perfectly balanced at any moment in time, these oscillations would have made stabilization difficult and unlikely. Figure IV.30 gives an overview of the power flows and frequencies during the period 16:10:45 through 16:11:00, capturing most of the key events in the final phase of the cascade.
