Evaluation and Repair of Concrete Structures Part III

Chapters 7 through 9

CECW-EG Engineer Manual 1110-2-2002	Department of the Army U.S. Army Corps of Engineers Washington, DC 20314-1000	EM 1110-2-2002 30 June 1995
	Engineering and Design EVALUATION AND REPAIR OF CONCRETE STRUCTURES	
	Distribution Restriction Statement Approved for public release; distribution is unlimited.

Engineering and Design
EVALUATION AND REPAIR OF CONCRETE STRUCTURES

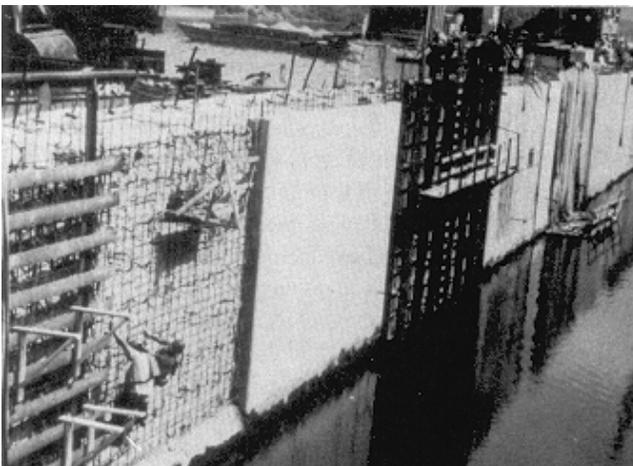
Figure 8-1. Placing reinforcing steel and horizontal armor prior to concrete placement, Locks and Dam No. 3, Monogahela River

(3) Reinforcement. Mats of reinforcing steel, usually No. 5 or 6 bars on 305-mm (12-in.) centers each way, are hung vertically on the dowels (Figure 8-1). Concrete cover over the reinforcing is usually 100 or 127 mm (4 or 5 in.). In some cases, the reinforcing mat, wall armor, and other lock wall appurtenances are installed on the form prior to positioning the form on the face of the lock wall (Figure 8-2).

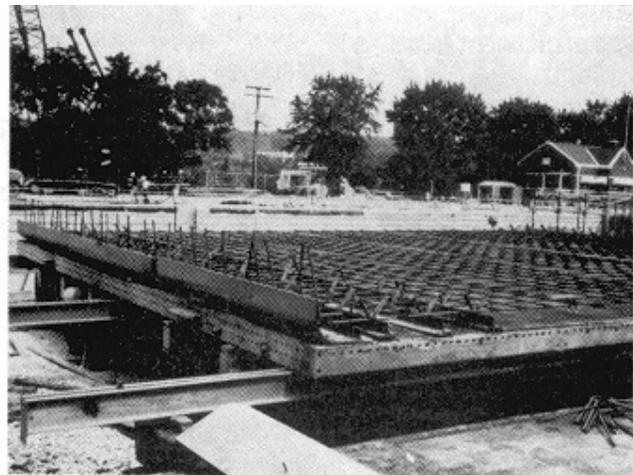
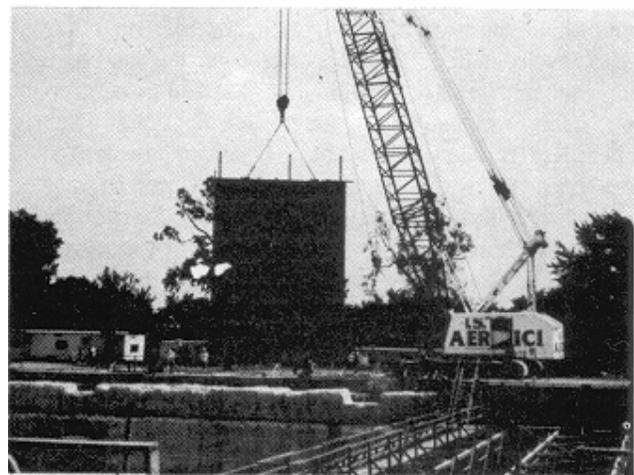
a. Wall armor and concrete reinforcement in place on the form

b. Concrete forming being placed in position on the lock wall

Figure 8-2. Lock wall rehabilitation, Brandon Rock Lock

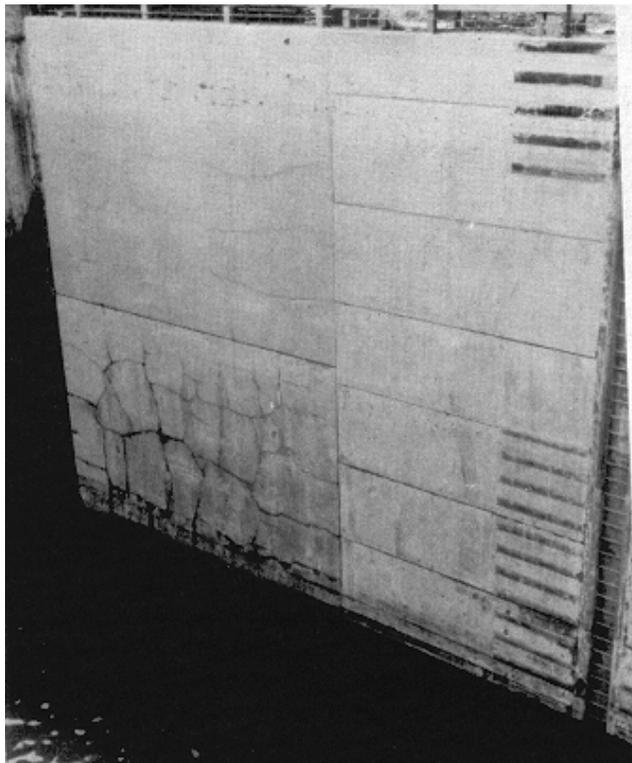
Figure 8-3. Concrete cracking in resurfaced monolith (left) compared to reconstructed monolith, Lock No. 1, Mississippi River

develop. The lock monolith on the left in Figure 8-3 was resurfaced with a 457-mm (18-in.) overlay of new concrete. As a result of the restraint provided by the existing concrete, extensive cracking developed. The monolith on the right was completely removed and reconstructed in 1.5-m (5-ft) lifts with the same concrete materials and mixture proportions. Without an existing concrete substrate to provide restraint, no cracking occurred.

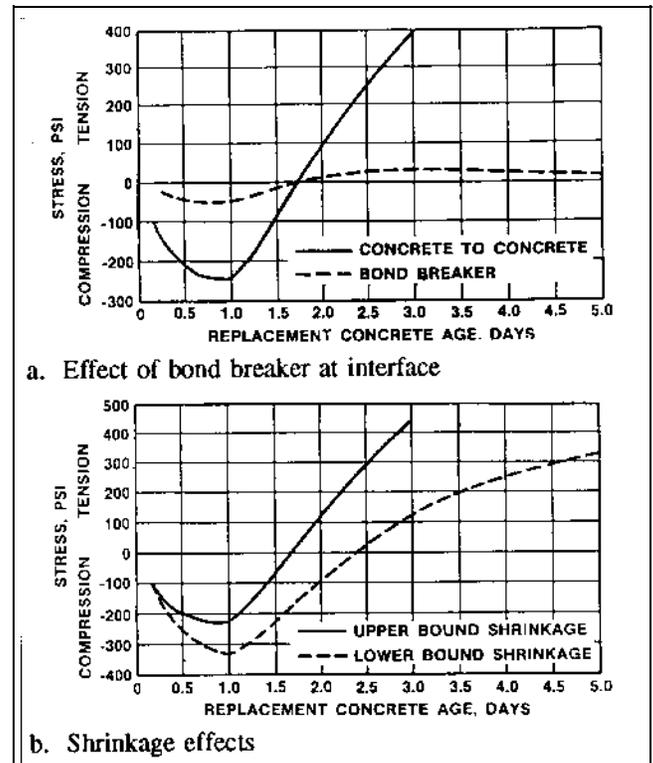
Figure 8-4. Results of a finite element analysis of a typical lock wall resurfacing

(a) A finite element analysis of a typical lock wall resurfacing (Norman, Campbell, and Garner 1988) also demonstrated the effect of restraint by the existing concrete. Under normal conditions of good bond between the two concretes, stress levels sufficient to cause cracking in the replacement concrete developed within about 3 days (Figure 8-4a). In comparison, a bond breaker at the interface resulted in almost no stress in the replacement concrete. The analysis also indicated that shrinkage was a significant factor (Figure 8-4b). Even the lower bound shrinkage resulted in tensile stresses in excess of 2.1 MPa (300 psi).

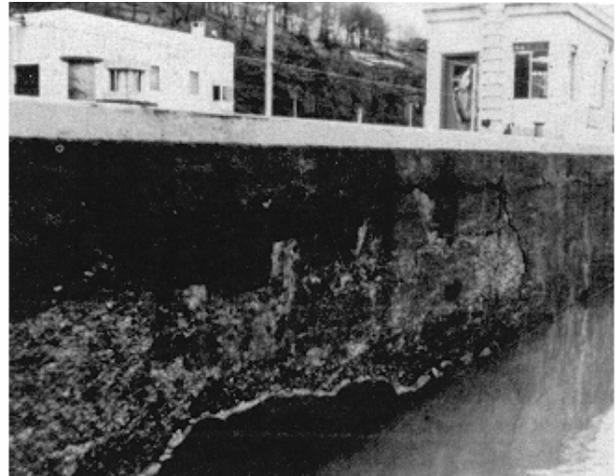
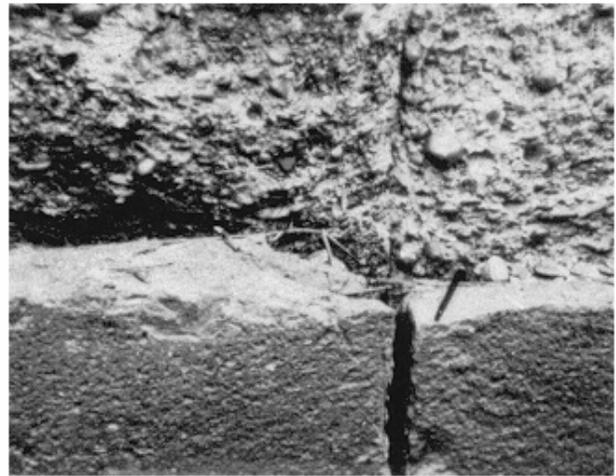
a. Overall view

b. Closeup view

Figure 8-5. Spalling of shotcrete used to reface river chamber wall, Emsworth Locks and Dam

(a) The river chamber at Emsworth Locks and Dam, opened to traffic in 1921, was refaced with shotcrete in 1959. By 1981 the shotcrete repair had deteriorated to the stage shown in Figure 8-5. Spalling appeared to have originated in the upper portion of the wall where the shotcrete overlay was relatively thin and surface preparation minimal. Deterioration apparently propagated down the wall to a point where the shotcrete was of sufficient thickness (approximately 100 mm (4 in.)) to contain dowels and wire mesh. Horizontal cores from the chamber walls showed the remaining shotcrete to be in generally good condition (Figure 8-6a). However, the original concrete immediately behind the shotcrete exhibited significant deterioration, probably caused by freezing and thawing. Cores of similar concrete from the land chamber which did not receive a shotcrete overlay were in generally good condition from the surface inward (Figure 8-6b). This appears to be an example of an overlay contributing to the saturation of the original concrete with increased deterioration resulting from freezing and thawing.

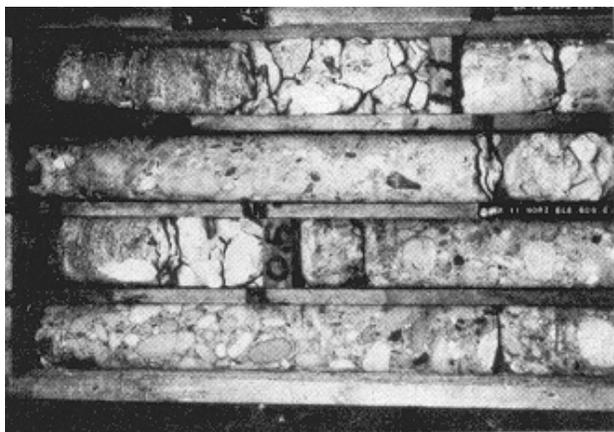
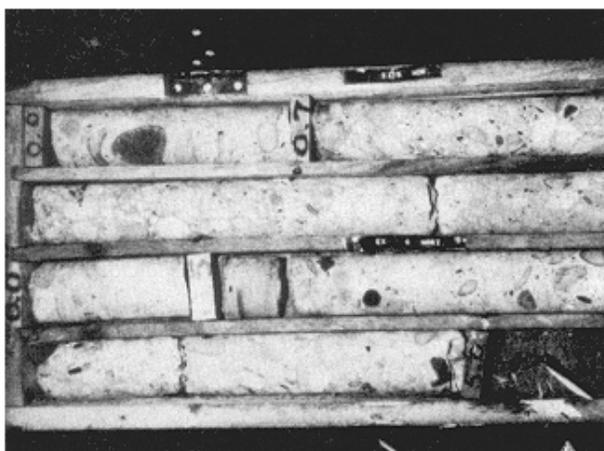
a. Portions of the core from two drill holes through river chamber wall which had been refaced with shotcrete

b. Portions of the core from two drill holes through land chamber wall which was not refaced

Figure 8-6. Comparison of cores taken horizontally from lock chamber walls, Emsworth Locks

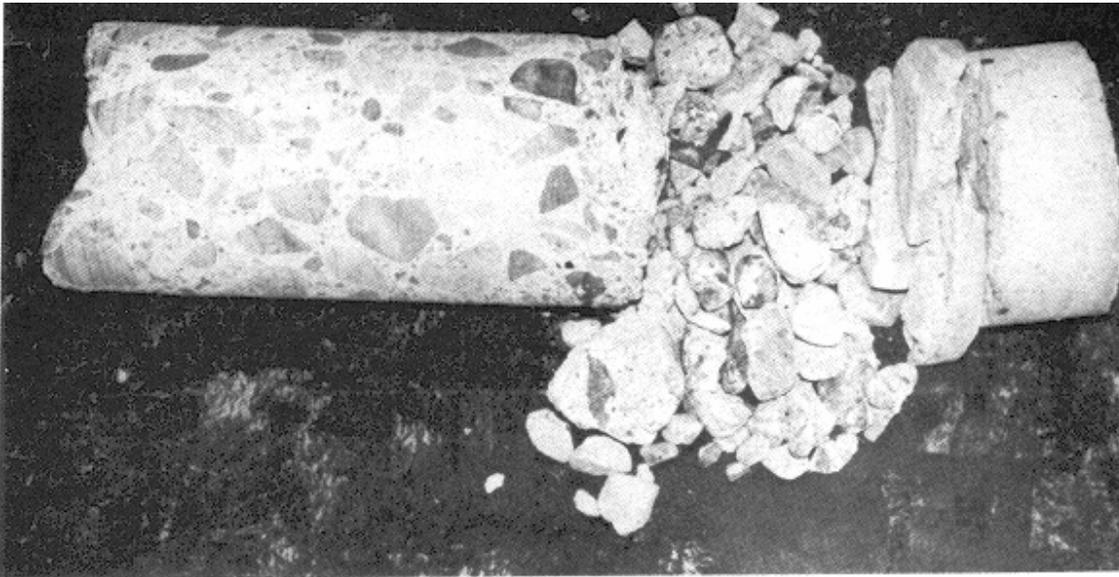
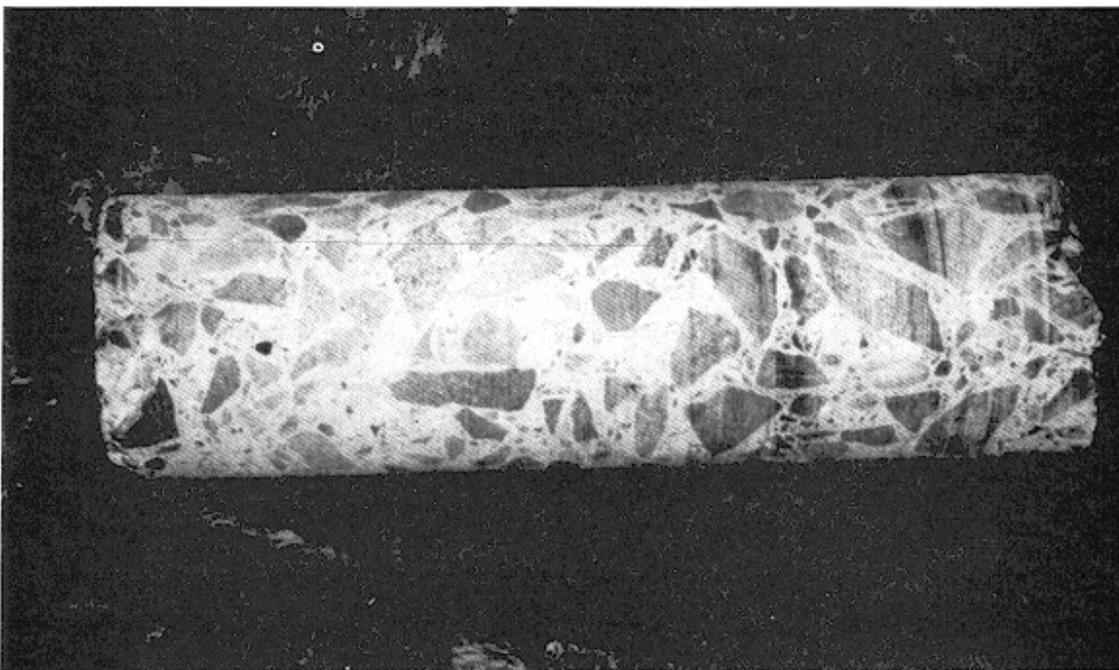
a. Concrete deterioration immediately behind shotcrete overlay

b. Concrete not refaced with shotcrete

Figure 8-7. Comparison of cores taken from lock chamber walls, Davis and Sabin Locks

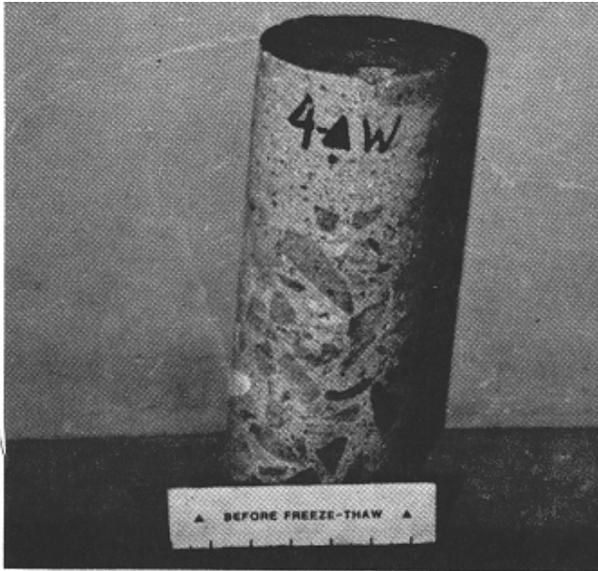
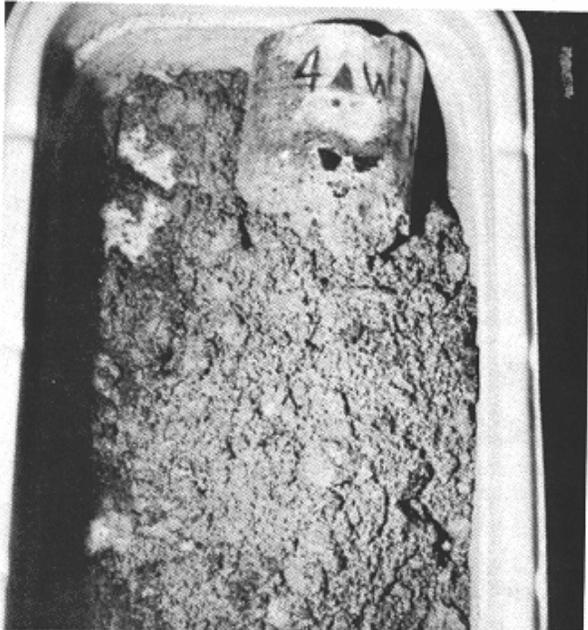
a. Before freezing and thawing

b. After freezing and thawing

Figure 8-8. Combination shotcrete and concrete core before and after 35 cycles of freezing and thawing in a saturated condition

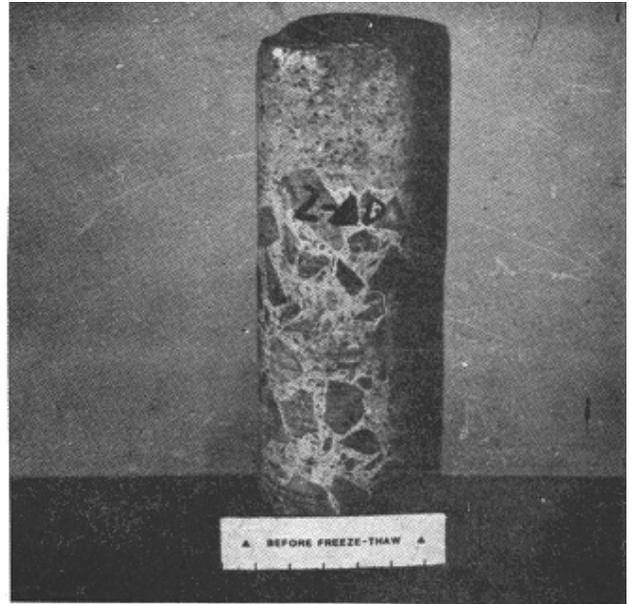
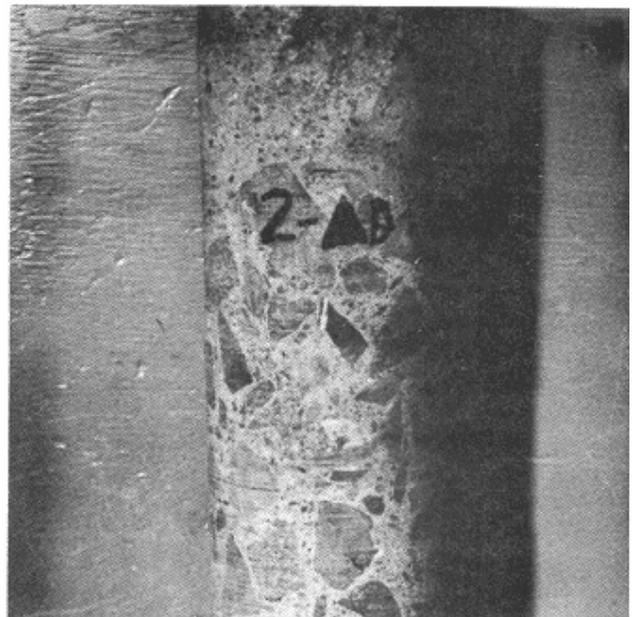
a. Before freezing and thawing

b. After freezing and thawing

Figure 8-9. Combination shotcrete and concrete core before and after 35 cycles of freezing and thawing in a dry condition

1.8-percent air voids compared to 0.9 percent in the concrete. In areas where moisture migration did not cause the concrete behind the shotcrete to become critically saturated during cycles of freezing and thawing, the shotcrete was well bonded to the concrete and there was no evidence of deterioration in either material. However, when cores from such areas were subjected to accelerated freeze-thaw testing in a saturated state, the concrete completely disintegrated while the shotcrete remained generally intact (Figure 8-8). Similar cores subjected to accelerated freeze-thaw testing in a dry state remained substantially intact (Figure 8-9).

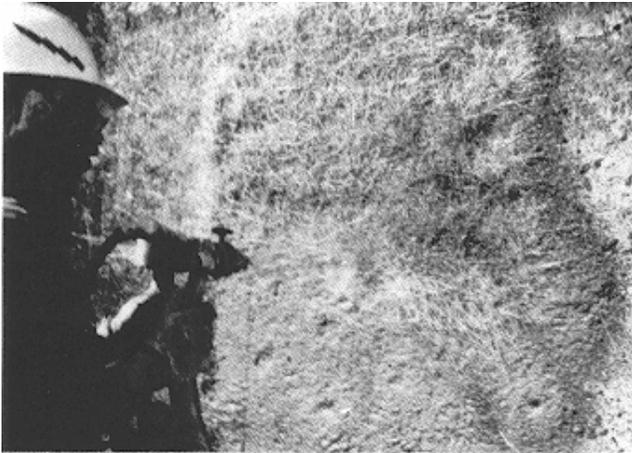
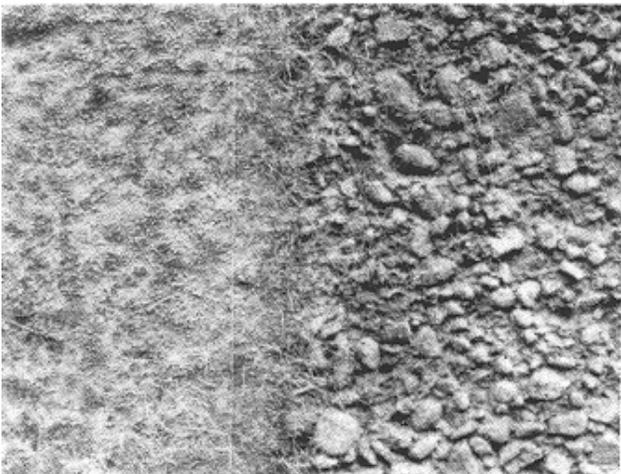
a. Applying the coating with equipment that simultaneously sprays the mortar from one nozzle while it chops and blows the fiber from a cutterhead

b. Typical appearance of the lock wall before and after repair

Figure 8-10. Application of coating to lock wall, Lower Monumental Lock

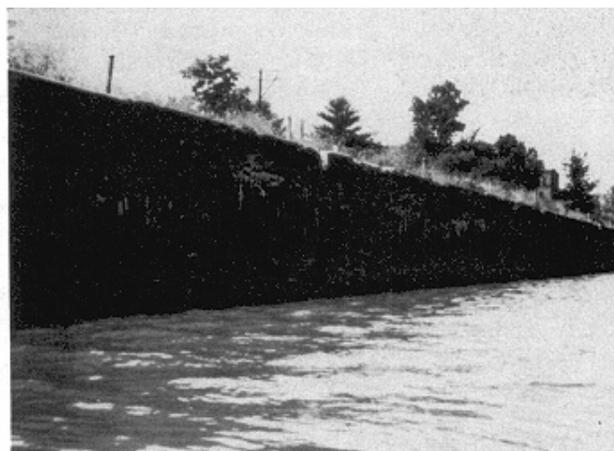
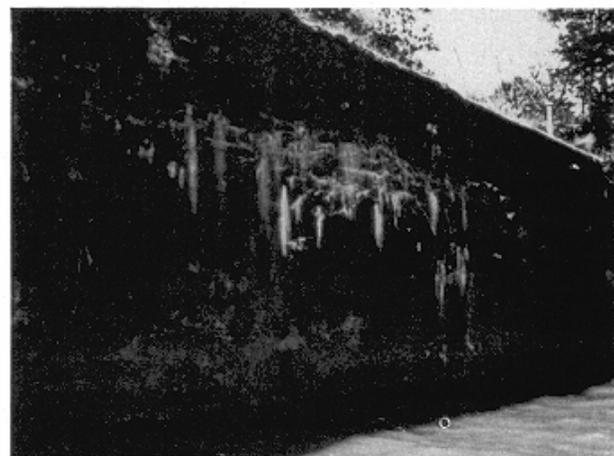
a. Overall view

b. Closeup view

Figure 8-11. Condition of lock chamber wall 35 years after refacing with preplaced-aggregate concrete

(b) Lock No. 5 was removed from service and, with the exception of the land wall, razed in conjunction with the construction of Maxwell Lock and Dam in 1964. A visual examination of the remaining wall in July 1985 showed that the preplaced-aggregate concrete had some cracking and leaching (Figure 8-11) but overall appeared to be in generally good condition after 35 years exposure. This repair demonstrates that the preplaced-aggregate method of concrete placement is a practical alternative to conventional methods for refacing lock walls.

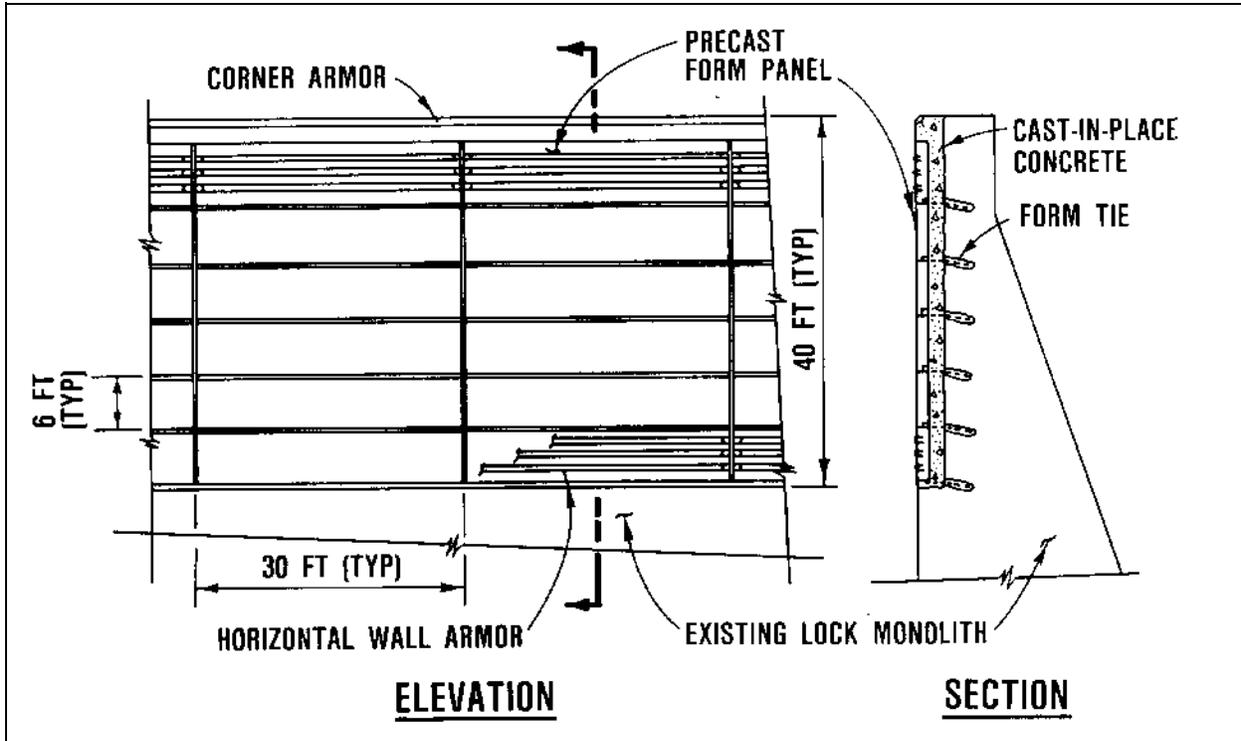
Figure 8-12. Precast concrete stay-in-place forming system for lock wall rehabilitation

(a) A wide range of alternatives for achieving the design objectives was evaluated through a process of value engineering (ABAM Engineers 1987a). Based on this analysis, it was concluded that the most advantageous combination of design alternatives was a precast-quality concrete (minimum compressive strength of 45 MPa (6,500 psi)), conventionally reinforced, flat panel, horizontally oriented and tied to the lock wall (Figure 8-12). A typical panel was 165 mm (6-1/2 in.) thick, 1.8 m (6 ft) wide, 9.1 m (30 ft) long, and it weighed approximately 7 tons. The panels are tied to the lock monolith along the top and bottom edges with form ties designed to support the loads of the infill concrete placement.

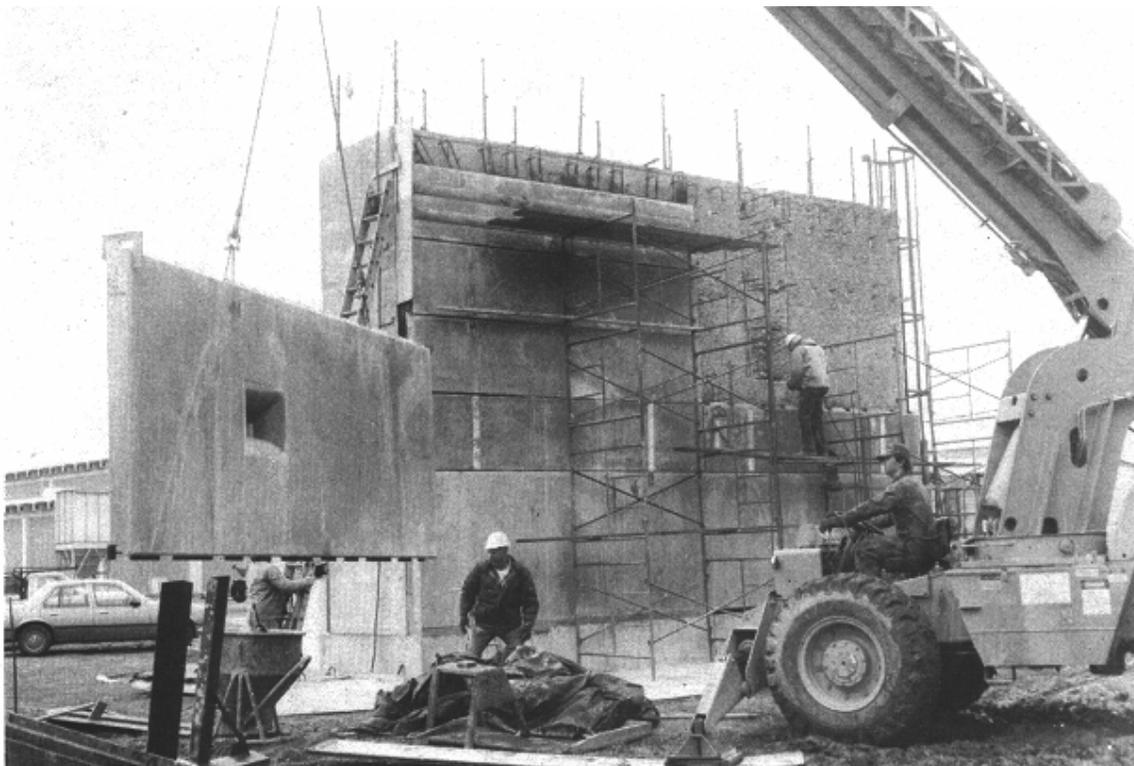
Figure 8-13. Demonstrating the constructibility of the precast concrete stay-in-place forming system

(b) To demonstrate the constructibility of the system, eight panels of varying sizes were precast and installed on two one-half-scale simulated lock monoliths (Figure 8-13). The purpose of the demonstration was to evaluate the feasibility of the precast concrete stay-in-place forming system without the risk and investment of undertaking a full-scale lock rehabilitation. Results of this work demonstrated that the precast concrete stay-in-place forming system is a viable method for lock wall rehabilitation (ABAM Engineers 1987b). In addition to providing a concrete surface of superior durability with minimal cracking, the construction cost was very competitive with the cost of conventional cast-in-place concrete. The demonstration also identified a number of areas where the design and installation procedures could be enhanced thus reducing both the cost and schedule associated with the stay-in-place forming system. Development of the precast concrete stay-in-place forming system is summarized in a video report (McDonald 1988) which is available on loan from the CEWES Library.

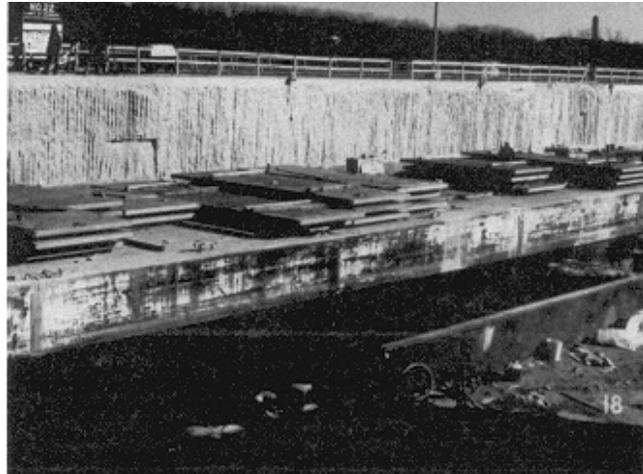
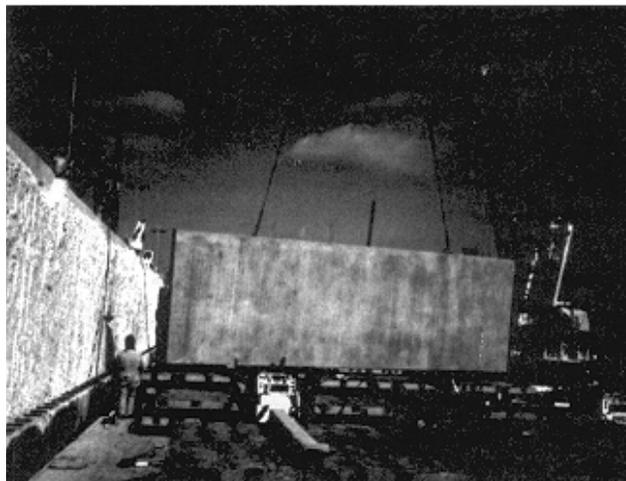
Figure 8-14. Installation of precast concrete stay-in-place forms at Lock 22, Mississippi River

(c) The panels were transported to the site by river barges and lifted into position with a barge-mounted crane (Figure 8-14). The panels were held on the sawcut ledge while they were leveled with the vertical alignment hardware and the bottom panel anchors were welded to the weld plates embedded in the panels. The top panel anchors were then installed and welded to the embedded weld plates. Each panel was aligned and welded in 2 to 3 hr. The space between the panels and lock wall was filled with nonshrink cementitious grout. Approximately 1,070 sq m (11,500 sq ft) of the lock walls were resurfaced. The bid price for the precast panel repair, including concrete removal, was \$980 per sq m (\$91 per sq ft). Bid prices for this initial application of the precast concrete stay-in-place forming system for lock wall rehabilitation were somewhat higher than anticipated. However, the rehabilitation went very smoothly, despite severe winter weather conditions, and the precast panels were installed in about one-half the time that would have been required for cast-in-place concrete.

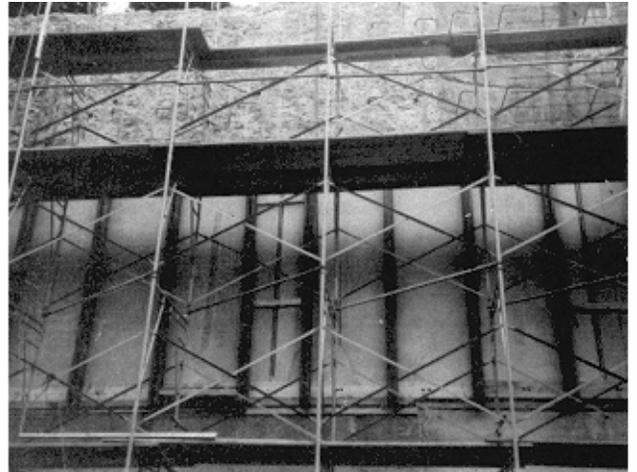
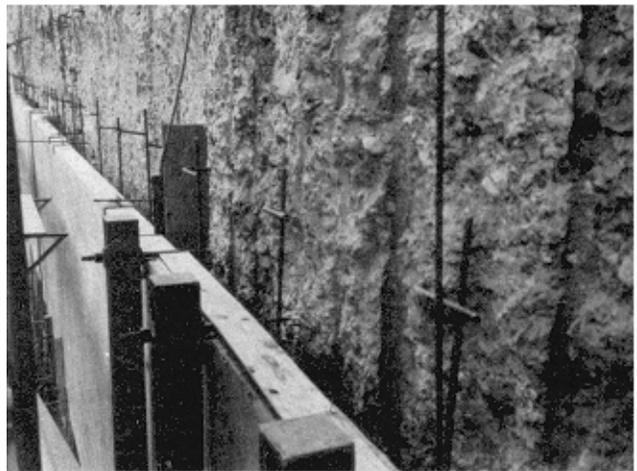
Figure 8-15. Installation of precast concrete stay-in-place forms at Troy Lock, Hudson River (Miles 1993)

(g) A total of 112 precast concrete panels were required to resurface the lock chamber walls. A typical panel was 190 mm (7-1/2 in.) thick, 3.6 m (11 ft 10 in.) high, and 6.1 m (20 ft) long. Ten special panels were required to accommodate line poles and ladders. These panels were 521 mm (1 ft 8-1/2 in.) thick except at the recesses where the thickness was reduced to 190 mm (7-1/2 in.). The panels were fabricated with a 25 by 305 mm (1 by 12 in.) taper and a 25 mm (1 in.) chamfer along the vertical joints to reduce impact spalling. Reinforcing mats with 51 mm (2 in.) of concrete cover were placed at both faces of each panel. Panel anchors were hoop-shaped reinforcing bars which extended 102 mm (4 in.) from the rear face of the panel. Two erection anchors were embedded in the top of each panel. A concrete mixture proportioned with a 0.31 water-cementitious ratio for a compressive strength of 48 MPa (7,000 psi) at 28 days was used to precast the panels. The panels were fabricated in a heated building during the winter of 1991-92.

(h) A minimum of 305 mm (12 in.) of concrete was removed from the lock walls by saw cutting around the perimeter of the removal area, line drilling, and explosive blasting. Following air-jet cleaning of the surface, anchors were grouted into holes drilled into the existing concrete. These bent reinforcing bar anchors were located to line up with the hoop anchors embedded in the precast panels. The majority of the panels were installed during the winter of 1991-92 when ambient temperatures were generally cold, at times reaching -18°C (0°F). The precast panels were lifted from delivery trucks with a crane and lowered onto steel shims placed on the sawcut ledge. The panels were positioned with temporary holding and adjustment brackets, shebolt form anchors at the top and bottom of the panels at 1.2-m (4-ft) spacings, and steel strongbacks spanning between the shebolts. Once the panels were positioned and aligned, vertical reinforcing bars were manually installed from the top down to intersect the panel and wall anchors (Figure 8-15). Once the bars were properly located, they were tied to the anchors to prevent misalignment during placement of the infill concrete.

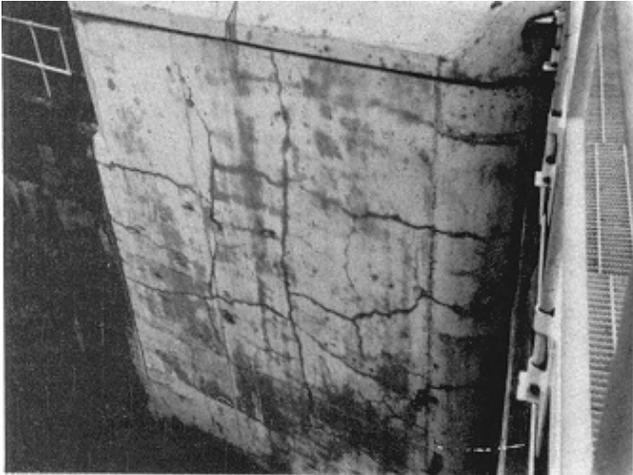
Figure 8-16. Typical cracking in miter gate monoliths resurfaced with cast-in-place concrete, Troy Lock, Hudson River (Miles 1993)

(i) The top of the precast panels was capped with 0.6 m (2 ft) of reinforced concrete, cast-in-place. A 152-mm (6-in.)-thick apron slab was also placed on top of the existing monolith wall to reduce water penetration and improve durability. Joints between panels and concrete cap and between cap and apron slab were sealed with joint sealant. Upon completion of the lock chamber resurfacing, an inspection of the precast panels revealed that 11 of 112 panels exhibited some fine cracks. Those cracks (four locations) with widths in excess of 0.15 mm (0.006 in.) were repaired by epoxy injection. In contrast, the miter gate monoliths previously resurfaced with cast-in-place concrete exhibited extensive cracking (Figure 8-16).

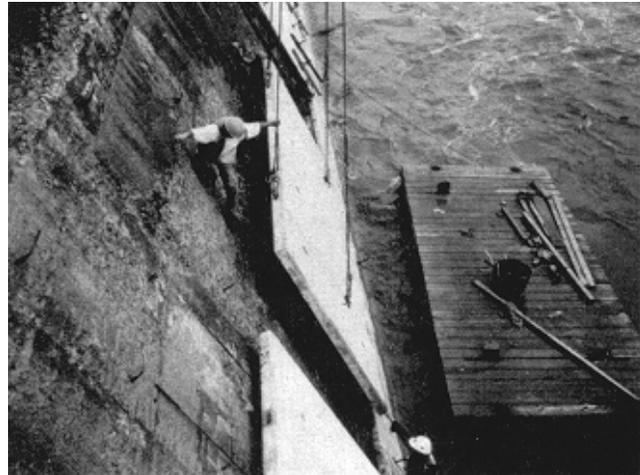
Figure 8-17. Installing precast concrete panels used to overlay the back side of the river wall at Troy Lock, Hudson River (Miles 1993)

(k) In addition to resurfacing the lock chamber, precast concrete panels were used to overlay the back side of the river wall at Troy Lock (Figure 8-17). Original plans for repair of this area required extensive removal of deteriorated concrete and replacement with shotcrete. This repair, which would have had to be accomplished in the dry, would have required construction of an expensive cofferdam to dewater the area. Therefore, it was decided that concrete removal could be minimized and the need for a cofferdam eliminated if this area was repaired with precast concrete panels. Three rows of precast panels were used in the overlay. The panels were installed in 1992 while the lock was in operation. The bottom row of panels was partially submerged during installation and

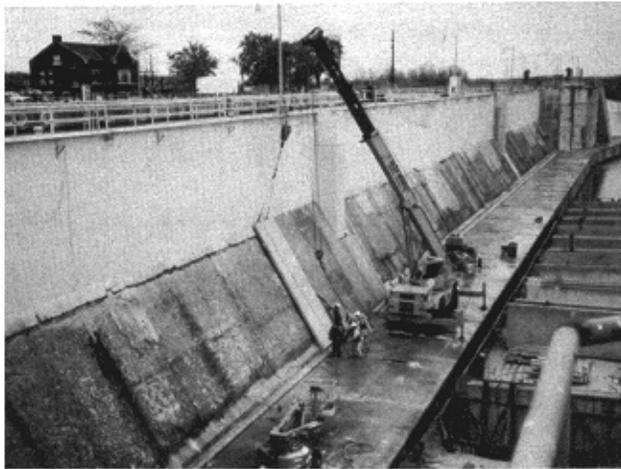
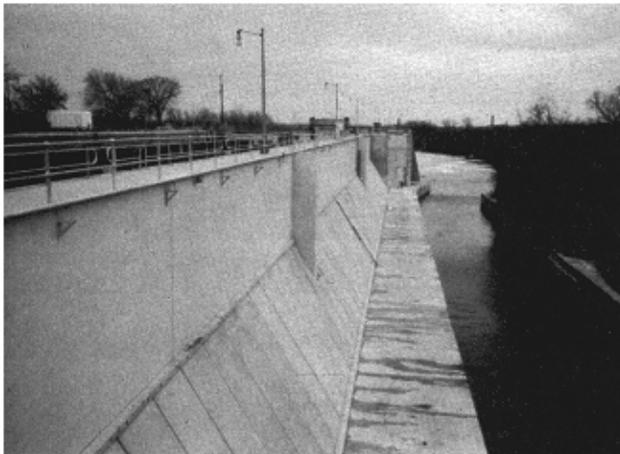
a. Installation of precast concrete panels

b. River wall complete with precast concrete panels

Figure 8-18. Backside of river wall, Lockport Lock, Illinois Waterway

(l) Precast concrete panels were also used to overlay the lower, battered section of the backside of the river wall at Lockport Lock, Illinois Waterway (Figure 8-18). Before the panels were placed, the concrete surface was cleaned of all loose concrete with a high-pressure water jet. Then the precast concrete base was positioned and anchored along the horizontal surface at the base of the wall. In addition to conventional reinforcement in each direction, the precast panels were prestressed vertically. Embedded items included weld plates at the bottom of the panels and steel angles with embedded bolts at the top of the panels. Typical panels were 152 mm (6 in.) thick, 7.1 m (23.2 ft) high, and 2.3 m (7.5 ft) wide.

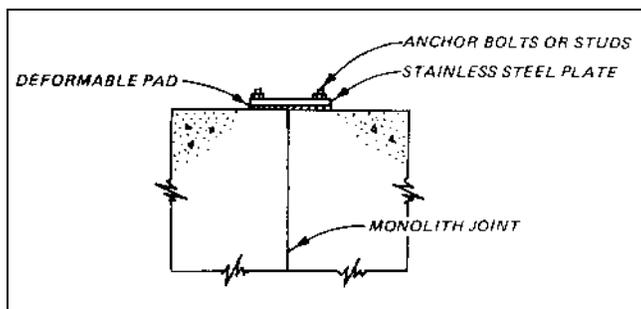
Figure 8-19. Typical plate type waterstop

a. Surface plates. A plate-type surface waterstop (Figure 8-19) consists of a rigid plate, generally stainless steel, spanning the joint with a neoprene or deformable rubber backing. The plate is attached with anchors which provide an initial pressure on the deformable pad. Water pressure against the plate provides additional pressure so that the deeper the waterstop is in a reservoir, the tighter the plate presses to the surface of the joint. This type waterstop has had varying degrees of success. At John Day Lock, it has worked relatively well but at Lower Monumental Lock, it has not performed satisfactorily. The major difference between these structures is that at Lower Monumental, the joint movement is more than that at John Day. Potential problems with this type of repair include: (1) loosening of the anchor bolts; (2) reverse hydrostatic pressure from water trapped behind the waterstop when the reservoir drops; (3) mechanical abuse such as a barge tearing off the plate; (4) ice pressure from

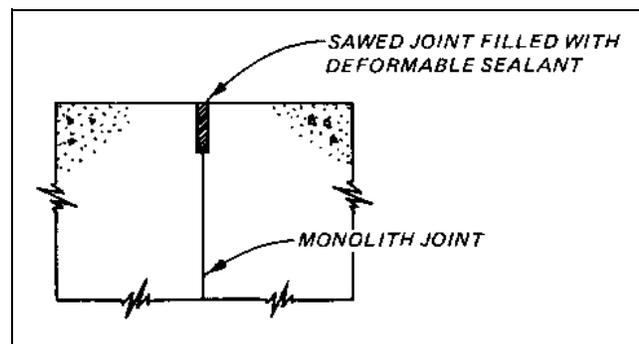
Figure 8-20. Typical sawed joint filled with sealant

b. Caulked joints. When the reservoir level can be dropped below the elevation to which repairs are necessary, and if the joint opening is not too great, a simple and economical repair may be possible by saw cutting along the joint on the positive pressure, or reservoir side, and then filling the cut with an elastic sealant (Figure 8-20). The sawcut should be wide enough to span the joint and cut about 3 mm (1/8 in.) minimum into the concrete on each side of it. The cut must also be deep enough to penetrate any unsound, cracked, or deteriorated materials. Typically, a cut 13 mm (1/2 in.) wide by 38 mm (1-1/2 in.) deep is acceptable. The cut should follow the joint to its base; otherwise, water migrating underneath the sealant can build up pressure in the joint behind the sealant. To perform satisfactorily, the sealant must set rapidly, bond to cool and damp concrete, and remain flexible under anticipated service conditions, and it must not sag in vertical applications or extrude through the joint under hydrostatic pressure. Once problems of partial extrusion due to inadequate curing were solved, this type of repair exhibited reasonable success for several years at Lower Monumental and Little Goose Locks.

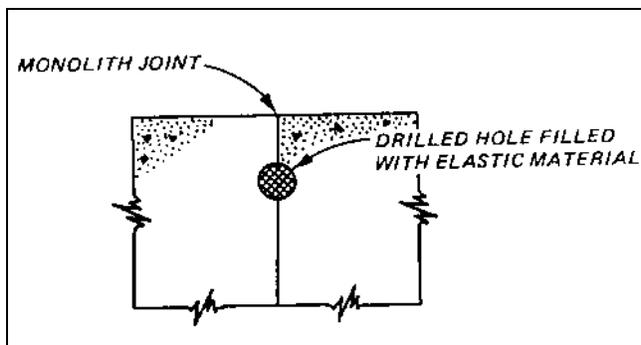
Figure 8-21. Drilled hole with elastic filler

c. Drill holes filled with elastic material. This approach (Figure 8-21) consists of drilling a large-diameter hole from the top of the monolith along the joint and into the foundation, and filling the hole with an elastic material. Typically, the hole is 76 to 152 mm (3 to 6 in.) in diameter and drilled by a "down-the-hole" hammer or core drill. The more costly core drilling allows easy visual inspection of hole alignment along the joint, but the down-the-hole hammer has proven to be the preferred method of drilling. Small underwater video cameras can also be used to inspect hole alignment and condition of the joint.

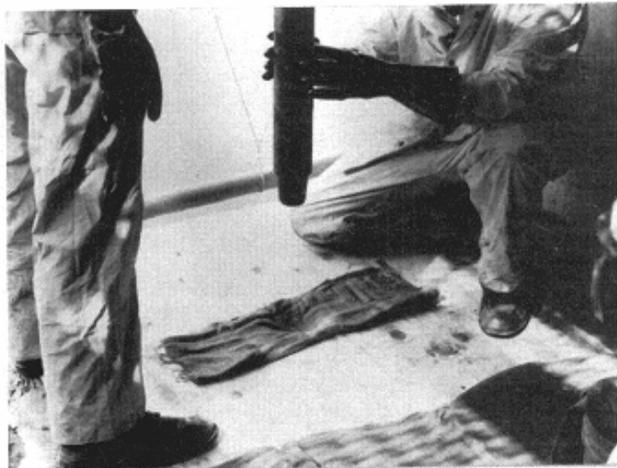
a. Saturating burlap bags with chemical grout

b. Saturated bag on top of drill hole awaiting insertion

Figure 8-22. Remedial waterstop installation, Dardanelle Lock

(b) Water-activated urethane foam grout systems have also been used as elastic fillers. These hydraulic polymers are activated when placed in contact with water and upon curing form a tough, flexible gel approximately 10 times its original volume. One approach in using these materials is to stuff burlap bags which have been saturated with the grout into the drill holes (Figure 8-22). Water in the drill holes activates the grout system causing the grout to expand and completely fill the holes. Tamping the bags as they are pushed into the holes with drill stem will force some of the grout into the joints prior to gel formation. Gel times will vary with ambient and water temperatures but generally can be controlled with additives to be in the range of 5 to 10 min. This procedure was used at Dardanelle Lock with a reduction in gallery leakage of approximately 95 percent. Technical representatives for the material manufacturers should be contacted for detailed guidance on specific grout systems.

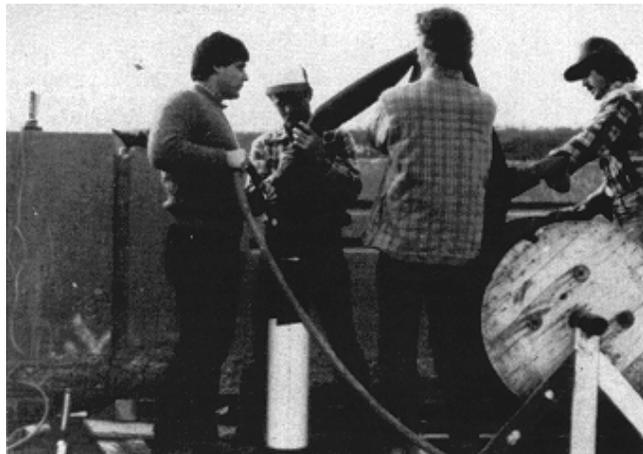
Figure 8-23. Two-component natural rubber and elastomer coated nylon sleeve being inserted into drill hole, Bagnell Dam

(2) Liner materials. In some cases, a continuous tube-type liner has been inserted into the drill hole (Figure 8-23) to contain the filler material. Liner materials include reinforced plastic firehose, natural rubber, elastomer coated fabric, neoprene, synthetic rubber, and felt tubes. In most cases, the liners are not bonded to the walls at the drill holes and rely on differential pressure between the interior of the liner and the external water level to force the liner against the sides of the hole. Obviously, any type of liner material should be of sufficient flexibility to allow the tube to conform to any voids and irregularities in the surface of the drill hole and to accommodate differential movement between adjacent monoliths.

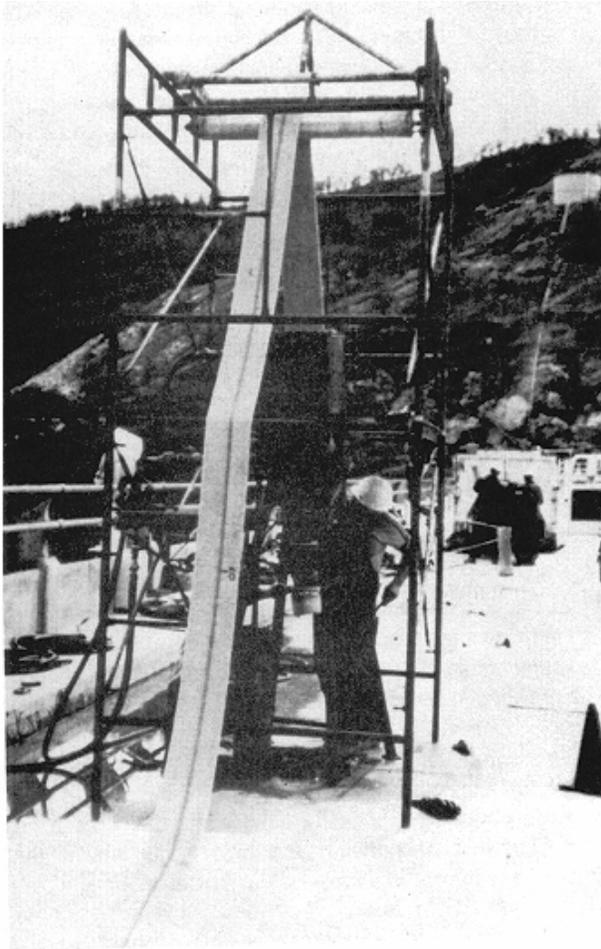
Figure 8-24. Inversion apparatus for installing tube in drill hole, Pine Flat Dam

bonding of the liner to the surface of the drill hole. In this procedure, the liner is fabricated from thin polyurethane film with an under layer of felt approximately 6 mm (1/4 in.) thick. Prior to installation, water-activated polyurethane resin is poured into the tube to saturate the felt lining. The resin is distributed evenly throughout the tube by passing it through a set of pinch rollers. The tube is then inserted into the drill hole, and as it is inserted water pressure is used to turn the tube inside-out (Figure 8-24). When the inversion process is complete, the resin-impregnated felt is in contact with the surface of

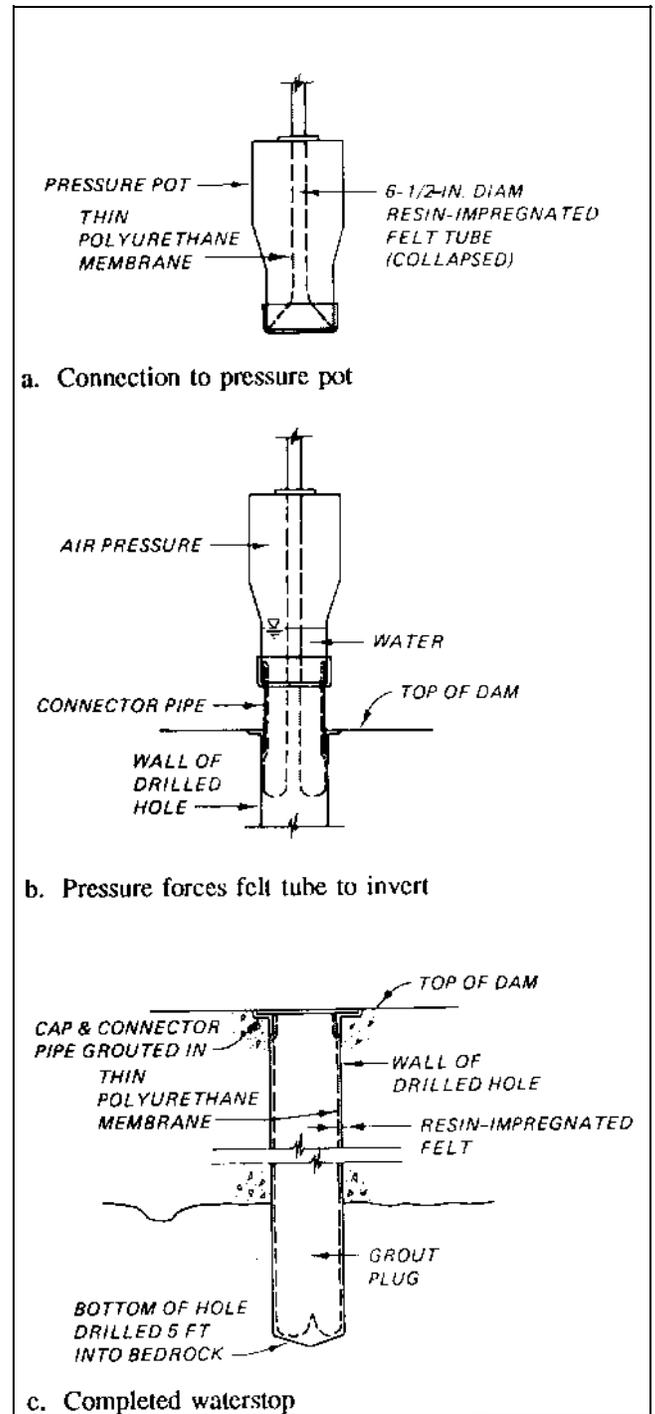
Figure 8-25. Remedial waterstop installation, Pine Flat Dam

the drill hole (Figure 8-25). Water inside the drill hole activates the resin grout creating a bond between the liner and the drill hole. This procedure was used to repair three leaking joints at Pine Flat Dam in March 1985. The drill holes ranged in depth from 58 to 78 m (189 to 257 ft) with a combined flow of 515 L/min (136 gal/min). After repair, the flow dropped to 45 L/min (12 gal/min). As a result of the excellent performance of these repairs, the same procedure was used in 1993 to correct leakage through additional monolith joints at Pine Flat Dam.

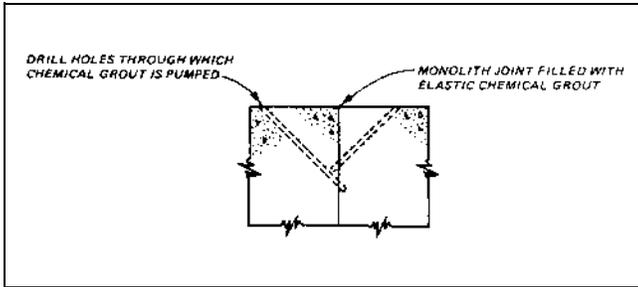
Figure 8-26. Joint filled with elastic grout through injection

joint behind the waterstop (Figure 8-26). An elastic chemical grout is then injected through the drill hole. Criteria for the injection grout require that it have low

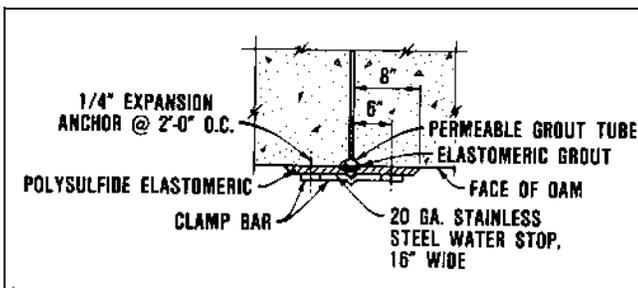
Figure 8-27. Combination grouted joint and surface plate-type waterstop, Richard B. Russell Dam

(2) Exterior joints. A combination of grouted joint and surface plate waterstop techniques was used to seal vertical contraction joints on the upstream face of the Richard B. Russell Dam (Figure 8-27). A permeable grout tube was placed in the vertical vee along the face of each joint and covered with an elastomeric sealant. After

the sealant hardened, the grout tube was injected with a polysulfide sealant to fill the joints from the dam face into the embedded waterstop. The polysulfide sealant was also placed on the face of the dam for a distance of 203 mm (8 in.) on either side of the joints. Prior to hardening of the sealant, a surface plate waterstop of 20-gauge stainless steel was anchored into position over the joint.

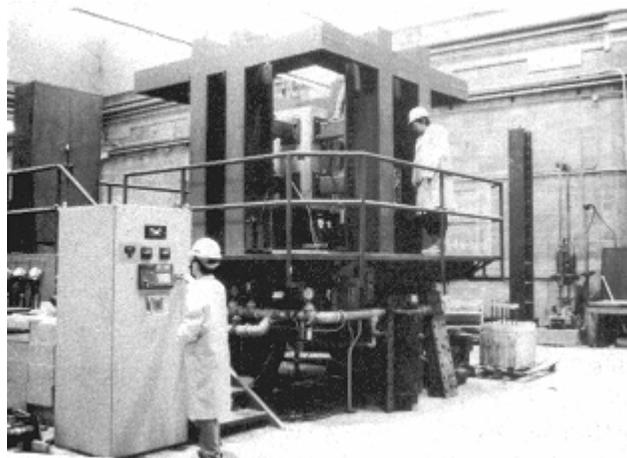
Figure 8-28. Remedial waterstop test apparatus

e. Summary. Because of a lack of appropriate test methods and equipment, most of the materials and procedures described have been used in prototype repairs with limited or no laboratory evaluation of their effectiveness in the particular application. Consequently, a test apparatus was designed and constructed, as part of the REMR research program, to allow systematic evaluation of waterstop repair techniques prior to application in prototype structures. The apparatus consists of two concrete blocks, one fixed and one movable, with a simulated monolith joint between the blocks (Figure 8-28). The performance of waterstop repairs can be evaluated for water heads up to 76 m (250 ft) and joint movements up to 10 mm (0.4 in.). Preliminary results of current short-duration tests indicate that grouted joint repairs and most caulked joint repairs begin to leak at joint movements between 1.3 and 2.5 mm (0.05 and 0.1 in.). Catastrophic failure, generally caused by debonding of the repair material, usually occurs at a joint movement of 2.5 mm (0.1 in.) for polyurethane grouts and 5 to 10 mm (0.2 to 0.4 in.) for most joint sealants. To date, the most successful repair consisted of polyurethane grout injection of the joint combined with caulking of the upstream face. This repair exhibited no leakage for joint movements up to 5 mm (0.2 in.) and a water head of 70 m (230 ft).

Leakage was first observed at a joint movement of 8 mm (0.3 in.) and a water head of 38 m (125 ft); however, the magnitude of the leakage was too small to measure for water heads up to 76 m (250 ft). Additional repair materials and procedures are currently being evaluated and a REMR report will be published upon completion of these tests. In the meantime, available test results can be obtained by contacting U.S. Army Engineer Waterways Experiment Station, Structures Laboratory, Concrete Technology Division, (CEWES-SC).

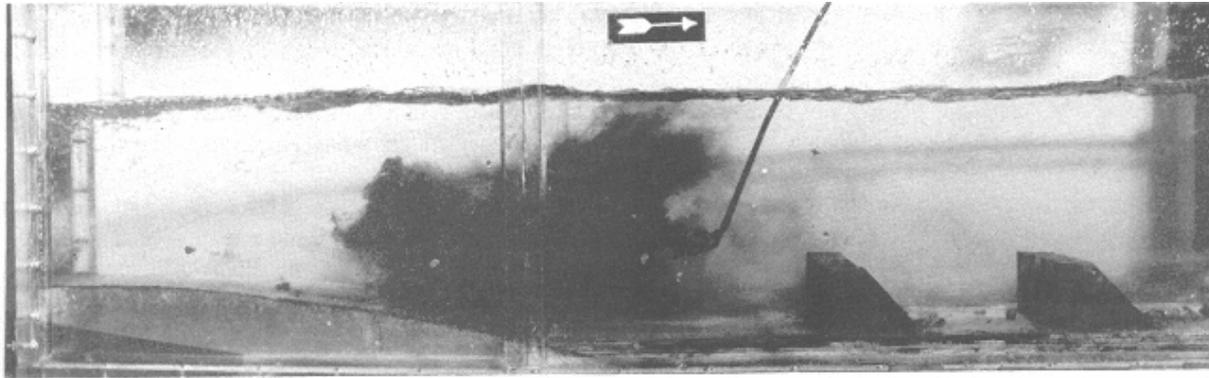
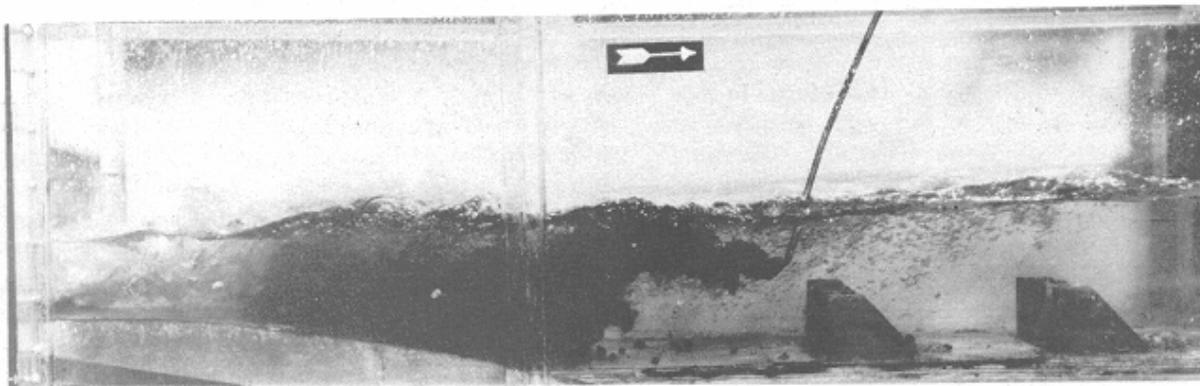
a. Tailwater elevation A

b. Tailwater elevation B

Figure 8-29. Subsurface upstream flow in the stilling basin at Pomona Dam (after Oswalt 1971)

b. Pomona Dam. Prior to repair, a hydraulic model study of the existing stilling basin at Pomona Dam was conducted to investigate discharge conditions which might account for debris in the basin and to evaluate potential modifications to eliminate these conditions. Model tests (Oswalt 1971) confirmed that severe separation of flow from one side wall and eddy action strong enough to circulate stone in the model occurred within the basin for discharges and tailwaters common to the site. Photographs (Figure 8-29) of subsurface upstream flow in the right side of the basin show the results of a discharge rate of 28 cu m/sec (1,000 cu ft/sec). Based on the model
