Evaluation and Repair of Concrete Structures Part III

Chapters 7 through 9

CECW-EG Engineer Manual 1110-2-2002	Department of the Army U.S. Army Corps of Engineers Washington, DC 20314-1000	EM 1110-2-2002 30 June 1995
	Engineering and Design EVALUATION AND REPAIR OF CONCRETE STRUCTURES	
	Distribution Restriction Statement Approved for public release; distribution is unlimited.

Engineering and Design
EVALUATION AND REPAIR OF CONCRETE STRUCTURES

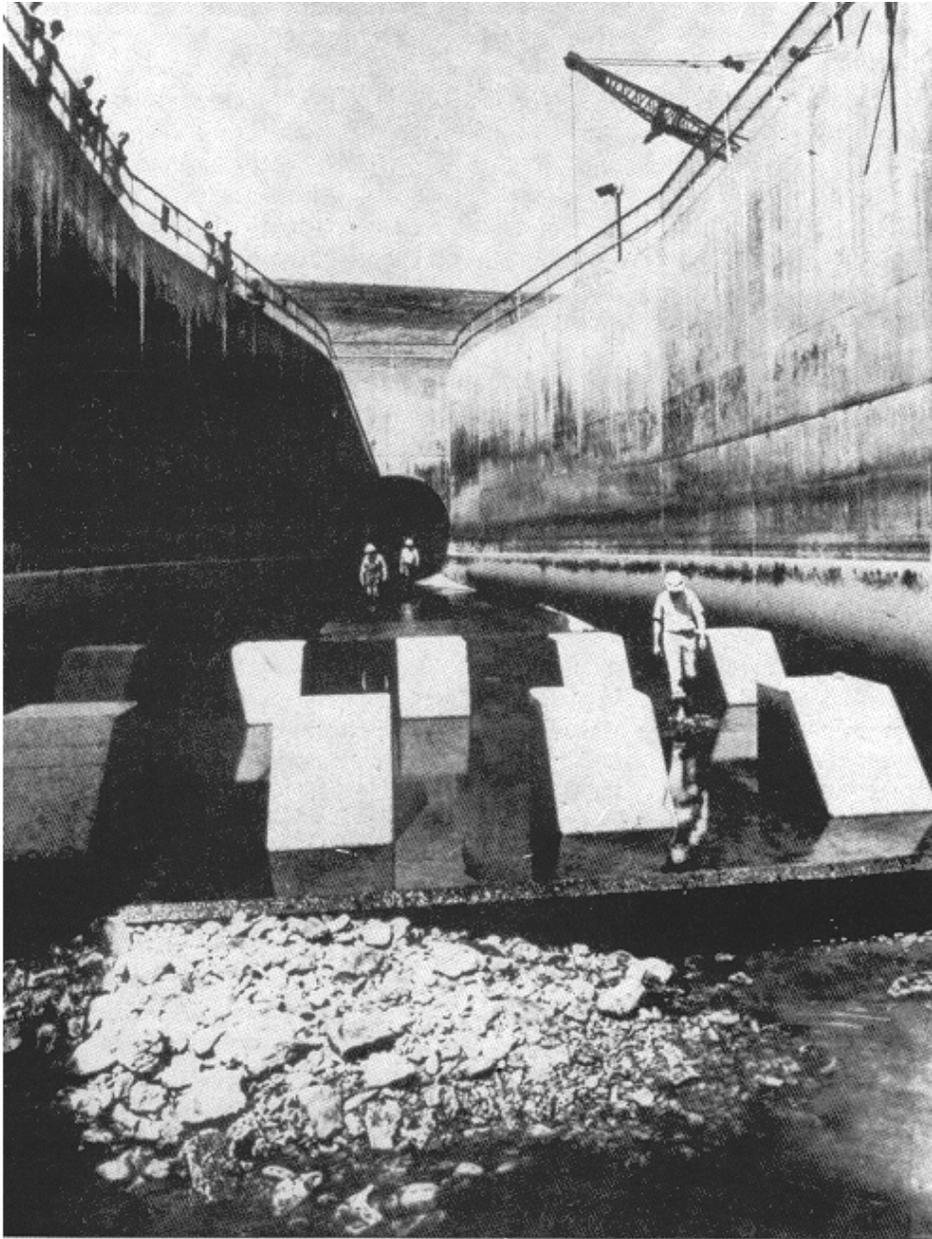
Figure 8-30. Stilling basin dewatered for inspection, Pomona Dam

(5) The next inspection, 5 years later, indicated that the stilling basin floor remained in good condition with essentially no damage since the previous inspection. Approximately 4 cu m (5 cu yd) of debris, mostly rocks, was removed from the debris trap at the downstream end of the basin (Figure 8-30).

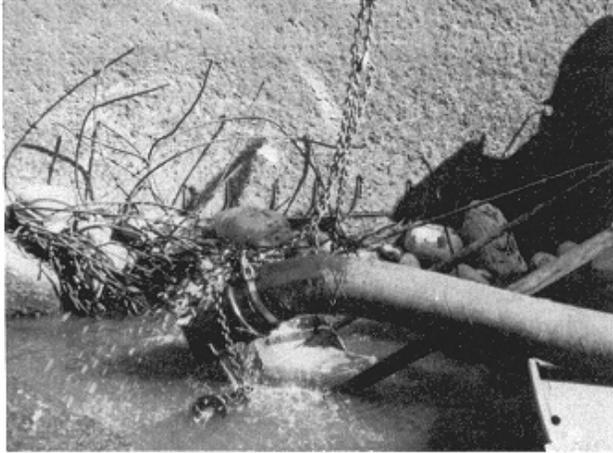
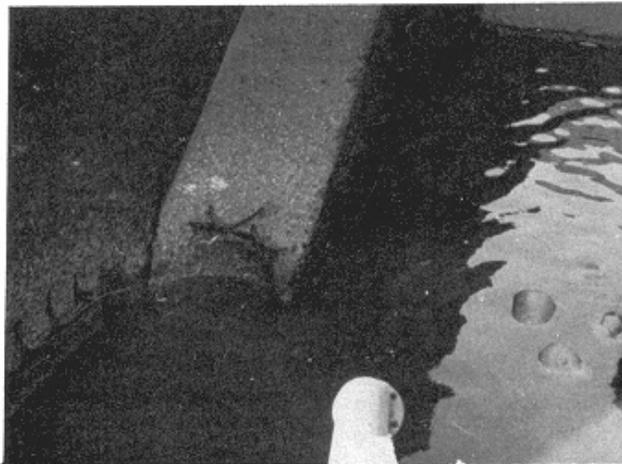
a. Debris collected behind wall baffle

b. Erosion behind wall baffle

Figure 8-31. Concrete erosion damage, Nolin Dam stilling basin, 1974

c. Nolin Lake Dam. The conduit and stilling basin at Nolin were dewatered for inspection in 1974. Erosion was reported in the lower portion of the parabolic section, the stilling basin floor, the lower part of the baffles, and along the top of the end sill. The most severe erosion was in the area between the wall baffles and the end sill where holes 0.6 to 0.9 m (2 to 3 ft) deep had been eroded into the stilling basin floor along the sidewalls (Figure 8-31).

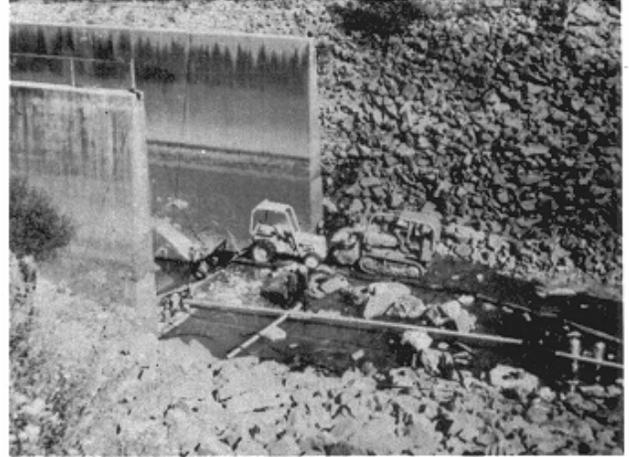
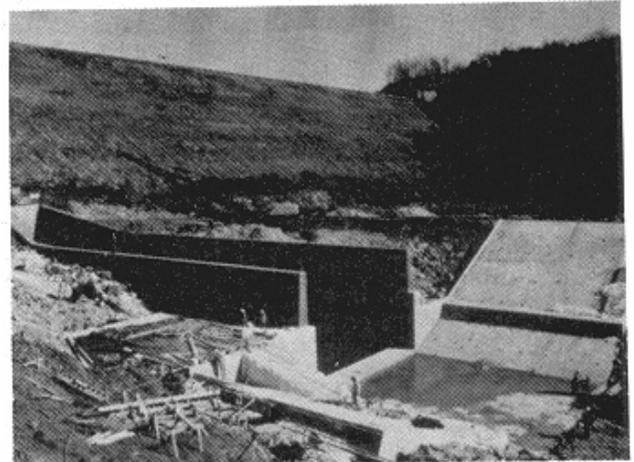
a. Prior to repair

b. After repair

Figure 8-32. Modifications to outlet work, Nolin Dam, 1975

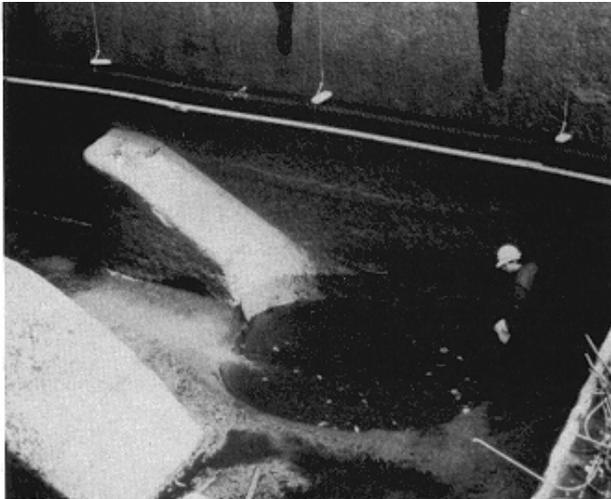
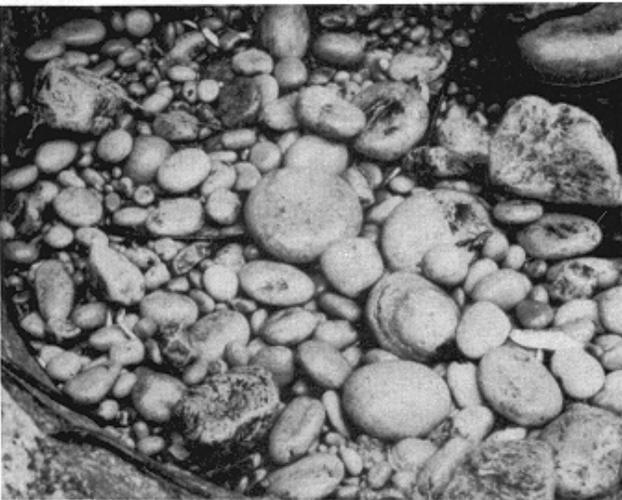
a. Scour holes behind baffles

b. Debris in scour holes

Figure 8-33. Concrete erosion damage, Nolin Dam stilling basin, 1984

(4) Significant erosion damage was reported when the stilling basin was dewatered for inspection in 1984. The most severe erosion was located behind the wall baffles (Figure 8-33) similar to that prior to repair in 1975. Each scour hole contained well-rounded debris. Temporary repairs included removal of debris from the scour holes and filling them with conventional concrete. Also, the half baffles attached to each wall of the stilling basin were removed. A hydraulic model of the stilling basin was constructed to investigate potential modifications to the basin to minimize chances of debris entering the basin with subsequent erosion damage to the concrete.

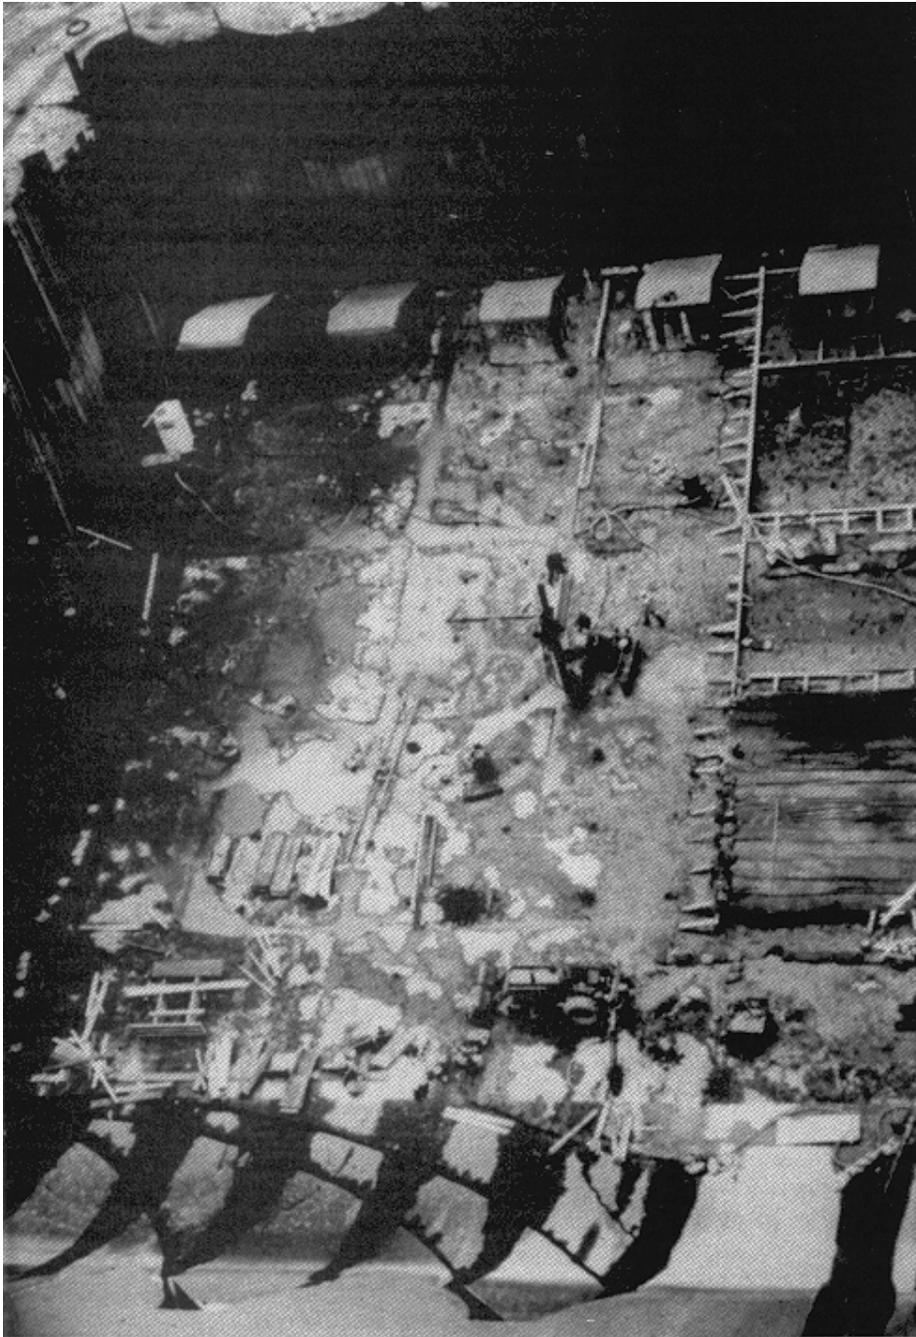
Figure 8-34. General view of repair operations, Kinzua Dam, 1974

stream flow in the unobstructed part of the stilling basin. Approximately 1,070 cu m (1,400 cu yd) of fiber-reinforced concrete was required to overlay the basin floor (Figure 8-34). A concrete mixture containing 25-mm (1-in.) steel fibers, proportioned for 8 and 41 MPa (1,100 and 6,000 psi) flexural and compressive strengths, respectively, was used for the anchored and bonded overlay. The overlay was placed to an elevation 0.3 m (1 ft) higher than the original floor from the toe of the dam to a point near the baffles.

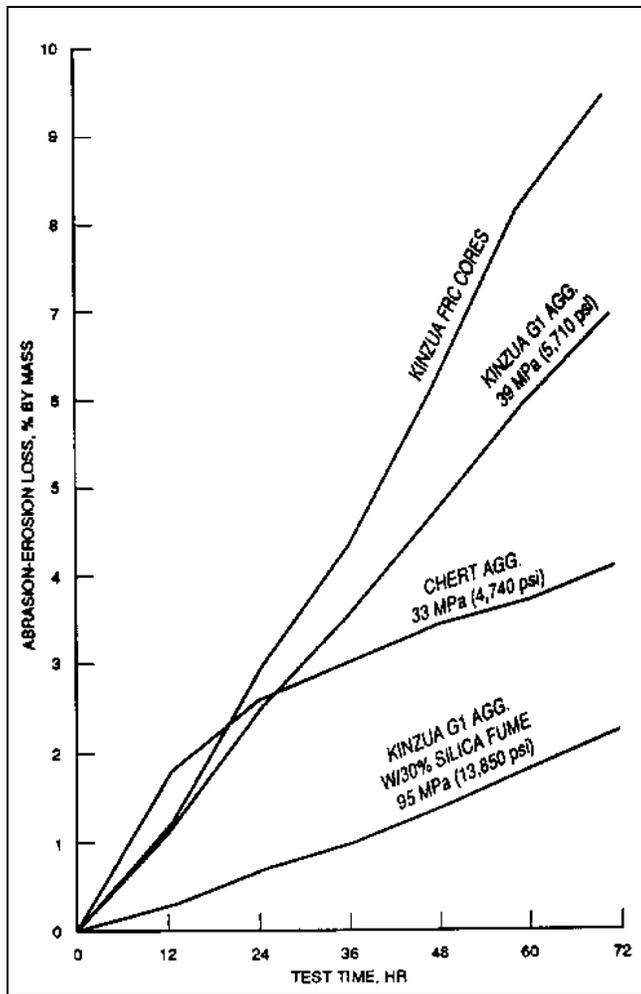
Figure 8-35. Results of selected abrasion-erosion tests, Kinzua Dam

(4) A materials investigation was initiated prior to the second repair to evaluate the abrasion-erosion resistance of potential repair materials (Holland 1983, 1986). Test results indicated that the erosion resistance of conventional concrete containing a locally available limestone aggregate was not acceptable. However, concrete containing this same aggregate with the addition of silica fume and an HRWRA exhibited high-compressive strengths and very good abrasion-erosion resistance (Figure 8-35). The poor performance of fiber-reinforced concrete cores taken from the original overlay correlates well with the poor performance of the material in the actual structure.

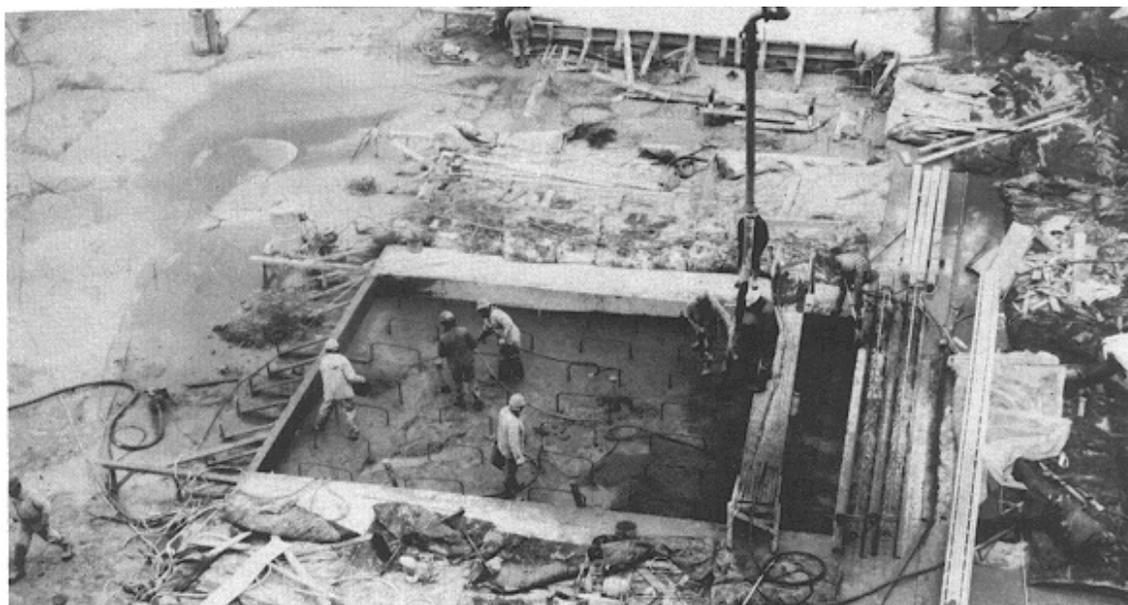
Figure 8-36. Pumping silica-fume concrete into the stilling basin from the top of the right training wall, Kinzua Dam

(9) Following dewatering and a thorough cleanup, the transit-mixed silica-fume concrete was pumped into the basin through approximately 46 m (150 ft) of 127-mm (5-in.) pump line (Figure 8-36). The concrete was consolidated with internal vibrators. Once the majority of the concrete was in the form, the screeding operation was started. The two vibrating screeds were connected in tandem with the second following the first at about a 1.5-m (5-ft) interval. Curing compound was applied immediately after the second screed passed over the concrete.

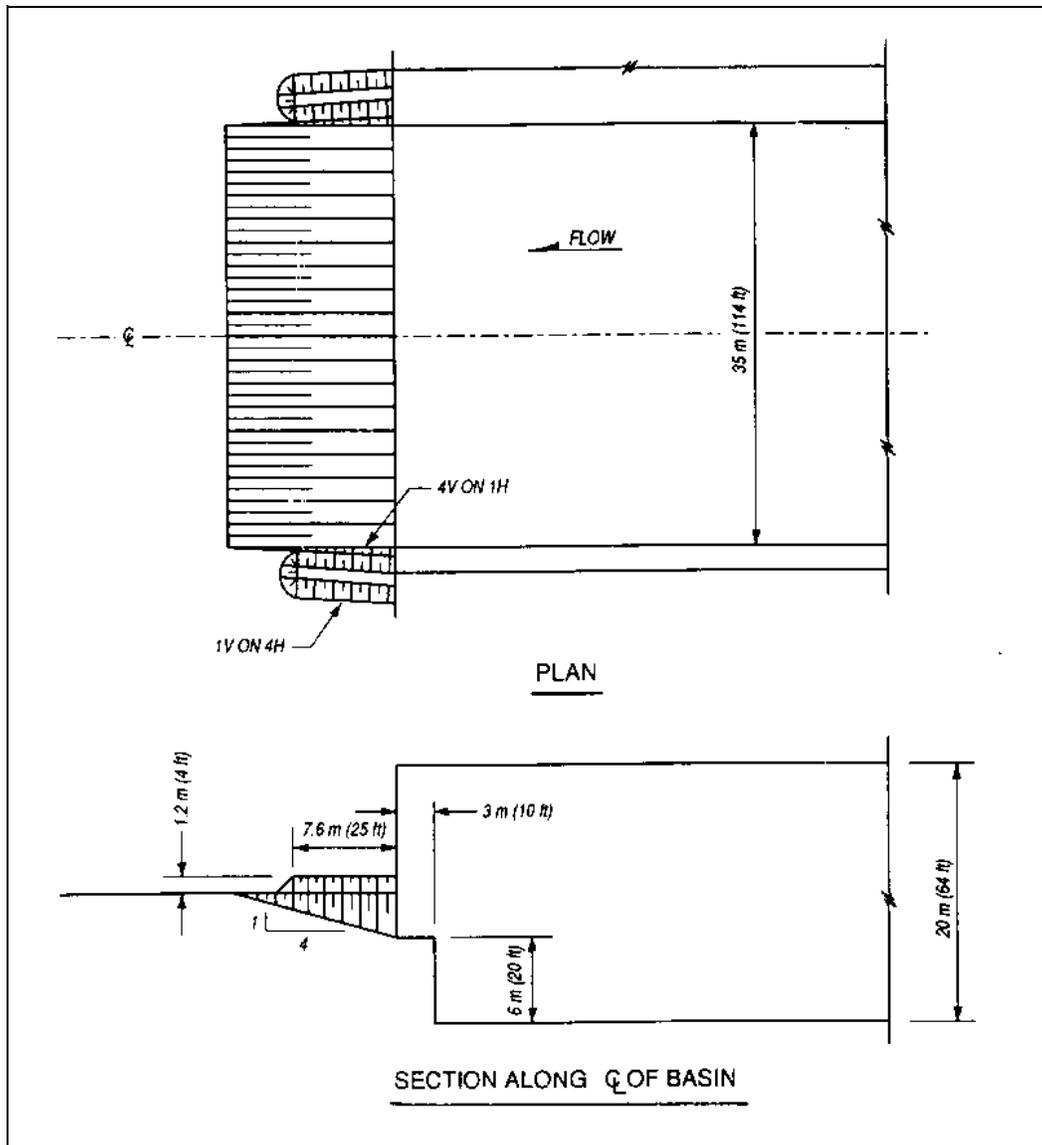
Figure 8-37. Stilling basin wall extension fills, Dworshak Dam

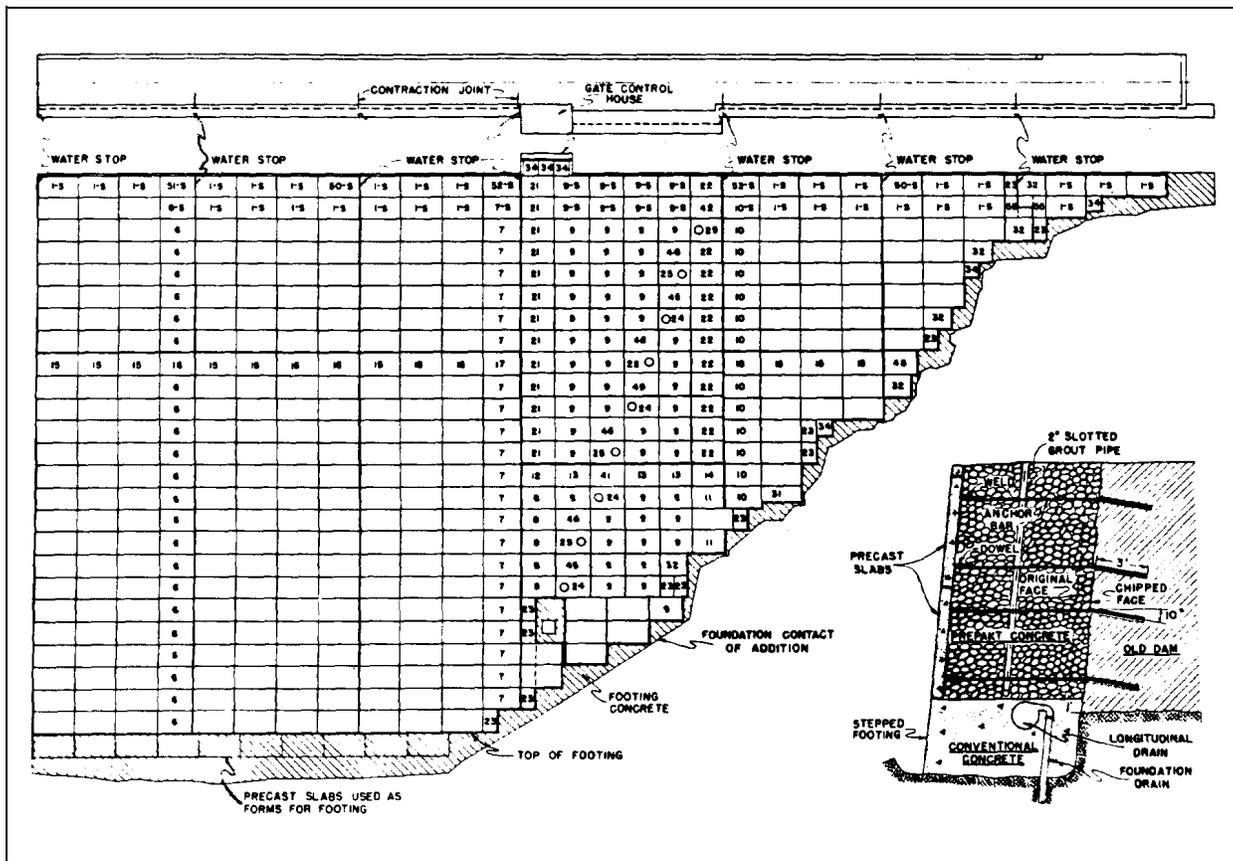
Figure 8-38. Footing and slab layout, south half of Barker Dam (from Davis, Jansen, and Neelands 1948)

upstream face, placing coarse aggregate between the dam face and the precast panels, and then grouting the aggregate (Figure 8-38). Several factors influenced the decision to select this repair method, including: (a) repair had to be completed between the time the reservoir was emptied in the fall and filled in the spring, (b) precast panels and aggregate could be placed in severe winter weather conditions, (c) precasting the panels the summer prior to installation and placing them during the winter reduced the potential for later opening of construction joints, (d) a grout with a low cement content could be used for the preplaced aggregate to minimize temperature rise, providing there was a protective shell of high-quality precast concrete, and (e) precast panels were not as expensive as the heavy wooden forms necessary for the placement of conventional concrete.

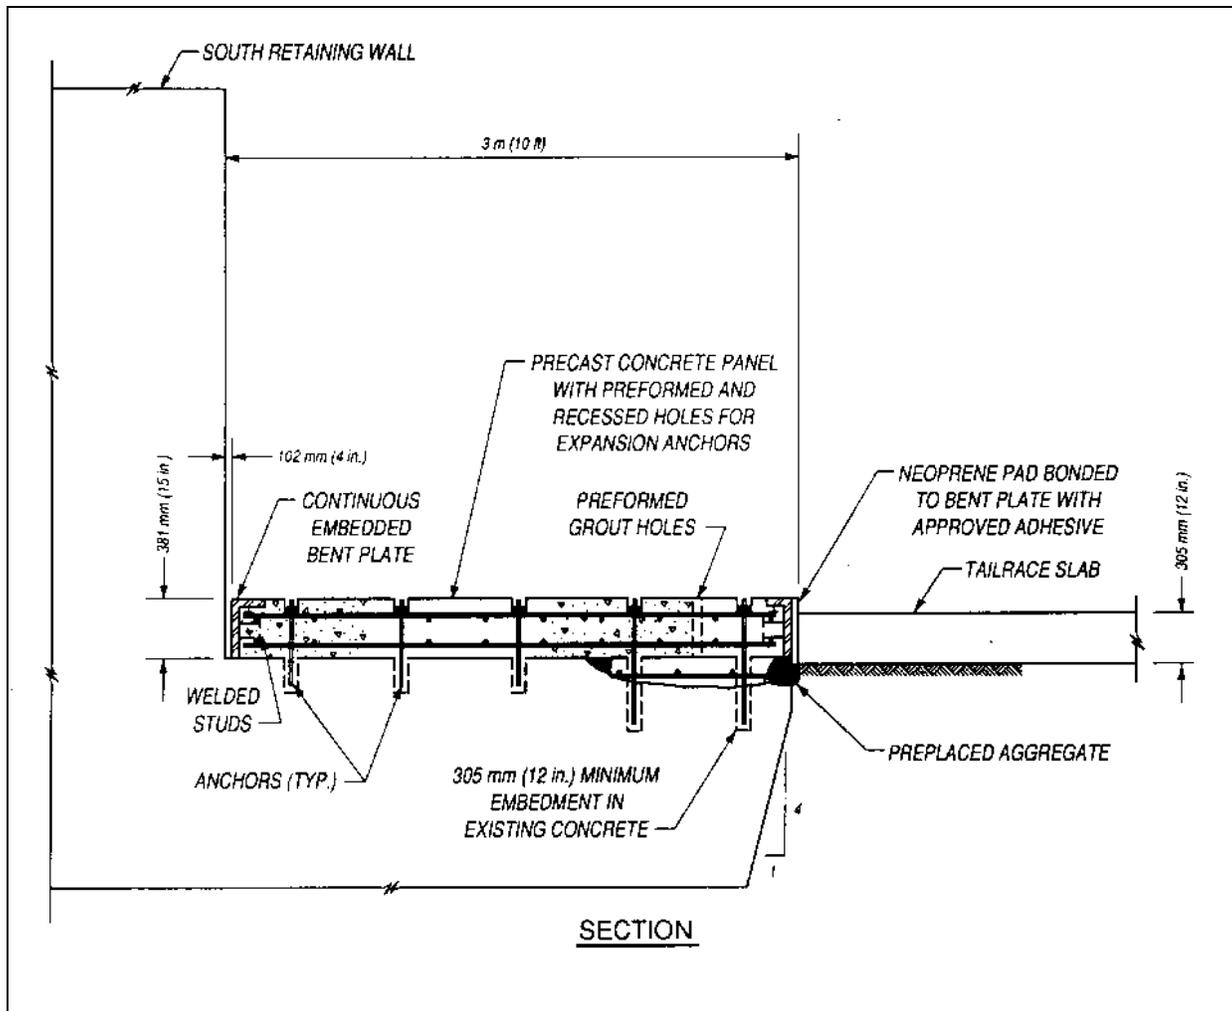
Figure 8-39. Underwater repair of concrete spalling, Gavins Point Dam

(1) After the spalled concrete surfaces were cleaned, the voids were filled with preplaced aggregate, covered by precast concrete panels, and grouted (Figure 8-39). The precast concrete stay-in-place forms were anchored to sound concrete to resist uplift caused by the pressure grouting and to improve stability during power plant operation.

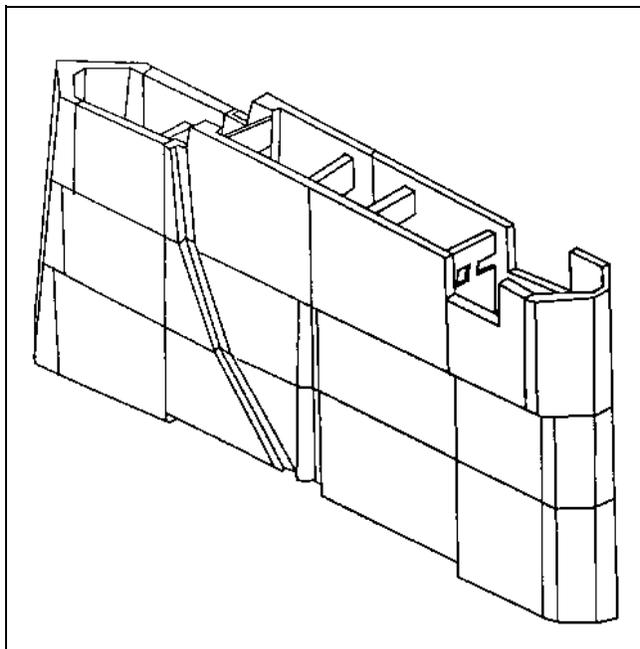
Figure 8-40. Isometric view of gate pier 6, C-1 Dam

1993. In stage I, a cellular cofferdam was constructed to enclose piers 5, 6, and 7. Following dewatering, the counterweights for each tainter gate were removed and placed on temporary supports immediately downstream of the gates. The steel tainter gates were then removed for refurbishing and the existing concrete gate piers were removed down to the original foundation. Precast concrete units were used to reconstruct the gate piers (Figure 8-40).

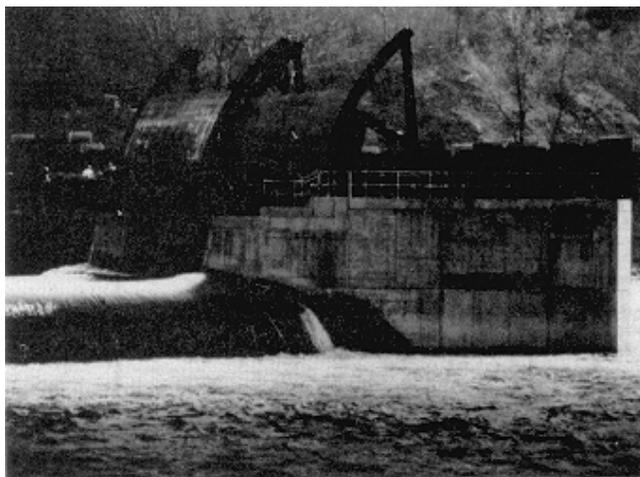
Figure 8-41. Completed precast concrete piers with tainter gates reinstalled, C-1 Dam

(2) The precast pier units were transported via tractor-trailer rigs to a launch ramp near the dam. At this point, the loaded rigs were driven onto a barge for transportation to the construction site in the river. The pier units were offloaded with a crane located on the cofferdam. A second crane inside the cofferdam was used to position the pier units. After each tier of units was properly proportioned and aligned, the vertical and horizontal joints were grouted, reinforcement was installed inside the units, and the units were filled with conventional concrete. Eighteen precast units were used in each gate pier. The completed piers are 2.4 m (8 ft) wide, 18.7 m (61.5 ft) long, and 8.7 m (28.5 ft) high. Following completion of the gate piers, the reconditioned tainter gates were reinstalled (Figure 8-41). A similar procedure is currently being used to reconstruct the four remaining gate piers.

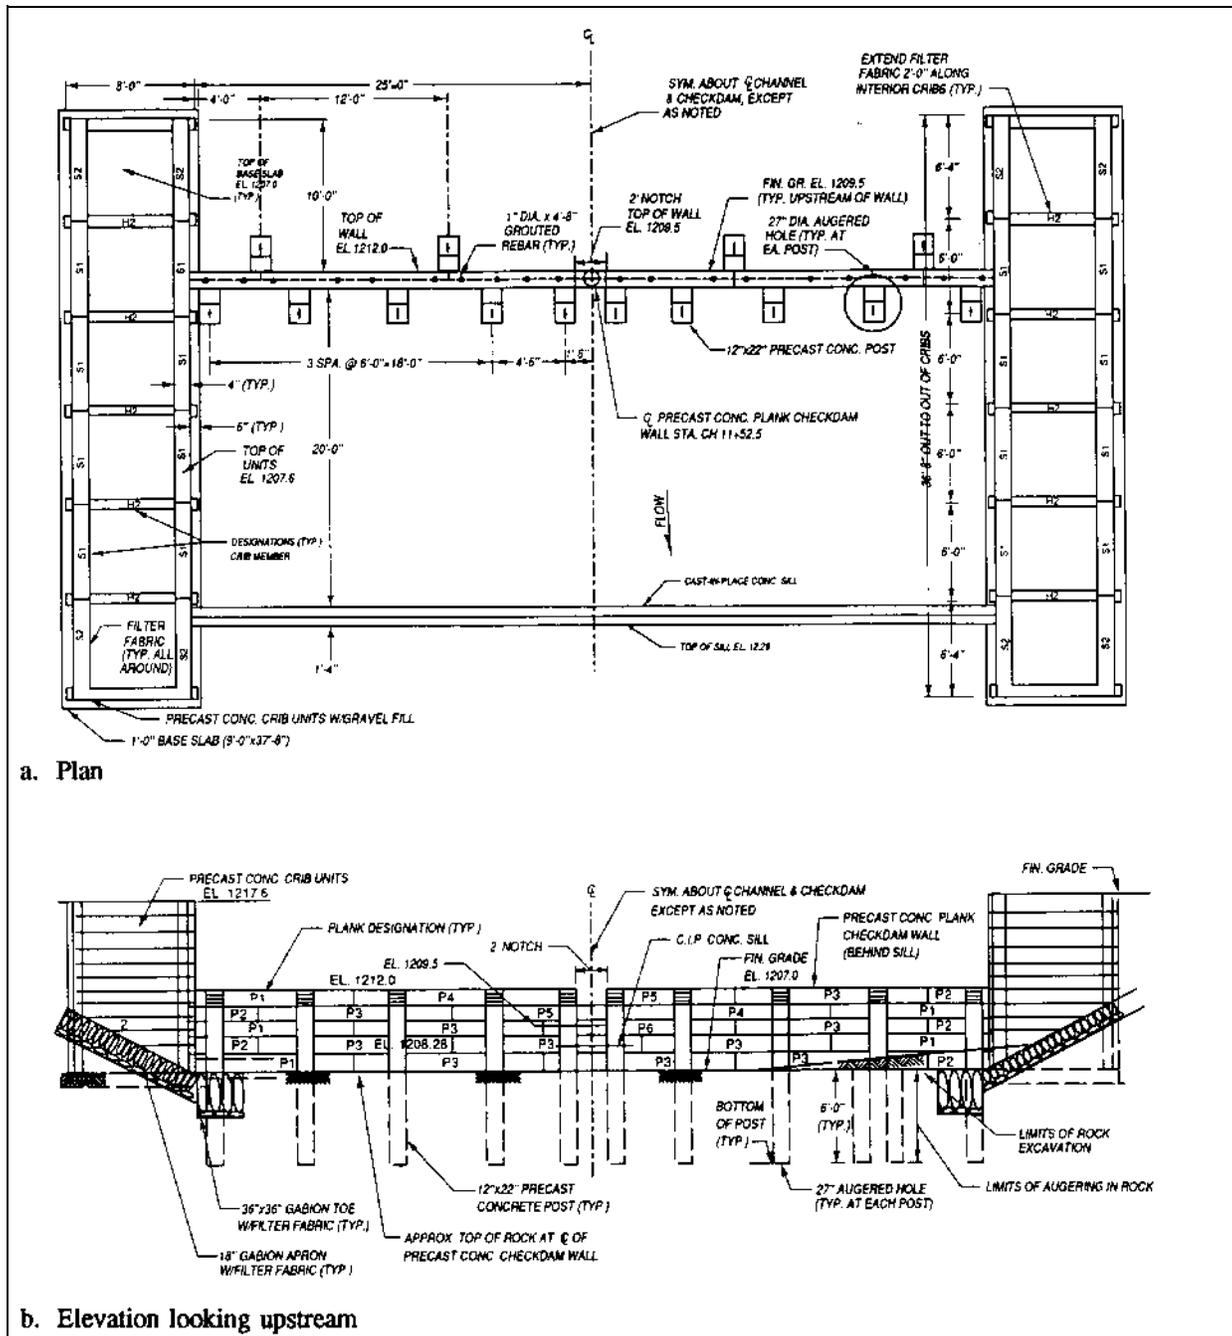
Figure 8-42. Structural plan and elevation, Chauncy Run Checkdam No. 2

d. Chauncy Run Checkdams. As part of the overall rehabilitation of the Hornell Local Flood Protection Project, two checkdams were constructed on Chauncy Run. The original plan was to use cast-in-place concrete gravity dams with fully paved stilling basins. However, cost estimates in the 30-percent design submission indicated the use of precast concrete could decrease the cost of the dams by 50 percent. In addition, precasting under controlled plant conditions would assure high quality materials. Precast concrete crib units were used to form the abutments which were then filled with gravel. The checkdams are specially designed precast concrete planks supported by precast concrete posts embedded in the rock

foundation (Figure 8-42). The use of precast concrete made it easy to maintain flows during construction, and the appearance of the new structures is well-suited to the site (Figure 8-43).

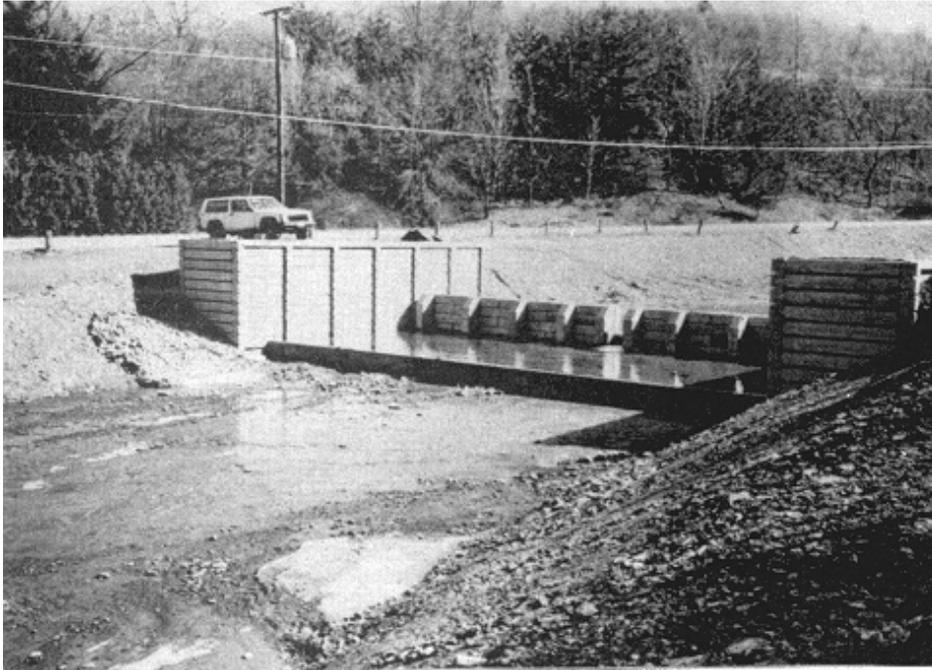
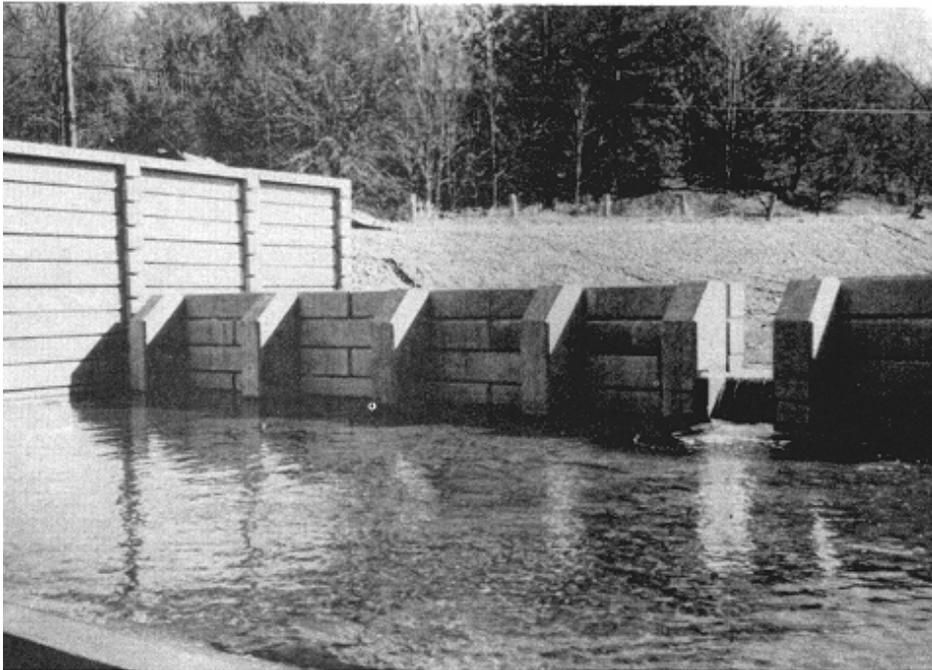
Figure 8-43. Precast concrete checkdams, Chauncy Run

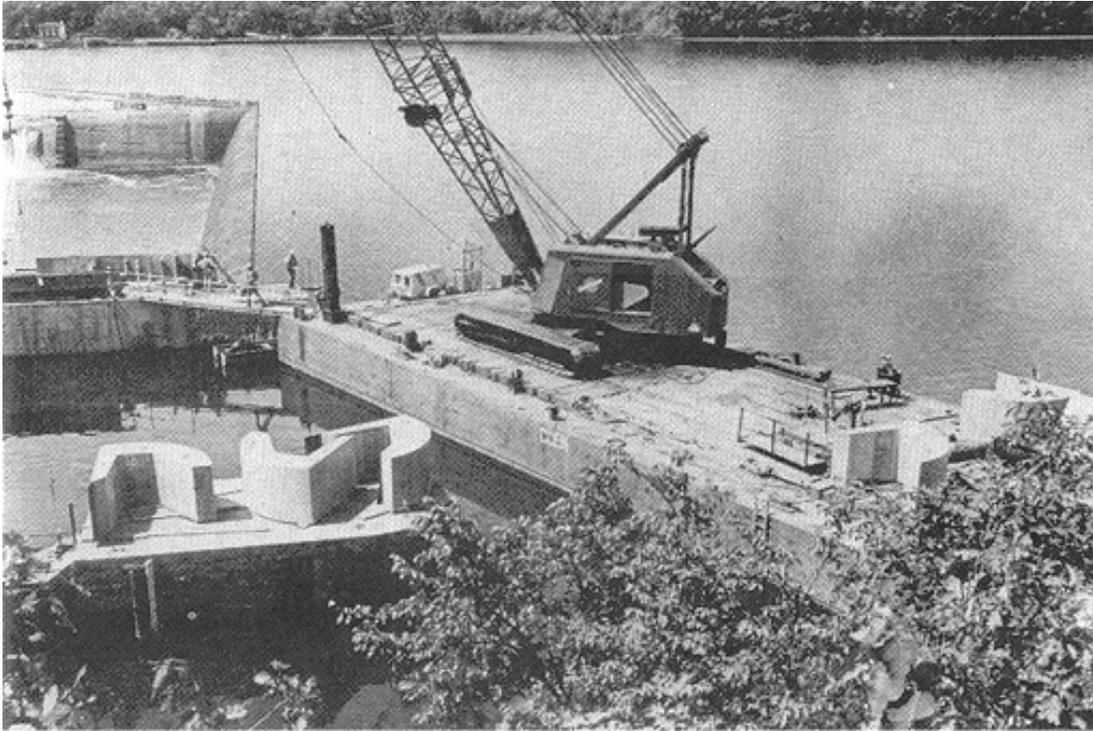
Figure 8-44. Precast pier nose sections ready for underwater installation, Vischer Ferry Dam (Summer 1993)

(1) The original design for the pier nose was based on cast-in-place concrete inside a dewatered cofferdam. However, the bid cost for the cofferdam alone was \$250,000, so the project team reviewed alternatives and decided to use six precast concrete sections stacked vertically with tremie concrete infill. Placement of the precast nose sections (Figure 8-44) and the tremie concrete required approximately 7 working days. The first section was positioned and leveled with jackposts, and sandbags were placed around the perimeter of this segment. Infill concrete was tremied to the top of this section and cured for 4 days. During this time, divers installed guide angles

and reinforcing dowels into the existing pier and spud pipes into the first section. Then, precast sections 2 through 6 were installed, and temporary intermediate connections were installed to resist plastic concrete loads during the second tremie concrete placement. Tremie concrete was placed to within 152 mm (6 in.) of the surface at a placement rate that did not exceed 3 m (10 ft) per hr. A cast-in-place concrete cap slab was then formed and placed.

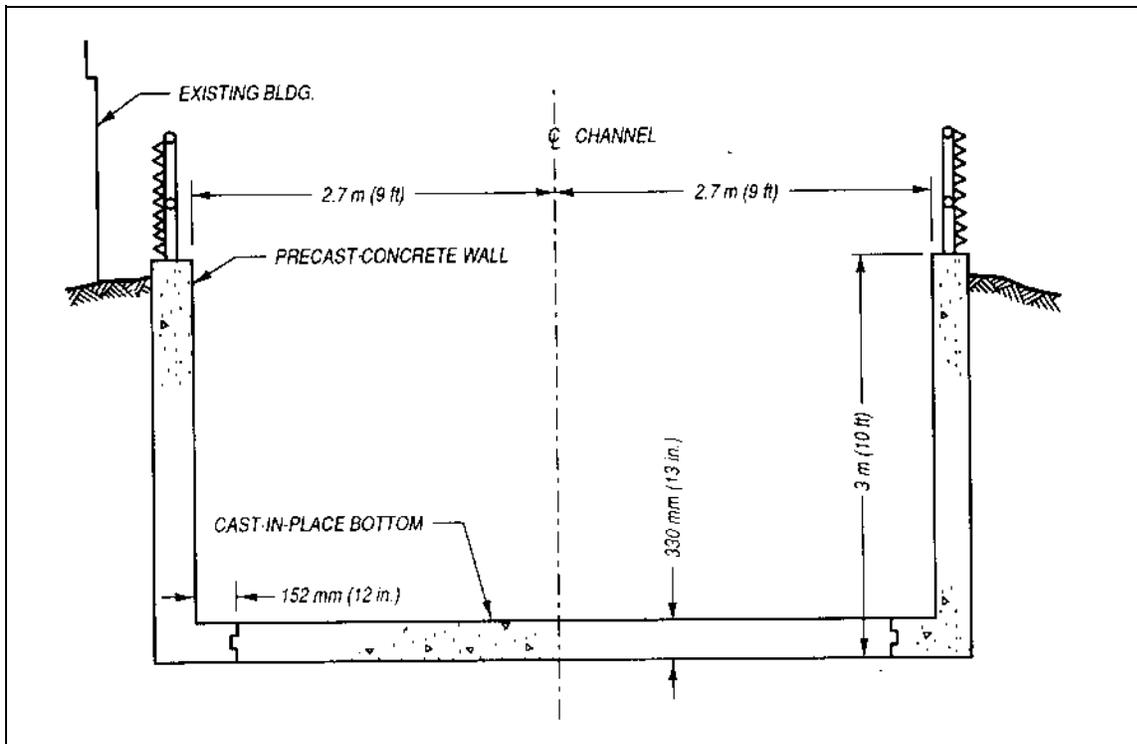
Figure 8-45. Typical channel repair section, Placer Creek (after Hacker 1986)

(1) The contractor elected to use a cast-in-place concrete bottom with precast concrete walls to rehabilitate a 1,128-m (3,700-ft)-long section of the channel (Figure 8-45). Approximately 600 reinforced-concrete panels were precast in a local casting yard. Each panel was 4.6 m (15 ft) long and 3 m (10 ft) high. A 305-mm (12-in.) stub at the bottom of each panel provided continuity of the reinforcement through the corner joint.

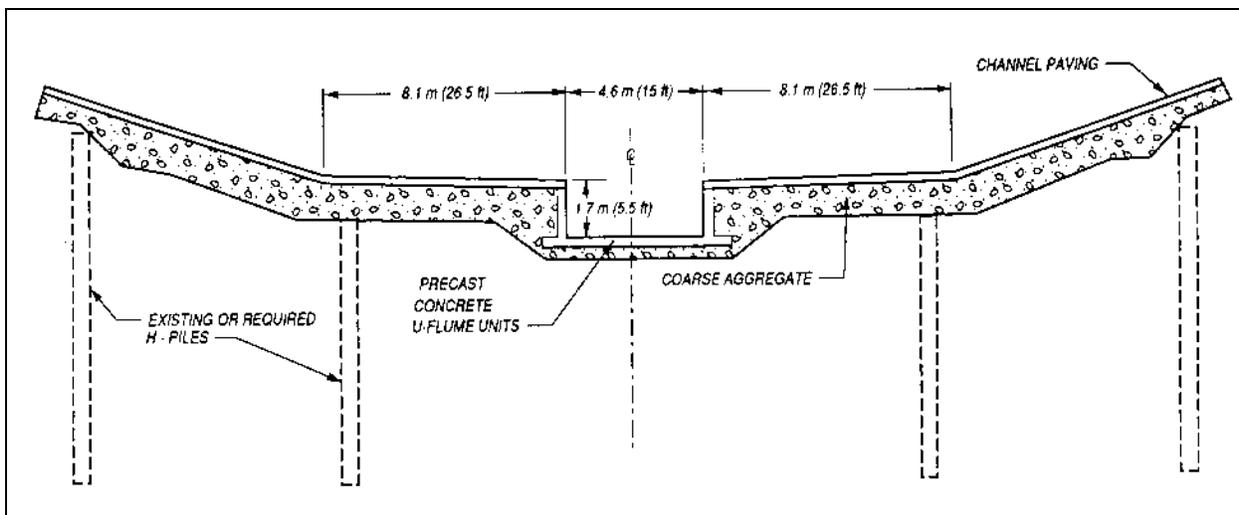
Figure 8-46. Cross section of precast low-flow channel, Blue River Channel (after Mitscher 1992)

g. Blue River Channel Project. The Blue River channel modification project was designed to provide flood protection to the Blue River Basin in the vicinity of Kansas City, MO. In an industrial reach of the river, the project consisted of extensive modification of the channel cross section, construction of a floodwall, paving of side slopes, and construction of a 4.6-m (15-ft)-wide by 1.7-m (5.5-ft)-deep low-flow channel for approximately 1.1 km (3,500 ft) of the river. The original design for the low-flow channel consisted of a pair of sheet-pile walls with a cast-in-place concrete strut between the walls. However, there was some concern about this method of construction because of steel smelting slag and other debris embedded in the existing channel. Driving sheet piles through this material could be very expensive or even impossible. Therefore, an alternate design for a precast concrete U-flume was prepared (Figure 8-46).

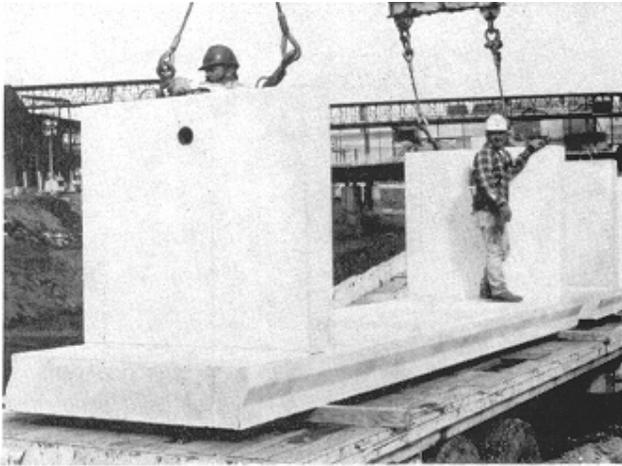
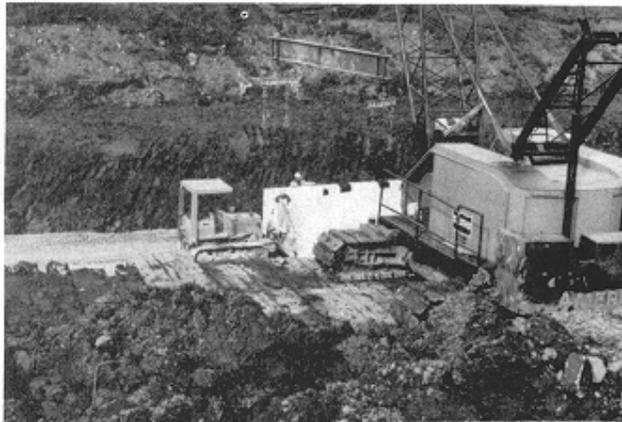
Figure 8-47. Channel section delivery and installation, Blue River Channel

(5) The precast sections were shipped, two at a time, by truck to the construction site as required where they were offloaded with a crane and positioned in the channel on a crushed rock subfoundation (Figure 8-47). A total of 700 precast sections were installed with daily placement rates ranging from 12 to 46 sections. The major advantages of precast concrete in this application included low cost, rapid construction, and ease of construction. Also, the use of precast concrete allowed the contractor to divert river water into the channel sections immediately following installation (Figure 8-48). Construction of the low-flow channel was completed in February 1992.

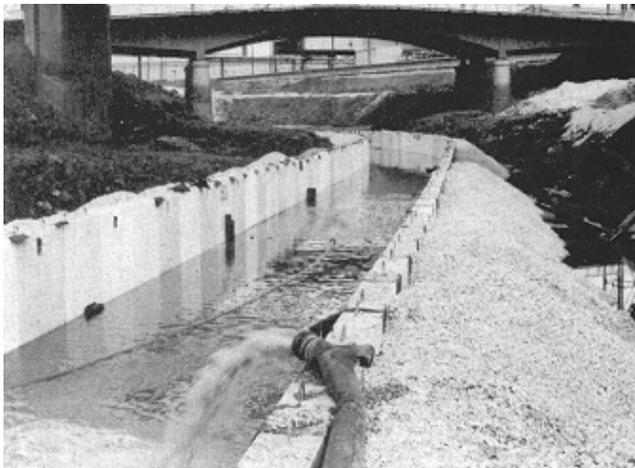
Figure 8-48. Diversion of river water through channel sections, Blue River Channel

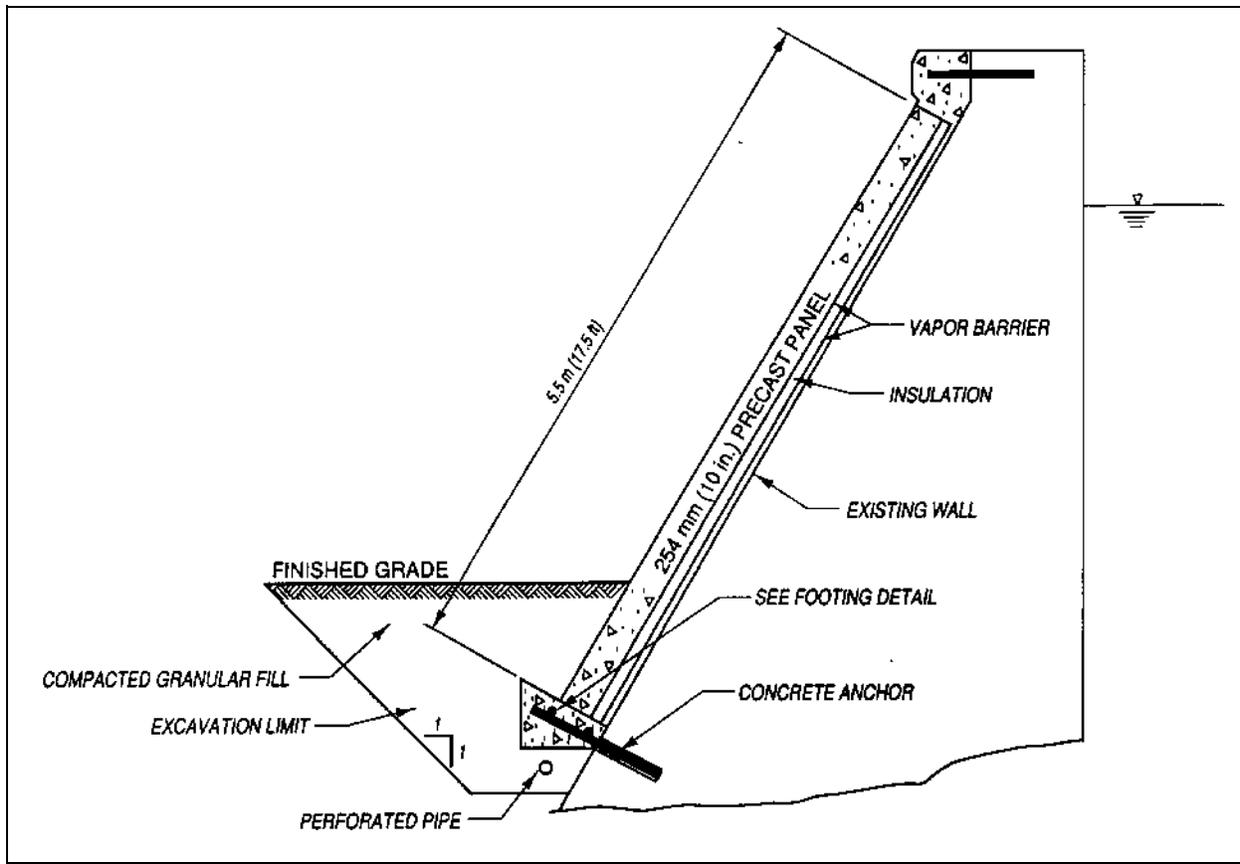
Figure 8-49. Typical repair section, Joliet Channel Wall

reduce the potential for additional freeze-thaw deterioration. Earth backfill, the most economical method of providing insulation, was not feasible in all reaches because of buildings near the wall and other right-of-way restrictions. Consequently, a precast concrete panel system that included insulation and drainage provisions was selected for the repair (Figure 8-49).

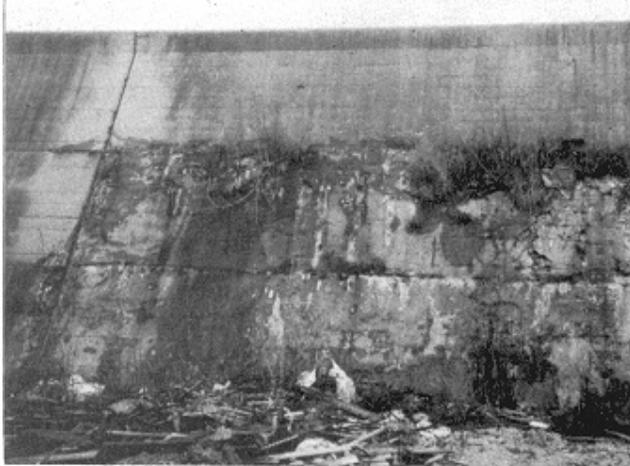
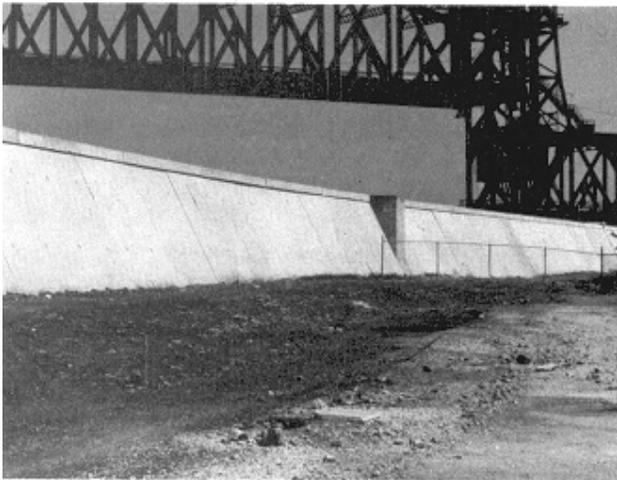
Figure 8-50. Joliet Channel Wall before and after repair

(5) The total length of the precast concrete repair was 349 m (1,145 ft). The contractor's bid price for the wall repair including drainage system, concrete footing, anchors, insulation, vapor barriers, and concrete cap was \$207 per sq m (\$19 per sq ft). The economical, aesthetically pleasing repair (Figure 8-50) was completed in August 1987 and the repair continues to perform satisfactorily.

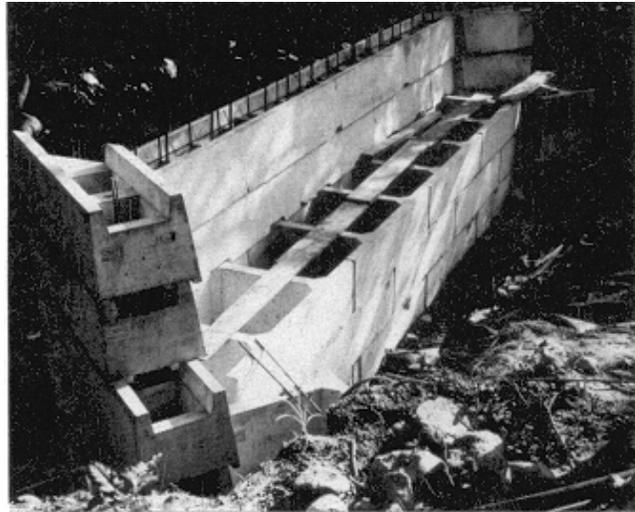
Figure 8-51. Top view of precast abutment prior to backfilling, Ulsterville Bridge

(1) Precast modules of reinforced concrete stacked on a base slab were used to construct the abutments (Figure 8-51). The modular units were precast in “startup” wood molds, which resulted in some minor fitting problems in the field; however, adjustments were made without the construction being interrupted. Once the modules were properly positioned and aligned, the back cavities in the units were filled with select granular backfill. Vertical reinforcing steel was inserted into the front cavities and these cavities were filled with cast-in-place concrete to form a sealed, monolithic-like front wall (Figure 8-52).

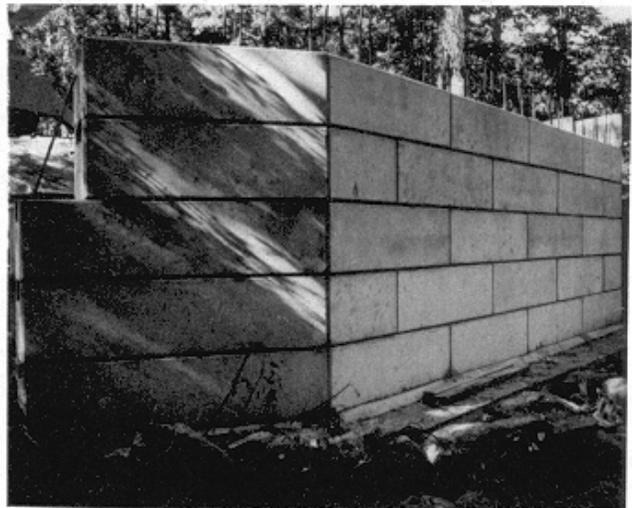
Figure 8-52. Front view of precast abutment prior to placing concrete cap, Ulsterville Bridge

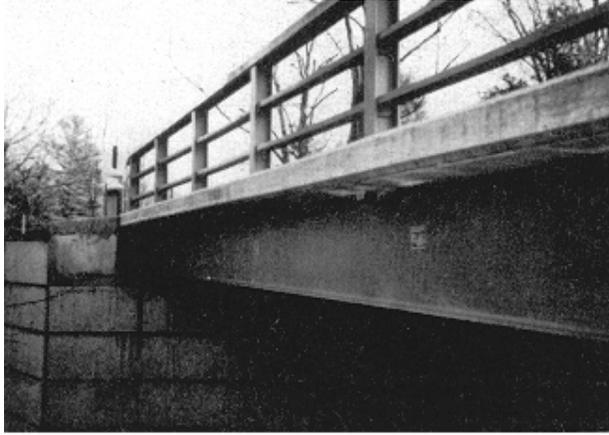
Figure 8-53. Precast abutment and deck units, Ulsterville Bridge

Another result of the upside down casting is that the densest, least permeable concrete is on the wearing surface. When the cured deck units are turned over, the concrete is precompressed which increases its resistance to cracking. The deck units were placed with a crane; steel diaphragms were installed between the units, and then all longitudinal joints were sealed with grout. The bridge was ready for traffic as soon as construction was complete (Figure 8-53).
