Evaluation and Repair of Concrete Structures Part III

Chapters 7 through 9

CECW-EG Engineer Manual 1110-2-2002	Department of the Army U.S. Army Corps of Engineers Washington, DC 20314-1000	EM 1110-2-2002 30 June 1995
	Engineering and Design EVALUATION AND REPAIR OF CONCRETE STRUCTURES	
	Distribution Restriction Statement Approved for public release; distribution is unlimited.

Engineering and Design
EVALUATION AND REPAIR OF CONCRETE STRUCTURES

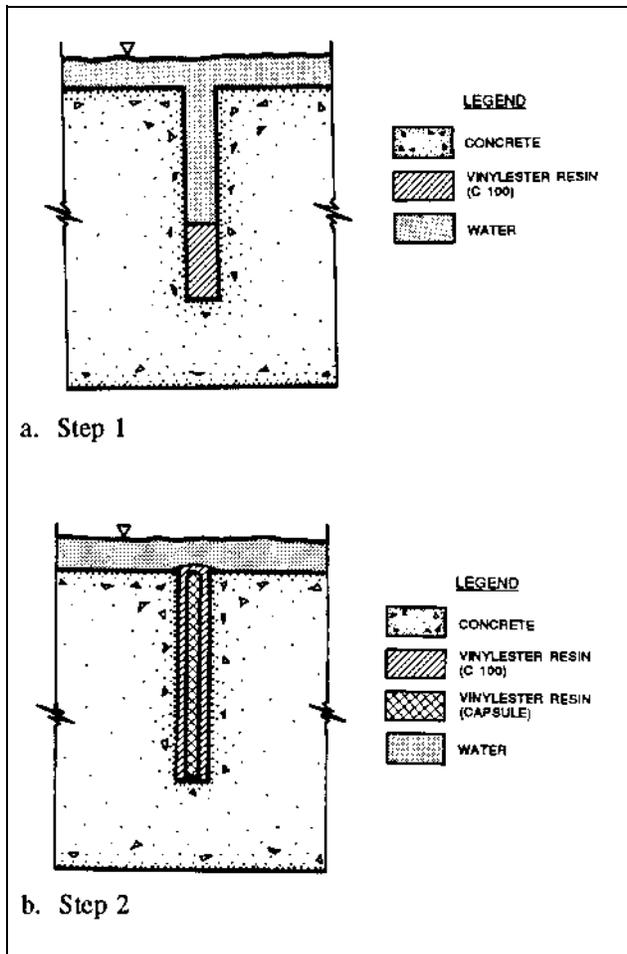
Figure 8-56. Two-step procedure for anchor installation under submerged conditions

(a) In the revised installation procedure (Figure 8-56), a small volume of adhesive was injected into the bottom of the drill hole in bulk form prior to insertion of the adhesive capsule. This injection was easily accomplished with recently developed paired plastic cartridges (Figure 8-57) which contained the vinyl-ester resin and a hardener. The cartridges were inserted into a tool similar to a caulking gun which automatically dispensed the proper material proportions through a static mixing tube directly into the drill hole. Once the injection was completed, insertion of a prepackaged vinyl-ester-resin capsule displaced the remainder of the water in the drill hole prior to anchor insertion and spinning.

(8) Pending completion of current tests, the two-step anchor installation procedure (Figure 8-56) should be followed when prepackaged vinyl ester resin is to be used as an embedment material for short (less than 381-mm (15-in.) embedment length) steel anchors in hardened

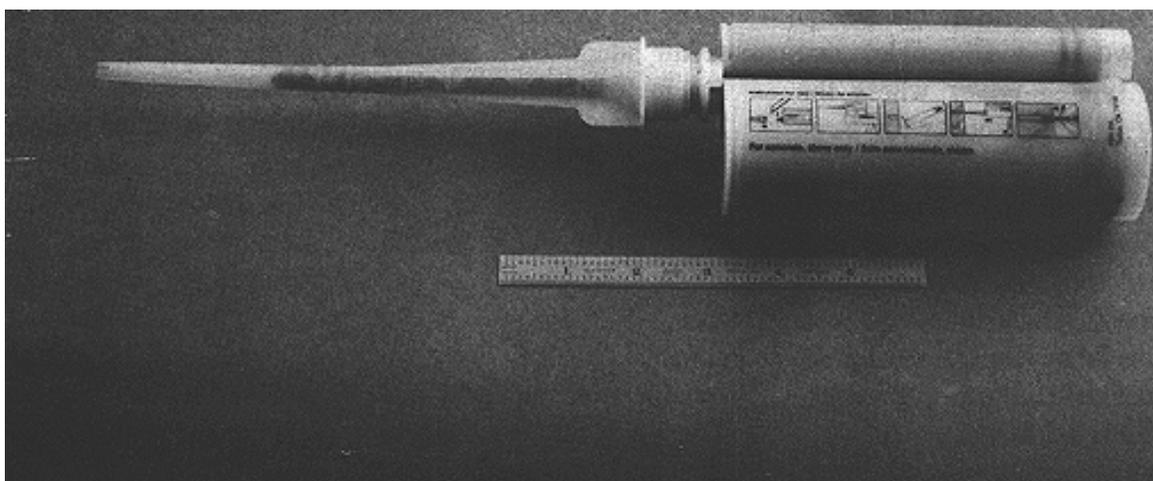
Figure 8-57. Paired disposable cartridges and static mixing tube

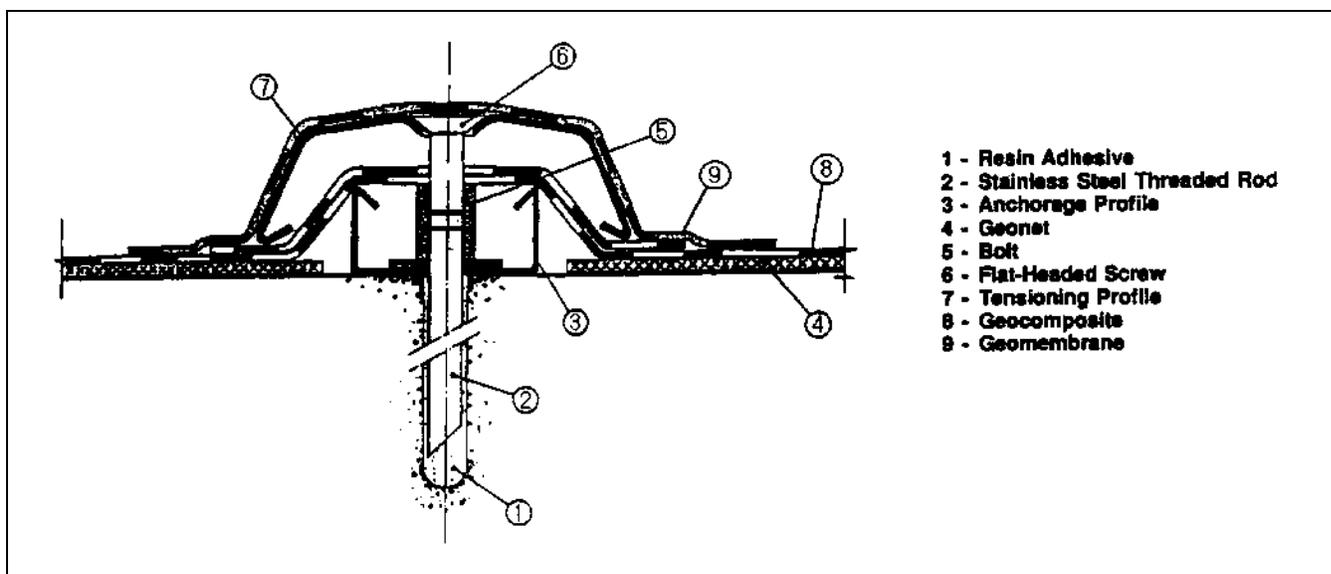
Figure 8-58. Detail of vertical anchorage and drainage profile

(1) Profiles are not installed near vertical monolith joints to allow the elastic geocomposite to accommodate longitudinal joint movements. The vertical anchorage and tensioning profiles are fabricated in 1.4-m (4.6-ft) lengths with slots for the threaded rods to allow relative vertical displacements between adjacent monoliths.

(2) Any water which might collect behind the geocomposite is conveyed, at atmospheric pressure, along the profiles to the heel of the dam where it can be collected in drainage pipes. A high-density polyethylene geonet, 4 mm (0.016 in.) thick with a diamond-shaped mesh, can be installed behind the geocomposite to increase the drainage capacity of the system. The perimeter of the membrane system is sealed against the concrete face with

(b) Approximately 8,000 sq m (9,600 sq yd) of geocomposite were installed with steel profiles shown in Figures 8-58 and 8-59. Vertical joints between rolls of the geocomposite and geomembrane strips covering the profiles (Figure 8-62) were welded to provide a continuous water barrier on the upstream face of the dam. A hot-air jet was used to melt the plastic, and the two surfaces were then welded together by hand pressure on a small roller.

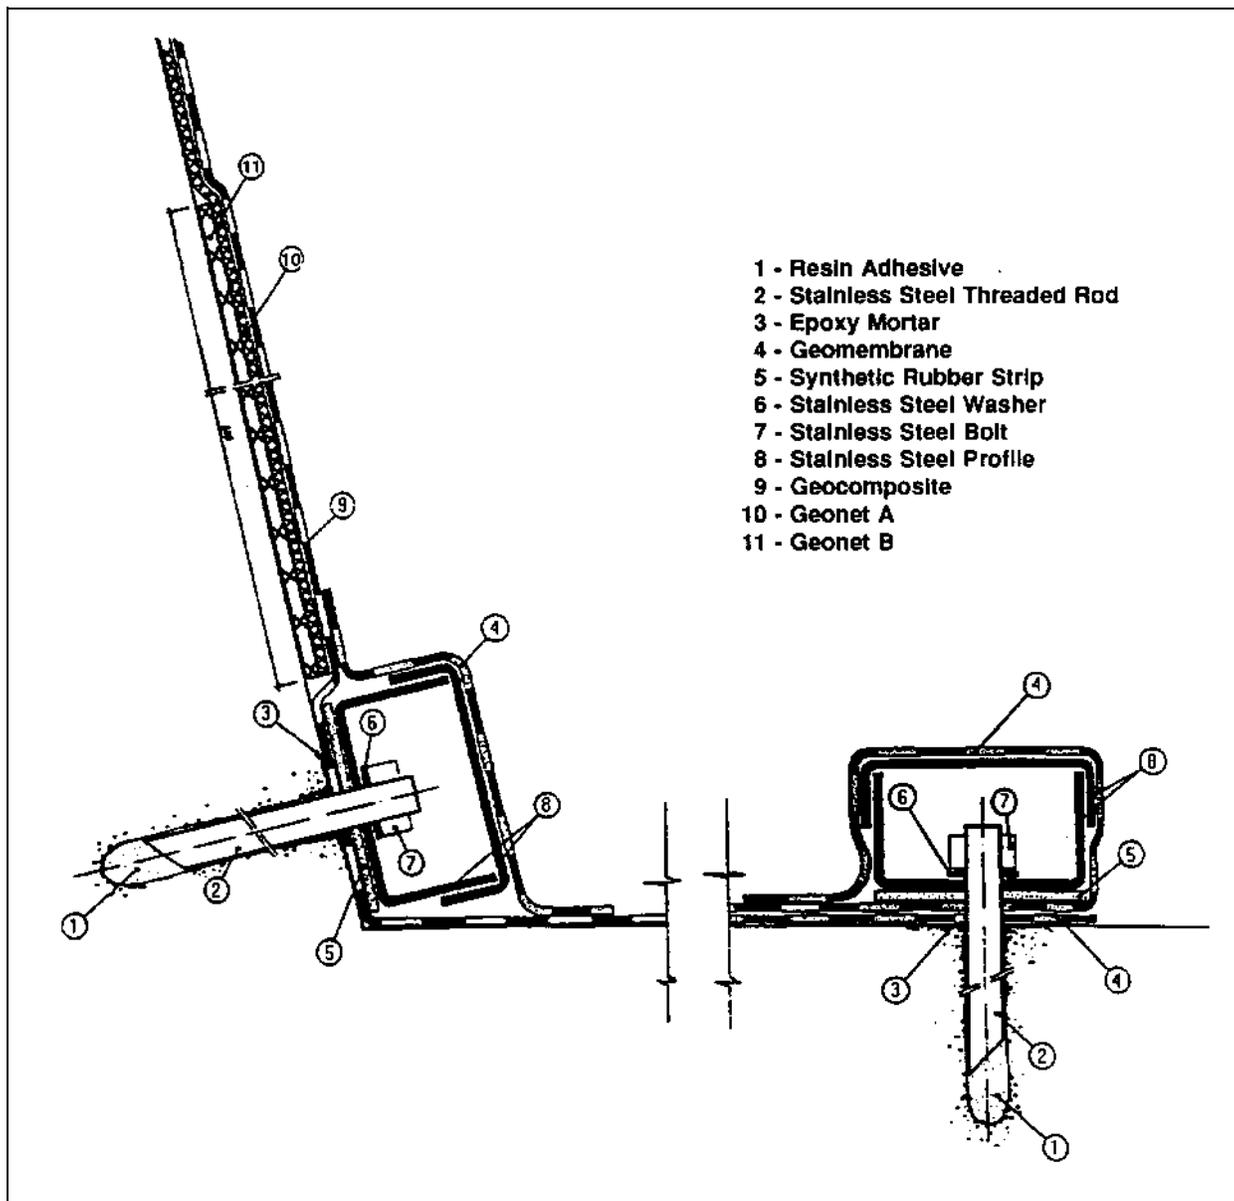
Figure 8-59. Detail of sealing profiles

stainless steel profiles to prevent intrusion of reservoir water. A flat profile is used for the horizontal seal at the crest of the dam and C-shaped profiles (Figure 8-59) are used along the heel of the dam and the abutments.

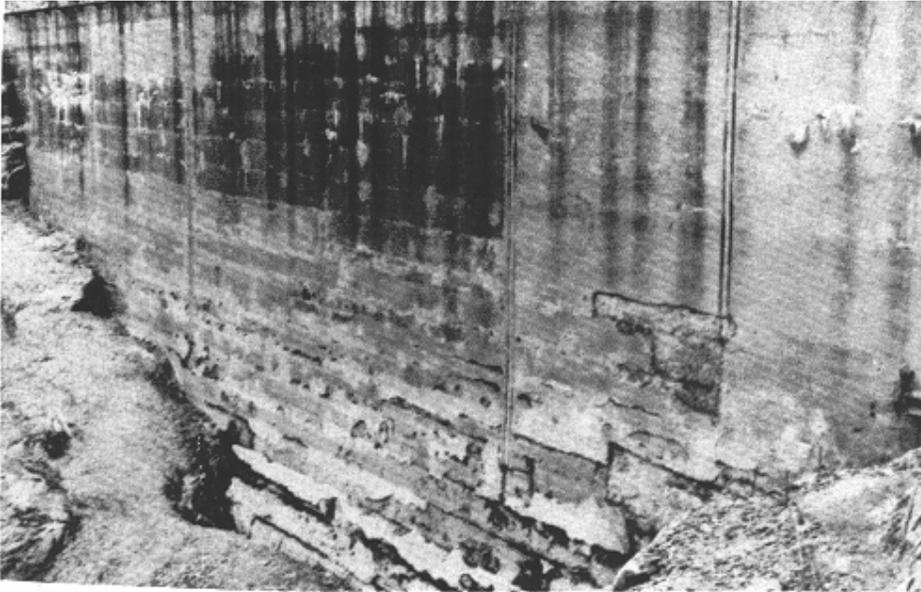
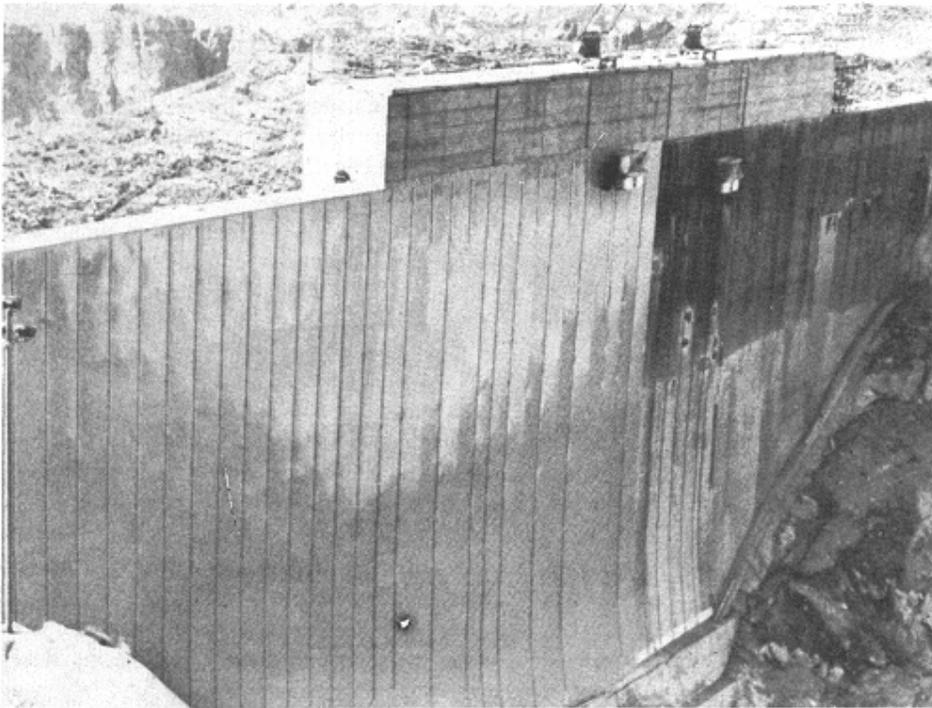
Figure 8-60. Upstream face of Lake Nero Dam

(a) In 1980, a geocomposite was installed on the upstream face of the dam and anchored with steel profiles (Monari 1984). Self-hoisting platforms secured to the dam's crest were used in the installation (Figure 8-60) which required 90 days to complete. The geocomposite was unrolled from the top of the dam down to the base. Adjacent sheets were overlapped and the vertical joints were welded prior to horizontal prestressing. The lower ends of the sheets were anchored to the base of the dam with metal plates.

a. Prior to rehabilitation

b. During rehabilitation

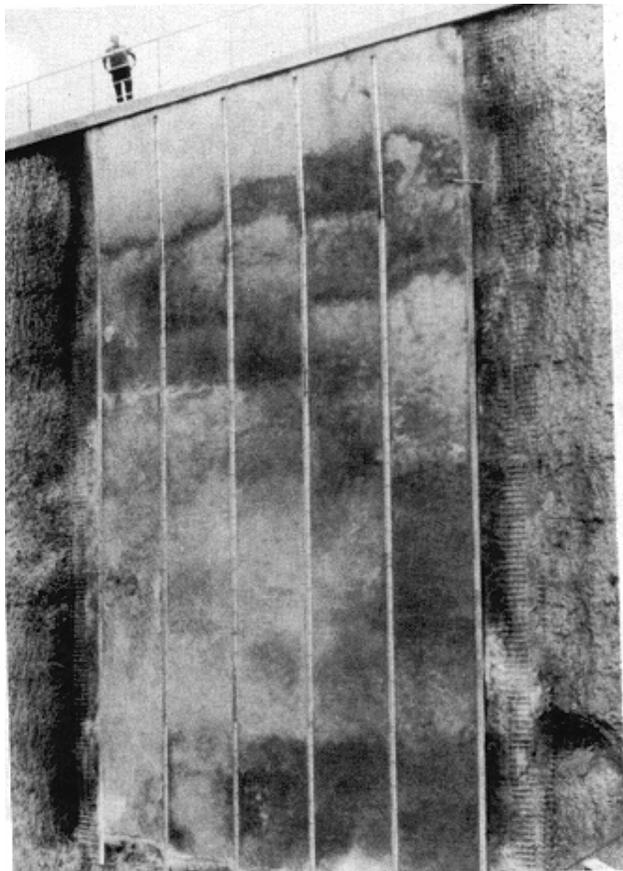
Figure 8-61. Steel profiles embedded in shotcrete, Cignana Dam

used to rehabilitate the dam in 1987. The repair was similar to that of Lake Nero Dam except that the vertical steel profiles were embedded in a layer of reinforced shotcrete used to resurface the upstream face of the dam. After removal of deteriorated concrete, a layer of shotcrete was applied, vertical profiles were installed, and the surface between adjacent profiles was made level by filling with a second layer of shotcrete (Figure 8-61).

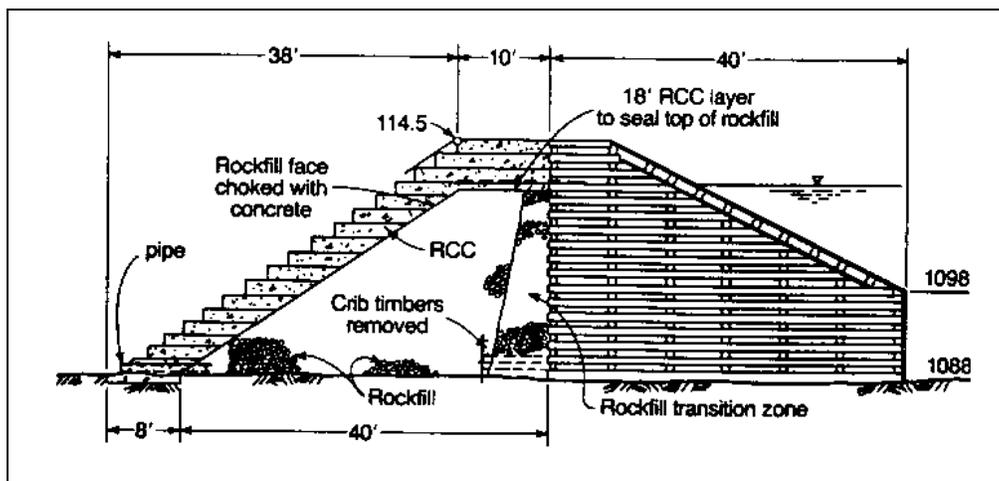
Figure 8-63. Section through modified dam, Ocoee Dam No. 2 (Hansen 1989)

a. Ocoee No. 2 Dam. This 9.1-m (30-ft)-high, rock-filled timber crib dam was completed in 1913, near Benton, TN. A riprap berm was placed on the downstream side of the dam in 1980 to improve the stability of the dam. However, flash floods during reconstruction resulted in four washouts of the rock and forced the agency to adopt another method for rehabilitation. The new solution was the first application of RCC to provide increased erosion resistance during overtopping (Hansen 1989). Approximately 3,440 cu m (4,500 cu yd) of RCC was placed in stairs on the downstream face of the dam (Figure 8-63). The dam has been subjected to periodic overtopping and, where the RCC was well compacted, it remains undamaged by water flow and weathering (Figure 8-64).

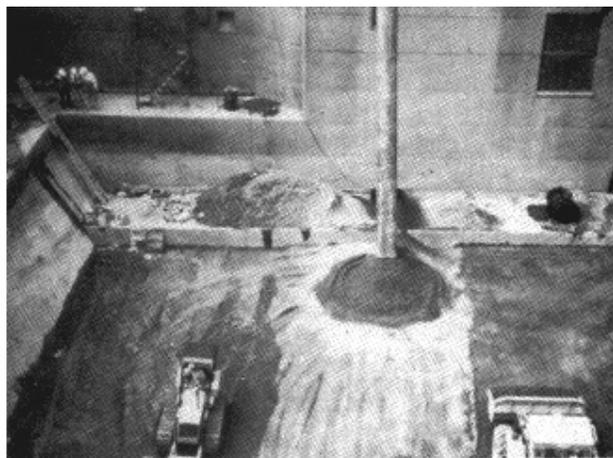
Figure 8-65. RCC placement, New Cumberland Lock (Anderson 1984)

b. New Cumberland Lock. RCC was used to pave the floor of the lock chamber between the upstream emergency bulkhead gate sill and the upstream miter gate sill (Anderson 1984). A drop pipe was used to transfer the RCC from the top of the lockwall to the floor where it was moved by a front end loader, leveled with a dozer, and compacted with a vibratory roller (Figure 8-65). The RCC was placed in 0.3-m (1-ft) layers to a maximum thickness of 1.5 m (5 ft). The nominal maximum size aggregate (NMSA) was 25.4 mm (1 in.), and the cement

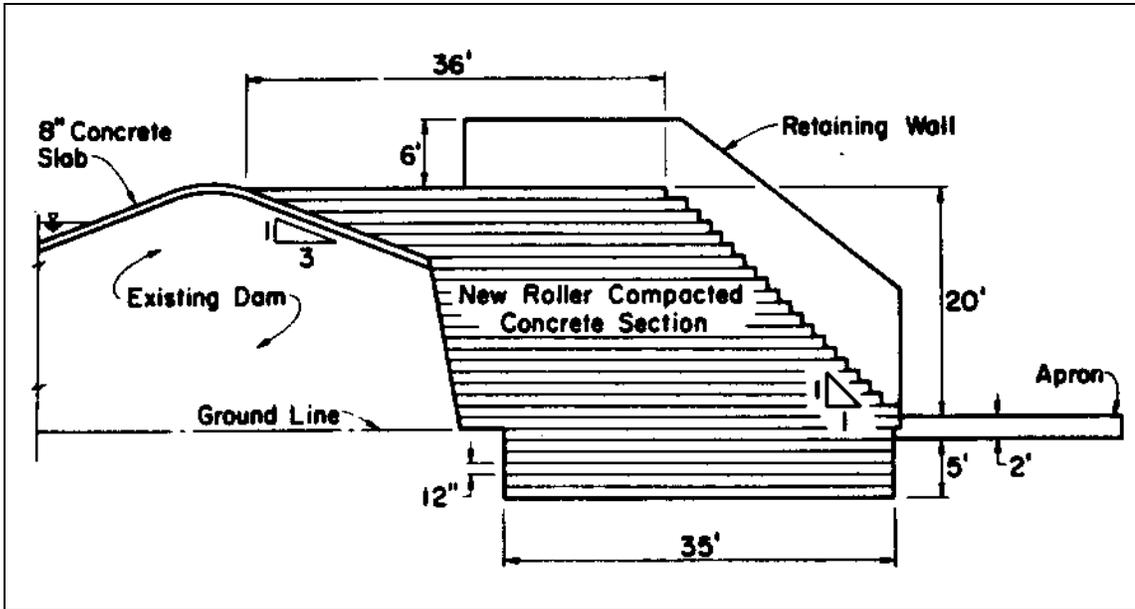
Figure 8-66. RCC gravity section, Kerrville Ponding Dam (Hansen and France 1986)

(1) After several repair alternatives were evaluated, the fastest and most practical solution was to construct an RCC section immediately downstream of the dam (Figure 8-66). The downstream portion of the embankment was removed; the undamaged upstream portion acted as a cofferdam during construction of the RCC section. An 89-mm (3.5-in.) maximum size pit-run aggregate with 10 percent cement by dry weight was used at the base of the dam and in the last five 0.3-m (1-ft)-thick lifts. Cement content was reduced to 5 percent for the middle of the gravity section. The average compressive strength of the richer RCC mixture was 14.5 MPa (2,100 psi) at 28 days. Placement of the 17,140 cu m (22,420 cu yd) of RCC began in late June 1985 and was completed in about 3 months.

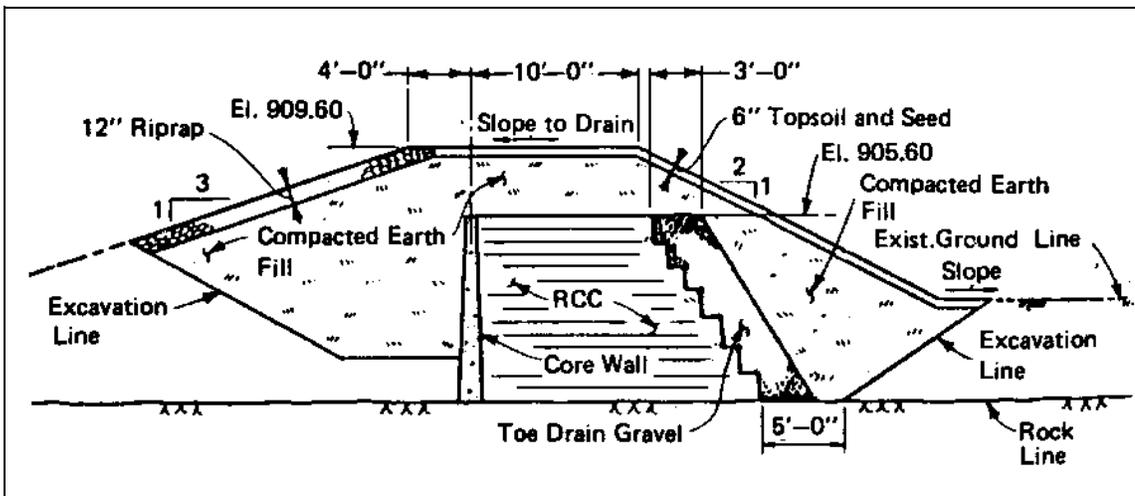
Figure 8-67. RCC spillway section, Boney Falls Dam (Marold 1992)

(1) In 1986, it was determined that the original spillways were not adequate to pass the Probable Maximum Flood (PMF) under present-day dam safety criteria. After studying several alternatives, it was concluded that RCC overtopping protection for 305 m (1,000 ft) of the left embankment would be the least costly plan for increasing spillway capacity (Marold 1992). This plan was eventually modified so that an RCC gravity section would be placed immediately behind an existing concrete core wall in the embankment. This modification reduced the length of the RCC spillway section to 152 m (500 ft). The shorter length required the crest of the RCC gravity section to be lower to pass the same flow as the longer paved section. Therefore, the crest of the new RCC gravity section was set at 0.3 m (1 ft) below normal pool and a 1.2-m (4-ft)-thick fuse plug of erodible earthfill was placed on top of the RCC (Figure 8-67).

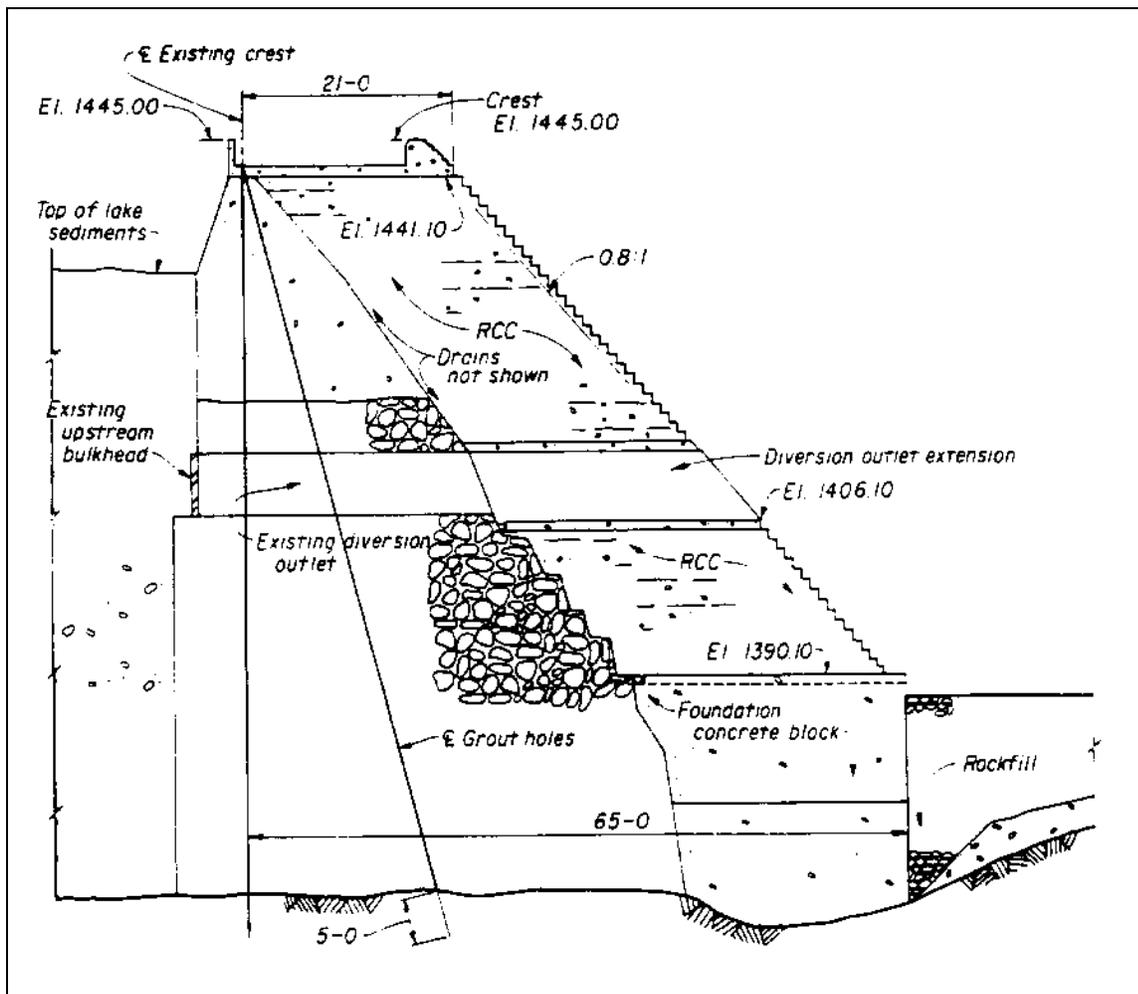
Figure 8-68. Cross section of modifications for Camp Dyer Diversion Dam (Hepler 1992)

downstream slope of 8H:1V. However, in the final design, the width was increased to 6.1 m (20 ft) to accommodate two lanes of construction traffic on the RCC lifts. The RCC buttresses were capped with a conventional reinforced-concrete apron and ogee overflow crest (Figure 8-68).

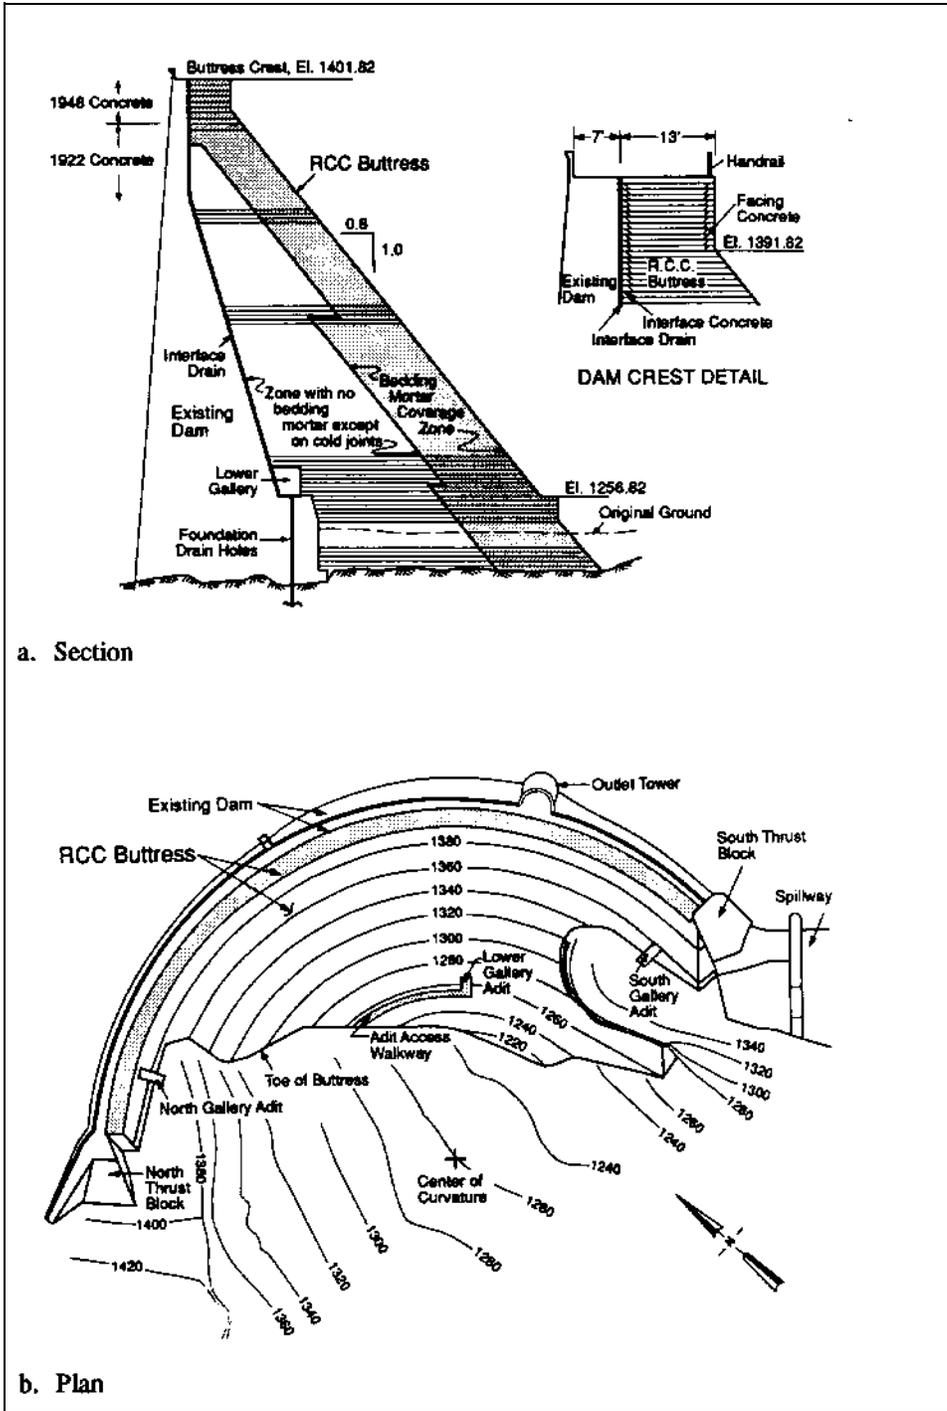
Figure 8-69. Section and plan of modified Gibraltar Dam (Wong et al 1992)

(1) The results of a 1983 safety evaluation indicated that the dam did not meet seismic safety standards. Therefore, an RCC buttress was constructed against the downstream face of the dam to alter the dynamic response characteristics of the dam and thus reduce the stresses induced during an earthquake. The addition of the gravity buttress effectively converted the existing arch into a curved gravity dam as shown in Figure 8-69 (Wong et al. 1992).

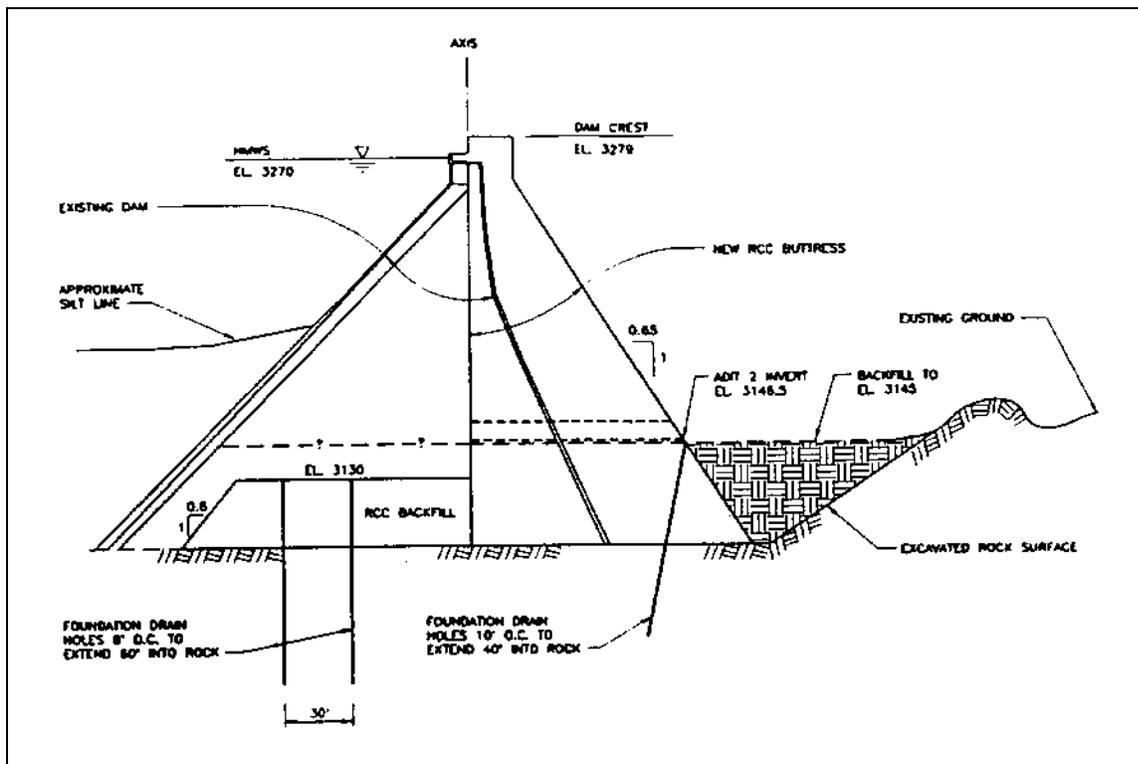
Figure 8-70. Littlerock Dam modification (Bischoff and Obermeyer 1993)

rehabilitation program that included construction of an RCC gravity section between and around the downstream portions of the existing buttresses (Figure 8-70). Also, steel fiber-reinforced shotcrete with silica fume was used to resurface and stiffen the arches of the existing dam. RCC placement began in November 1993, and approximately 70,500 cu m (93,000 cu yd) was placed in just over 2 months. The RCC essentially converted the multiple-arch dam into a gravity structure. In addition, the crest of the dam was raised 3.7 m (12 ft) with conventional concrete to increase water storage capacity. The cost of the RCC buttress repair was \$12.8 million compared to an estimated cost of \$22.5 million for filling the arch bays with mass concrete.
